## **PERFORMANCE OF NO VIBRATION / NO ADMIXTURE MASONRY GROUT CONTAINING HIGH REPLACEMENT OF PORTLAND CEMENT WITH FLY ASH AND GROUND GRANULATED BLAST FURNACE SLAG**

**James P. Mwangi, Ph.D., S.E.<sup>1</sup>, Craig Baltimore, Ph.D., S.E.<sup>2</sup> and Eric W. Bateman<sup>3</sup>**

### **ABSTRACT**

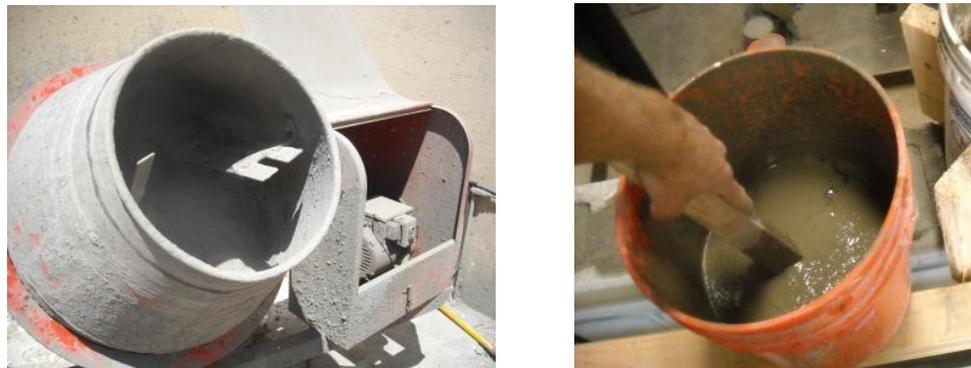
The material proportions were batched by volume and mixed in a mechanical mixer in accordance with ASTM C476 as seen in Figure 2.

**Figure 2: Grout Materials Mixing in (a) Mechanical Mixer and (b) Re-Mixing in Bucket**

The walls were grouted between 77 and 81 days after the walls were erected. The materials were batched by volume and mixed in a mechanical mixer in accordance with ASTM C476 as shown in Figure 2. The slump test, following ASTM C1019, was conducted for the conventional grouts or a slump flow test, following ASTM C1611, was conducted for the experimental grouts. The grout was poured into the grout column through a funnel at the top. A flashlight was used to check if there was any seepage from the grout into the adjacent grout columns and none was observed in all columns. For the conventional grout columns with mechanical consolidation, the mechanical internal-type vibrator was lowered into the center and all the way to the bottom of the column before the grout was poured. Once approximately one third of the grout column was poured, the vibrator was turned on and left for 5 seconds and slowly lifted out one third of the way. This was repeated until the grout column was completely grouted and vibrated. Figure 8 shows the grouting and vibration operations.

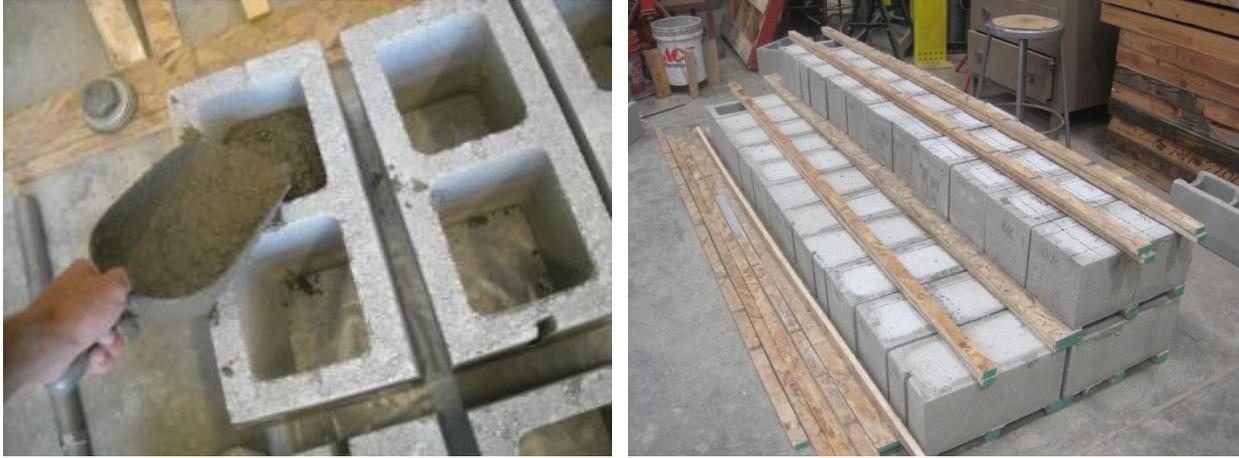
Grout specimens were made and tested in accordance with ASTM C1019, with one exception: the grout was poured into the cores of 203x203x406 mm (8x8x16 in.) (nominal) rather than constructing a grout mold using four CMUs. This exception was made in order to save space and mimic the same water absorption the grout experiences while curing in the core of the CMU, yet still providing the absorptive mold requirement in ASTM C1019. The grouted CMUs were dry cured, complying with ASTM C157, as seen in Figure 3.

**Figure 3: (a) Pouring Grout into Cores of CMUs and (b) Dry Curing Grout Specimens**

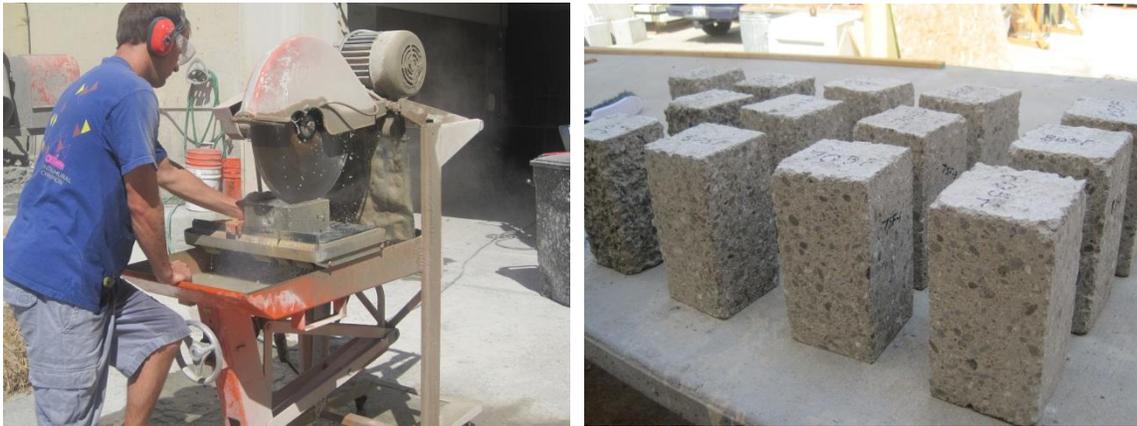
One day prior to testing, the compression test specimens were made by saw cutting the grout specimens to 102x102x203 mm (4x4x8 in.) nominal, satisfying the dimensional requirements of ASTM C1019 as shown in Figure 4.

**Figure 4: (a) Wet Saw Cutting Specimens and (b) Final Grout Compression Specimens**

A 508 mm (20 in.) diamond blade wet saw was used to cut the compression specimens into 102x102x203 mm (4x4x8 in.) (nominal) grout units and the consolidation specimens once across the middle of the grout cell in order to see the consolidation characteristic around the reinforcement as shown in Figure 4. In total, 96 compression test specimens and 96 consolidation specimens were retrieved from the walls. Figure 11 shows wall compression and consolidation specimens.

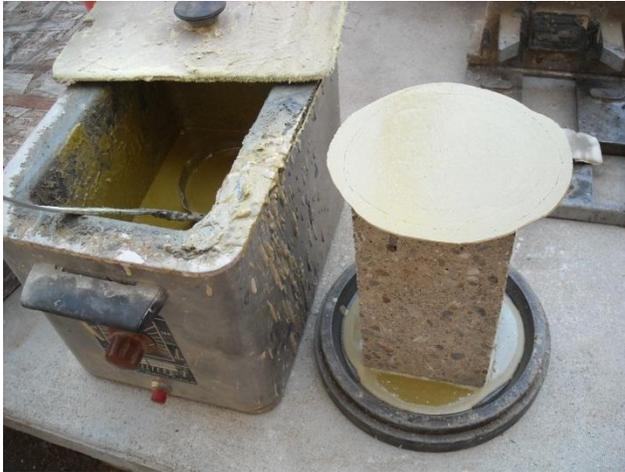
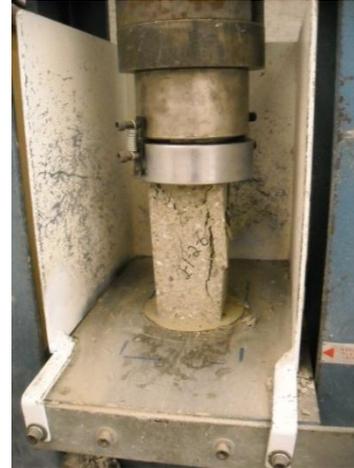
The specimens were capped and tested in compression in accordance with ASTM C1019 as shown in Figure 5.

**Figure 5: (a) Capping of Grout Compression Specimens and (b) Compression Testing**

The retrieved compression specimens were capped and prepared for testing in accordance with ASTM C1552 and ASTM C1314, as shown in Figure 5.

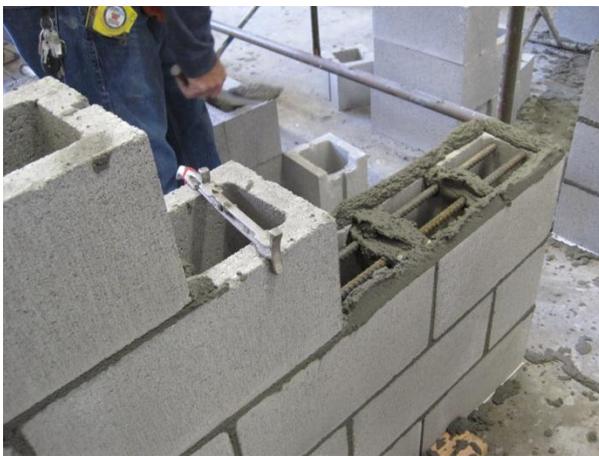
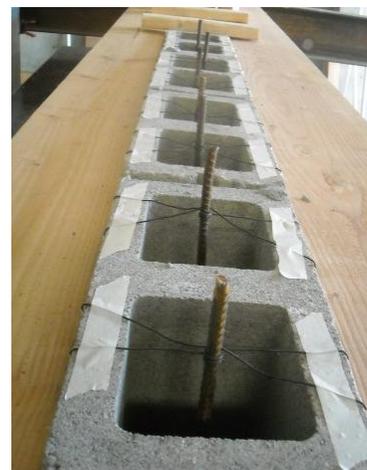
Four walls were constructed by professional masons in one lift for the Wall Experiment. All the walls were built in running bond using double square core, single wythe 203x203x406 mm (8x8x16 in.) nominal CMU, and 19 courses 3.86 m (12.67 ft) in height. Full mortar bedding was used to prevent the grout from flowing into adjacent grout columns. The walls were labeled 1, 2, 3, and 4. Walls 1, 2, and 3 were used for the evaluation of compression strengths and visual inspection of the flow characteristics around the mortar fins and reinforcement of the grouts at varying heights along the wall. Wall 4 was used for the evaluation of the bond between the reinforcement and grouts at varying heights along the wall. Walls 1, 2, and 3 were 1.2 m (4.0 ft) (nominal) wide and consisted of six grout columns. The walls had two 16 mm (#5) horizontal reinforcement bars placed at 0.61 m (2.0 ft) on center vertically. Wall 4 was 1.63 m (5ft-4in) (nominal) wide and consisted of eight grout columns. The wall had one 10 mm (#3) vertical reinforcing bar placed as close to the in the middle of each grout column as possible, throughout the entire height of the column as shown in Figure 6.

**Figure 6: Wall Construction (a) Horizontal Steel Placement and (b) Vertical Steel Placement**

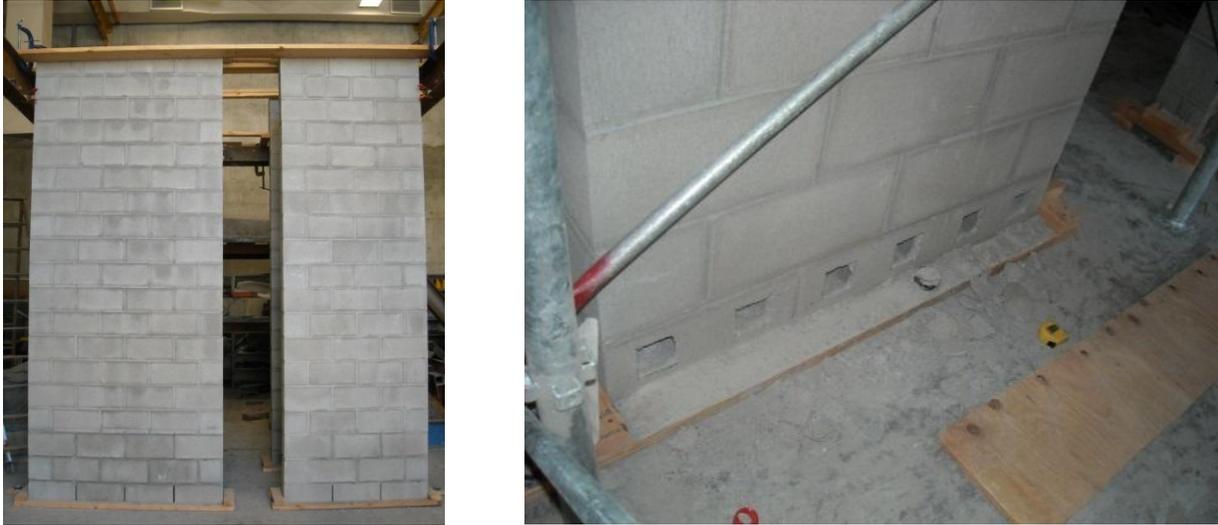
Cleanouts were provided in the first course of all the columns to be grouted as shown in Figure 7.

**Figure 7: (a) Wall Elevation and (b) Location of Cleanouts**

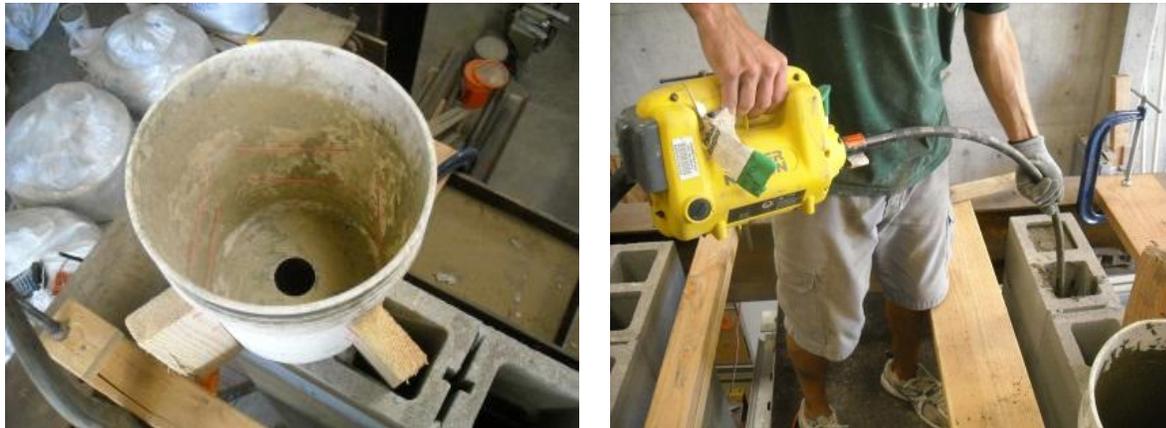
**Figure 8: (a) Grout Funnel Leading into One Grout Column and (b) Mechanical Vibration**

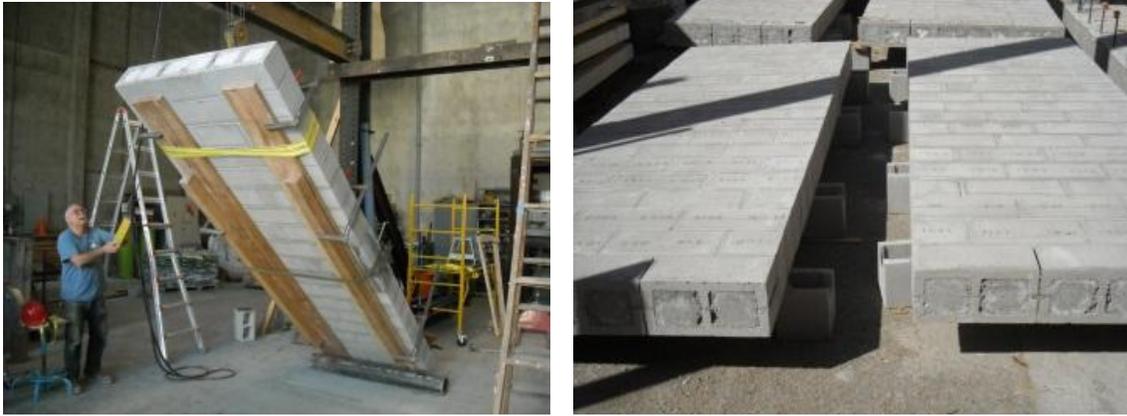
The walls were lowered to a horizontal position approximately 70 days after being grouted using an overhead crane as shown in Figure 9

**Figure 9: (a) Lowering the Wall and (b) Lowered Walls**

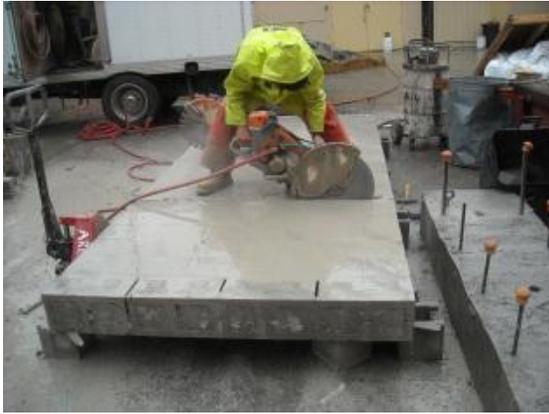
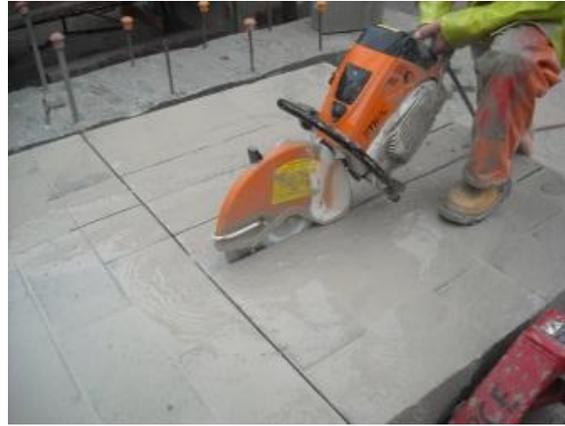
The walls were cut by a demolition company using 355.6, 406.4 and 457.2 mm (14, 16 and 18 in.) diameter diamond blades and hydraulic ring saws in order to retrieve the test specimens. The walls were cut horizontally and vertically as shown in Figure 10.

**Figure 10: Cutting Wall 3 at Every Course with a 16” Diameter Diamond Blade Cut-Off Saw**

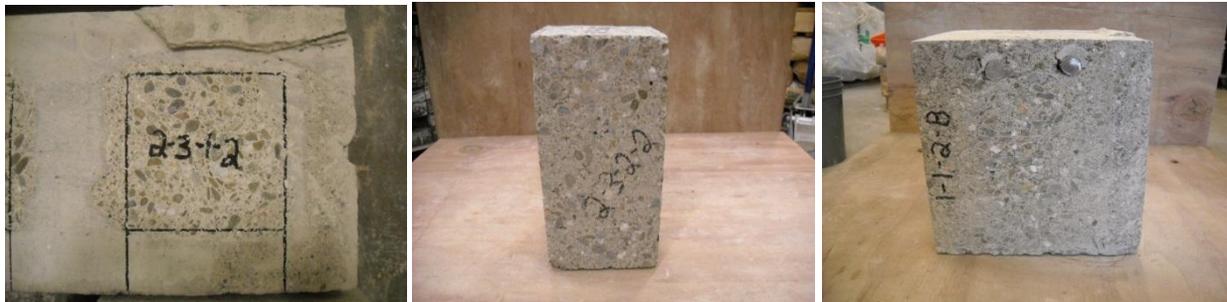
**Figure 11: (a), (b), Side of Compression Specimen and (c) Consolidation Specimen**
