## **PERFORMANCE OF NO VIBRATION / NO ADMIXTURE MASONRY GROUT CONTAINING HIGH REPLACEMENT OF PORTLAND CEMENT WITH FLY ASH AND GROUND GRANULATED BLAST FURNACE SLAG**

**James P. Mwangi, Ph.D., S.E.<sup>1</sup>, Craig Baltimore, Ph.D., S.E.<sup>2</sup> and Eric W. Bateman<sup>3</sup>**

### **ABSTRACT**

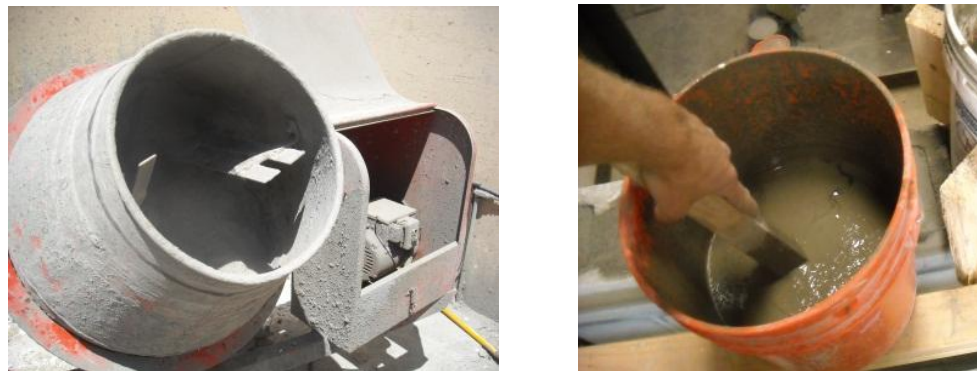
The material proportions were batched by volume and mixed in a mechanical mixer in accordance with ASTM C476 as seen in Figure 2.

**Figure 2: Grout Materials Mixing in (a) Mechanical Mixer and (b) Re-Mixing in Bucket**

The walls were grouted between 77 and 81 days after the walls were erected. The materials were batched by volume and mixed in a mechanical mixer in accordance with ASTM C476 as shown in Figure 2. The slump test, following ASTM C1019, was conducted for the conventional grouts or a slump flow test, following ASTM C1611, was conducted for the experimental grouts. The grout was poured into the grout column through a funnel at the top. A flashlight was used to check if there was any seepage from the grout into the adjacent grout columns and none was observed in all columns. For the conventional grout columns with mechanical consolidation, the mechanical internal-type vibrator was lowered into the center and all the way to the bottom of the column before the grout was poured. Once approximately one third of the grout column was poured, the vibrator was turned on and left for 5 seconds and slowly lifted out one third of the way. This was repeated until the grout column was completely grouted and vibrated. Figure 8 shows the grouting and vibration operations.

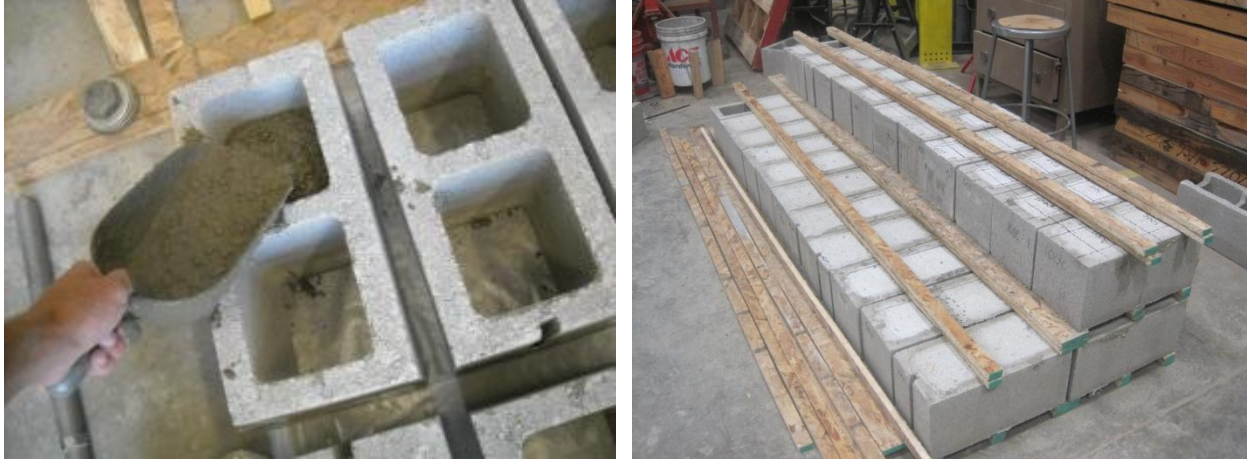
Grout specimens were made and tested in accordance with ASTM C1019, with one exception: the grout was poured into the cores of 203x203x406 mm (8x8x16 in.) (nominal) rather than constructing a grout mold using four CMUs. This exception was made in order to save space and mimic the same water absorption the grout experiences while curing in the core of the CMU, yet still providing the absorptive mold requirement in ASTM C1019. The grouted CMUs were dry cured, complying with ASTM C157, as seen in Figure 3.

**Figure 3: (a) Pouring Grout into Cores of CMUs and (b) Dry Curing Grout Specimens**

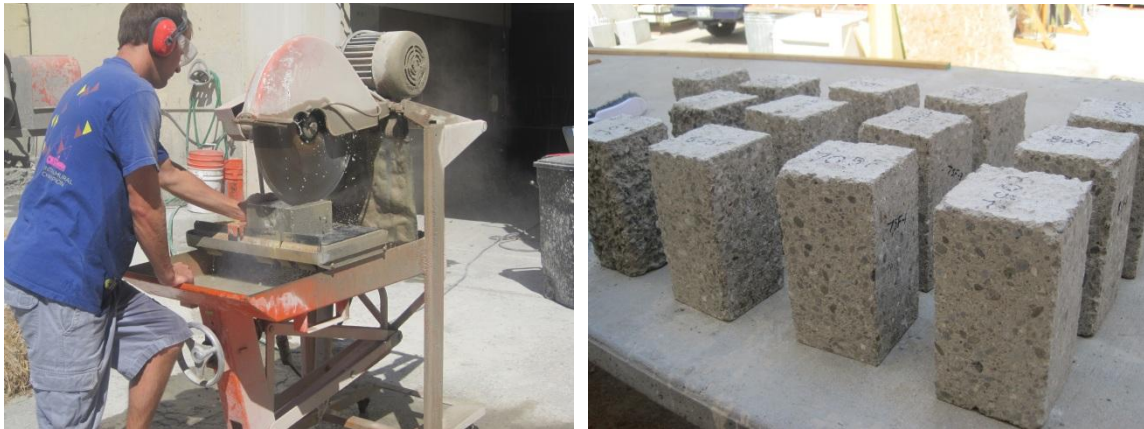
One day prior to testing, the compression test specimens were made by saw cutting the grout specimens to 102x102x203 mm (4x4x8 in.) nominal, satisfying the dimensional requirements of ASTM C1019 as shown in Figure 4.

**Figure 4: (a) Wet Saw Cutting Specimens and (b) Final Grout Compression Specimens**

A 508 mm (20 in.) diamond blade wet saw was used to cut the compression specimens into 102x102x203 mm (4x4x8 in.) (nominal) grout units and the consolidation specimens once across the middle of the grout cell in order to see the consolidation characteristic around the reinforcement as shown in Figure 4. In total, 96 compression test specimens and 96 consolidation specimens were retrieved from the walls. Figure 11 shows wall compression and consolidation specimens.

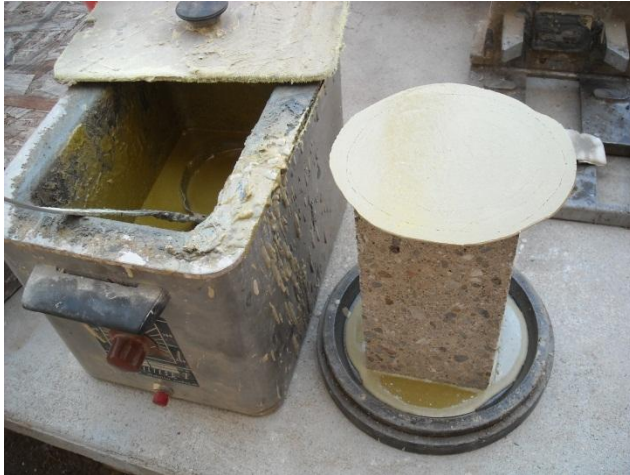
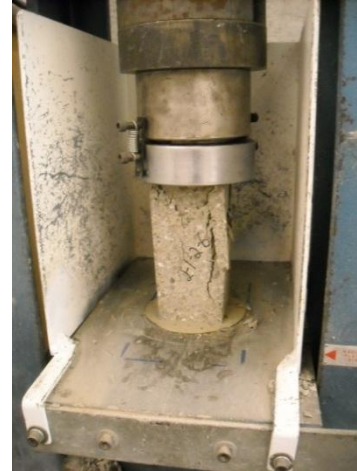
The specimens were capped and tested in compression in accordance with ASTM C1019 as shown in Figure 5.

**Figure 5: (a) Capping of Grout Compression Specimens and (b) Compression Testing**

The retrieved compression specimens were capped and prepared for testing in accordance with ASTM C1552 and ASTM C1314, as shown in Figure 5.

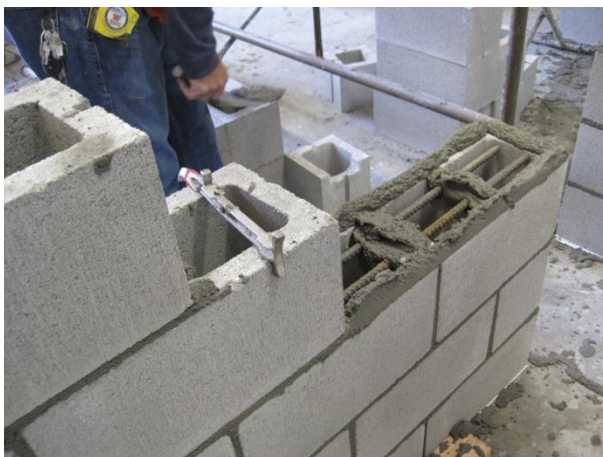
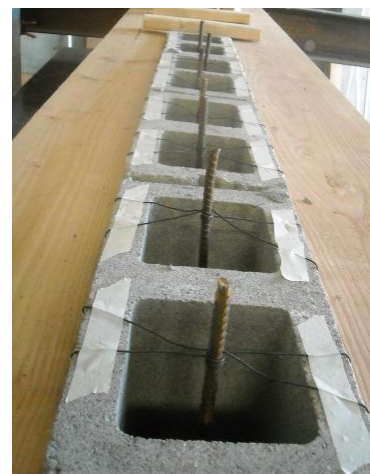
Four walls were constructed by professional masons in one lift for the Wall Experiment. All the walls were built in running bond using double square core, single wythe 203x203x406 mm (8x8x16 in.) nominal CMU, and 19 courses 3.86 m (12.67 ft) in height. Full mortar bedding was used to prevent the grout from flowing into adjacent grout columns. The walls were labeled 1, 2, 3, and 4. Walls 1, 2, and 3 were used for the evaluation of compression strengths and visual inspection of the flow characteristics around the mortar fins and reinforcement of the grouts at varying heights along the wall. Wall 4 was used for the evaluation of the bond between the reinforcement and grouts at varying heights along the wall. Walls 1, 2, and 3 were 1.2 m (4.0 ft) (nominal) wide and consisted of six grout columns. The walls had two 16 mm (#5) horizontal reinforcement bars placed at 0.61 m (2.0 ft) on center vertically. Wall 4 was 1.63 m (5ft-4in) (nominal) wide and consisted of eight grout columns. The wall had one 10 mm (#3) vertical reinforcing bar placed as close to the in the middle of each grout column as possible, throughout the entire height of the column as shown in Figure 6.

**Figure 6: Wall Construction (a) Horizontal Steel Placement and (b) Vertical Steel Placement**

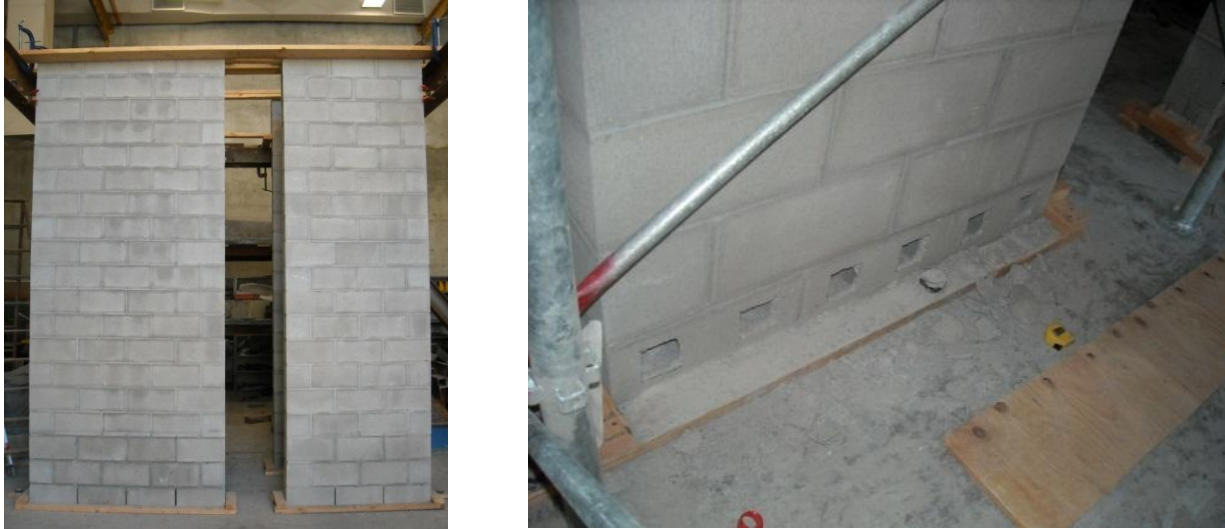
Cleanouts were provided in the first course of all the columns to be grouted as shown in Figure 7.

**Figure 7: (a) Wall Elevation and (b) Location of Cleanouts**

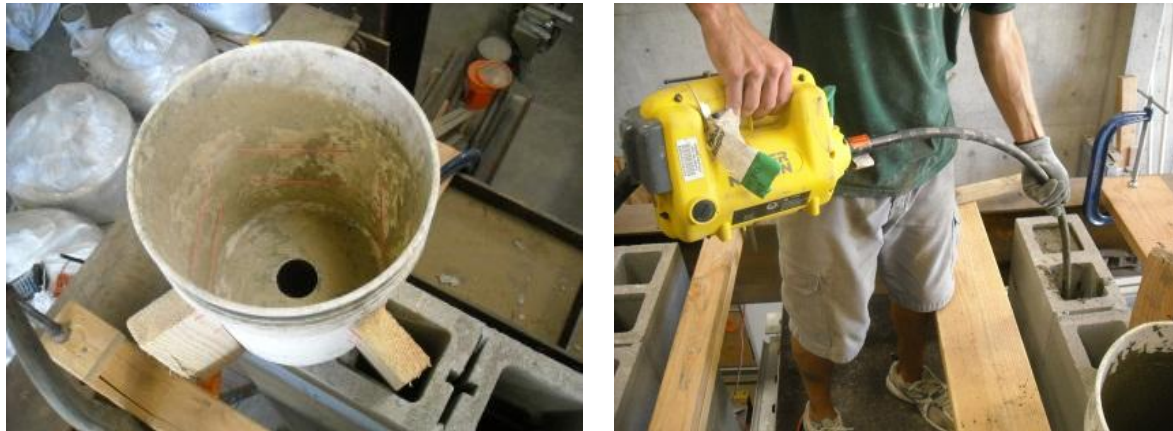
**Figure 8: (a) Grout Funnel Leading into One Grout Column and (b) Mechanical Vibration**

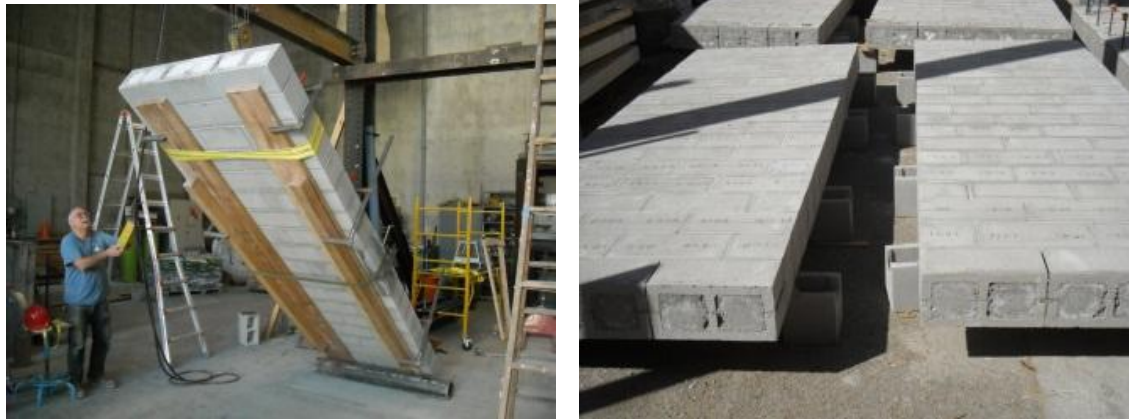
The walls were lowered to a horizontal position approximately 70 days after being grouted using an overhead crane as shown in Figure 9

**Figure 9: (a) Lowering the Wall and (b) Lowered Walls**

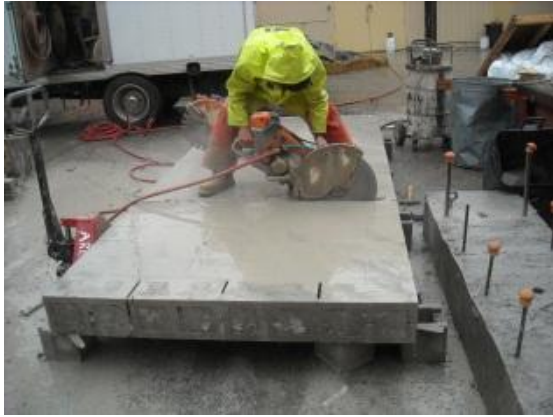
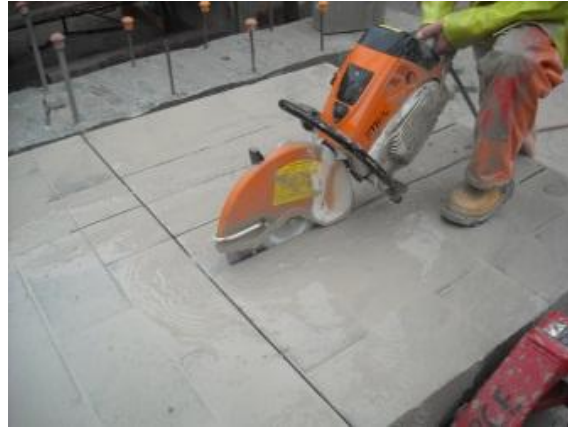
The walls were cut by a demolition company using 355.6, 406.4 and 457.2 mm (14, 16 and 18 in.) diameter diamond blades and hydraulic ring saws in order to retrieve the test specimens. The walls were cut horizontally and vertically as shown in Figure 10.

**Figure 10: Cutting Wall 3 at Every Course with a 16” Diameter Diamond Blade Cut-Off Saw**

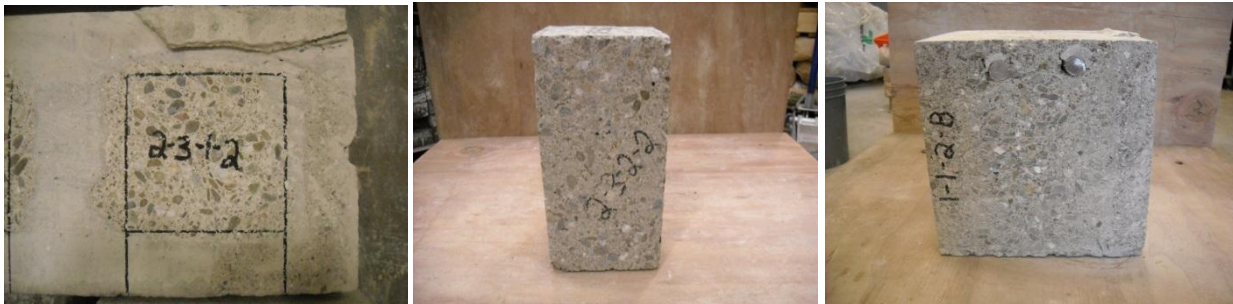
**Figure 11: (a), (b), Side of Compression Specimen and (c) Consolidation Specimen**

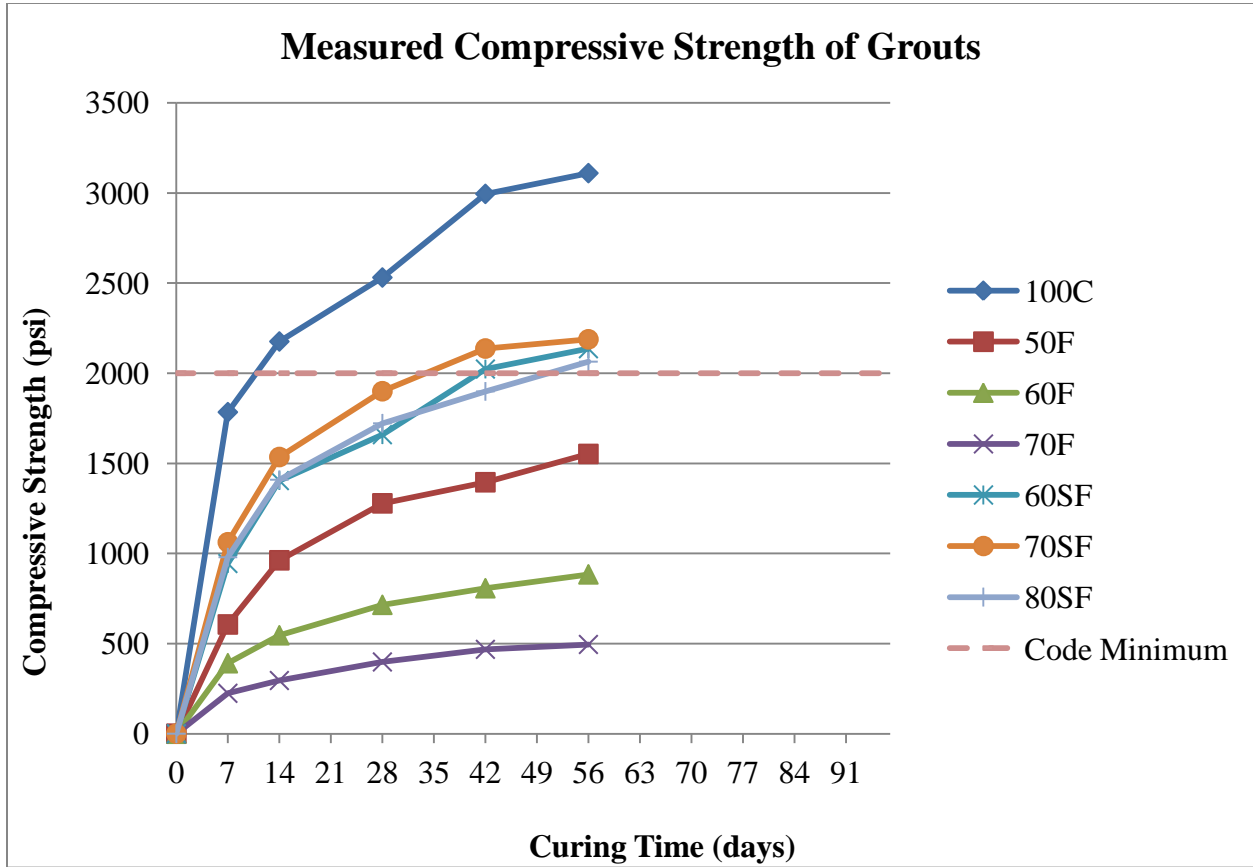
Compression test results for the experimental and conventional grouts are shown in Figure 12.

**Figure 12: Average Net Corrected Compressive Strength of Grouts**
