INTERNATIONAL SUSTAINABILITY THROUGH KNOWLEDGE TRANSFER CONSIDERING CULTURE AND RESOURCES – SLEDGEHAMMER ATTACKS ON ADOBE MASONRY WALLS.

Abstract

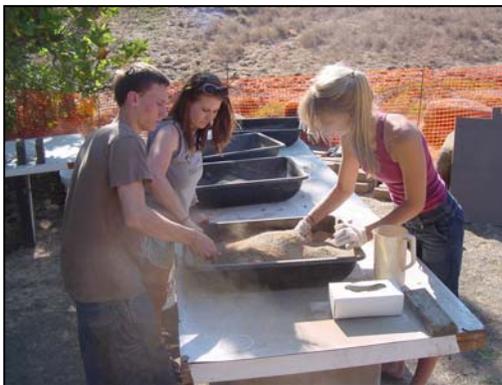
Figure 1. Students measuring and mixing dry materials of adobe mix.

The students were given a lesson in adobe brick making and then left to themselves to make bricks. The mixture consisted of 30% clay, 60% sand, 10% cement (dry mix), and enough water to give the proper consistency (Blondet 2003) (U.S.D.A. 1999). Measuring of the materials was done by volume with $\frac{1}{2}$ gallon plastic water pitcher (Figure 1). Since the goal was to mimic the conditions in a developing nation, (minimal quality control), the students were unsupervised and relied on each other for assuring quality of product. The mixture was placed in a brick press and compressed. (Figure 2). The bricks were then laid out in open air to cure. The bricks were sprayed with water during the first 3 days.

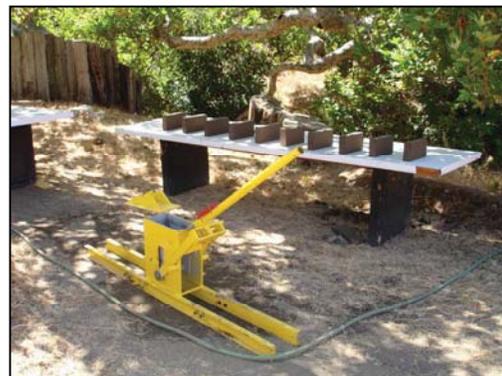
Figure 2: Hand brick press and bricks air curing.

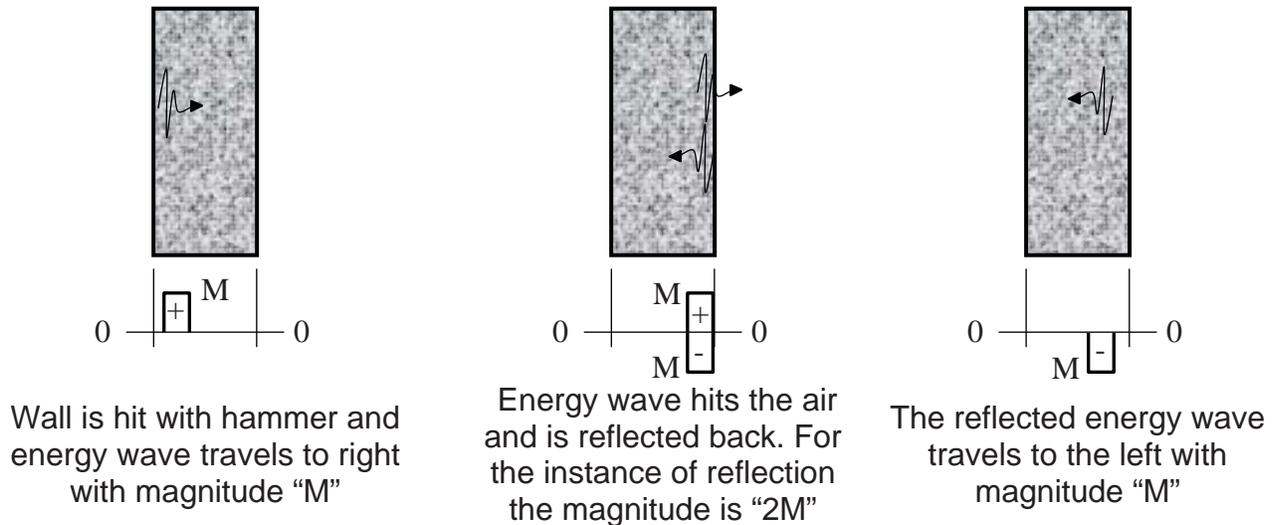
Figure 3. Energy wave transmission sequence

The solution for improved adobe wall performance to resist sledgehammer impact was based on energy wave transmission (Hinrose 1991). When a solid is impacted with a hammer, an energy wave is set into motion. When the wave travels to the end of the material, the air acts as an insulator and the wave is reflected back within the wall. At the instance of reflection, the energy wave is doubled in magnitude; often breaking the material (see Figure 3).

To reduce the doubling in the magnitude of the energy wave, at the instant of reflection, another material can be attached such that the new material will allow the wave to continue (not reflect); the new material will have damping properties (dissipate the energy). By providing a two wythe wall with a cavity, the damping material can be added in the cavity. Considering the local resources (sustainability), sand was chosen as the energy dissipating material.

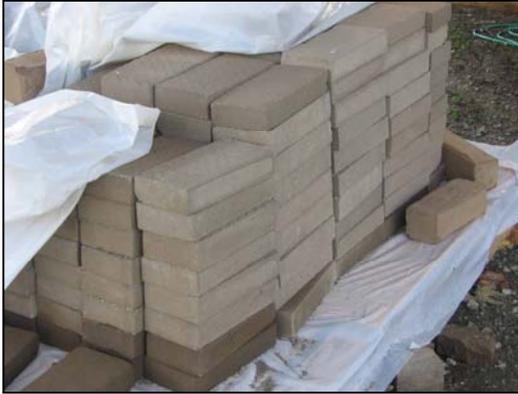
Figure 4: Bricks made by students

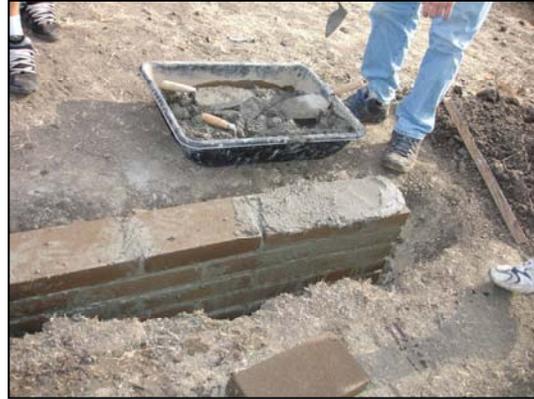
Figure 5: Brick wall laid directly on ground starting 5 course below grade

Each wall was constructed from adobe bricks 6"x12"x2.5". The mortar mix used was 7 parts sand to one part cement (characteristic proportions for the rural area) . Because foundations vary in the rural regions, from no foundation to a foundation of stone and mortar; an intermediate foundation was constructed by building the wall in contact with the ground, but starting the wall 5 courses below grade (Figure 5).

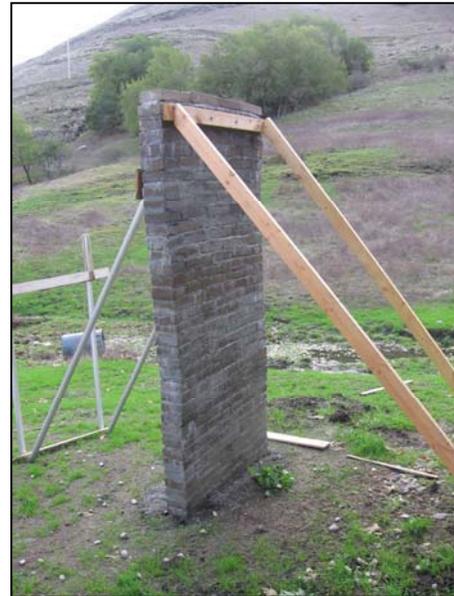
Figure 6: Flexible top of wall support

To represent the typical roof construction of wood framing with sheet metal, a wooden brace system was used to give similar flexibility in the top of wall support (Figure 6).

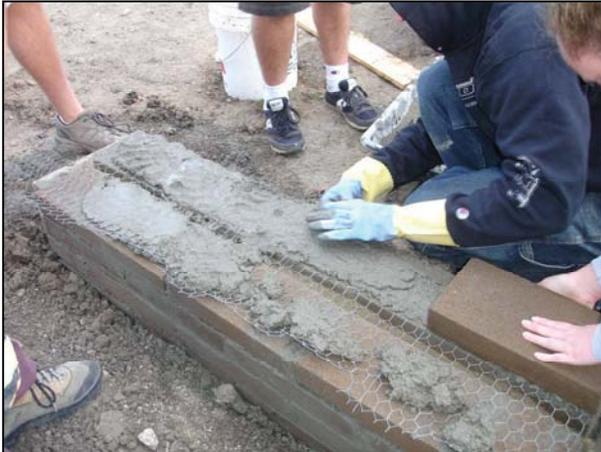
Figure 7: Chicken wire used to tie double wythe wall together.

In constructing the double wythe wall, chicken wire at every 5th course was used to tie the wythes together. At every 5th course, prior to the placement of chicken wire, the cavity was filled with sand (Figures 7 and 8). The ends of the wall were capped with adobe brick.

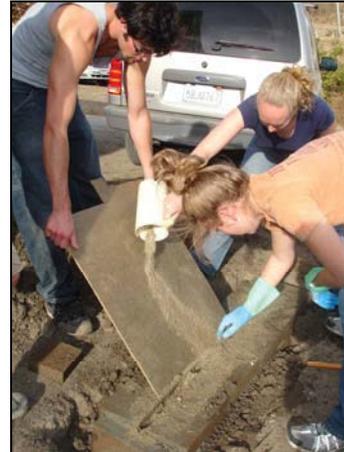
Figure 8: Placement of sand in cavity of double wythe wall

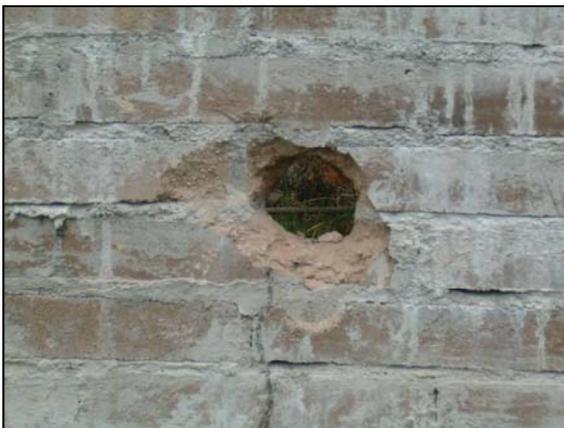
Figure 9: Single wythe wall and penetration, front face

9 hammer blows were needed to break through the single wythe wall and the result was an explosive penetration. The 9 swings took less than 2 minutes to complete. The sledgehammer penetrated the front face (side of the wall being impacted by the hammer) by one inch at which time the back face exploded outward creating the hole (Figures 9 and 10).

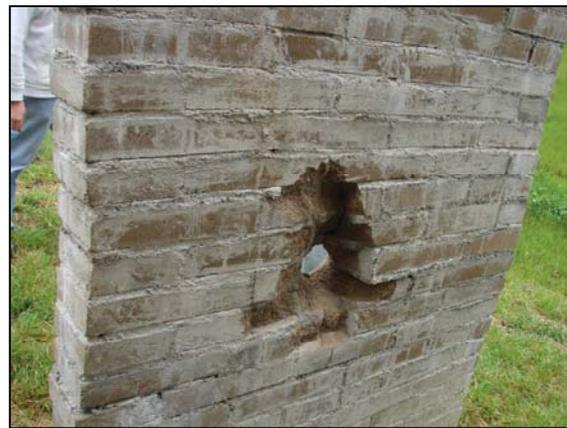
Figure 10: Single wythe wall and penetration, back face

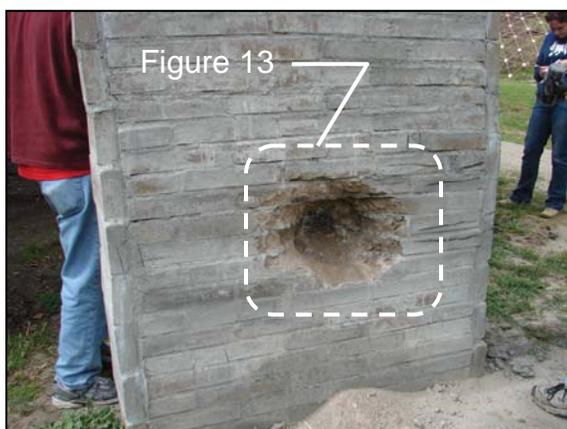
Figure 11: Double wythe wall and penetration by a chipping action of the hammer head, front face

The double wythe wall took well over 100 hammer blows (139) to penetrate and the result was a chipping out of the wall with the hammer head. It took over 20 minutes to completely

break through the wall. The process of chipping away of the wall is non-explosive. During the process, the hammer head would occasionally become lodged in the hole or the sledgehammer shaft would hit the wall before the hammer head -- extending the amount time needed to penetrate. The hammerhead had to dig through the major part of the wall. There was approximately two inches of wall remaining when the hammer impact penetrated the wall (Figures 11 and 12)

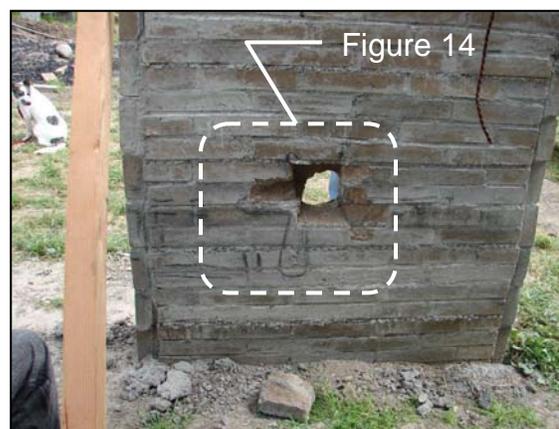
Figure 12: Double wythe wall and penetration, back face

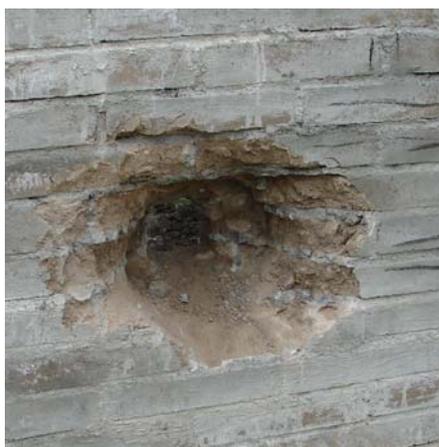
Figure 13: Double wythe wall and penetration by a chipping action of the hammer head, front face

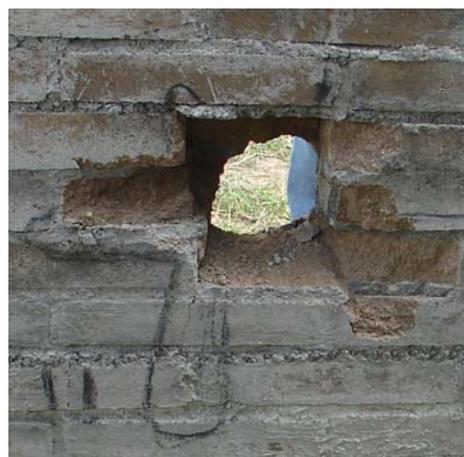
Figure 14: Double wythe wall and penetration, back face
