INTERNATIONAL SUSTAINABILITY THROUGH KNOWLEDGE TRANSFER CONSIDERING CULTURE AND RESOURCES – SLEDGEHAMMER ATTACKS ON ADOBE MASONRY WALLS.

Abstract

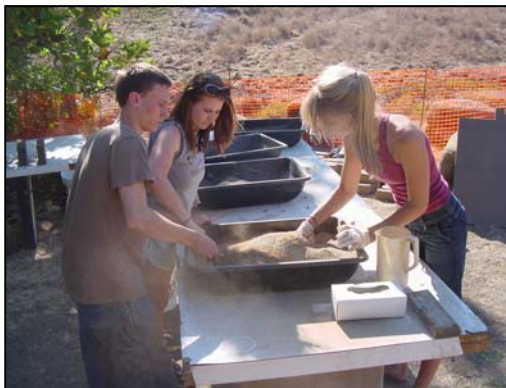
Figure 1. Students measuring and mixing dry materials of adobe mix.

The students were given a lesson in adobe brick making and then left to themselves to make bricks. The mixture consisted of 30% clay, 60% sand, 10% cement (dry mix), and enough water to give the proper consistency (Blondet 2003) (U.S.D.A. 1999). Measuring of the materials was done by volume with $\frac{1}{2}$ gallon plastic water pitcher (Figure 1). Since the goal was to mimic the conditions in a developing nation, (minimal quality control), the students were unsupervised and relied on each other for assuring quality of product. The mixture was placed in a brick press and compressed. (Figure 2). The bricks were then laid out in open air to cure. The bricks were sprayed with water during the first 3 days.

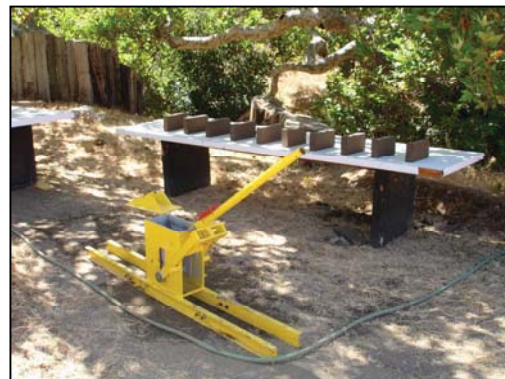
Figure 2: Hand brick press and bricks air curing.

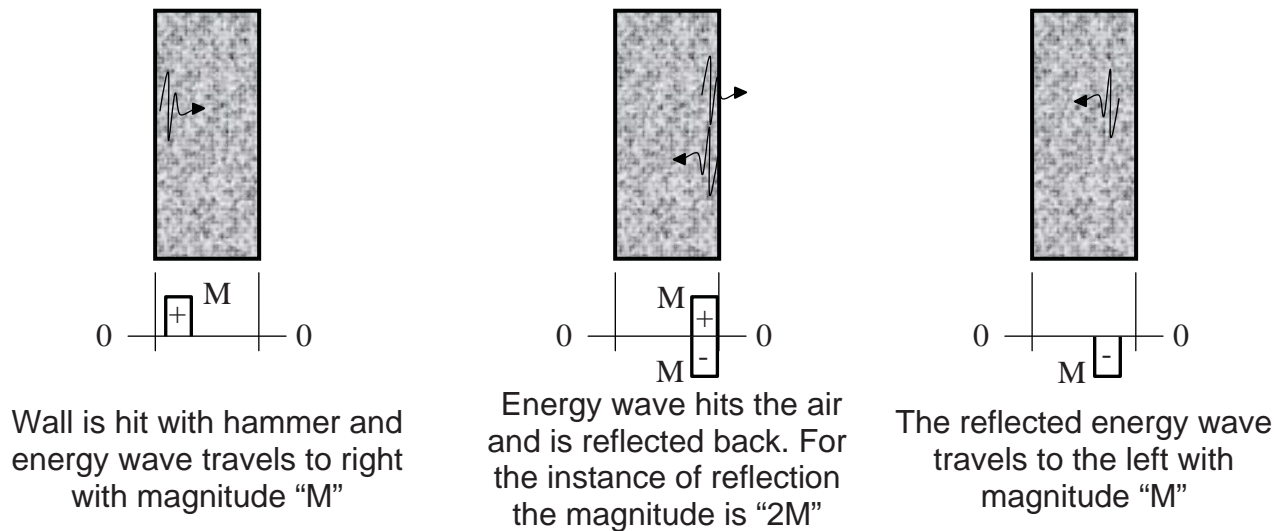
Figure 3. Energy wave transmission sequence

The solution for improved adobe wall performance to resist sledgehammer impact was based on energy wave transmission (Hinrose 1991). When a solid is impacted with a hammer, an energy wave is set into motion. When the wave travels to the end of the material, the air acts as an insulator and the wave is reflected back within the wall. At the instance of reflection, the energy wave is doubled in magnitude; often breaking the material (see Figure 3).

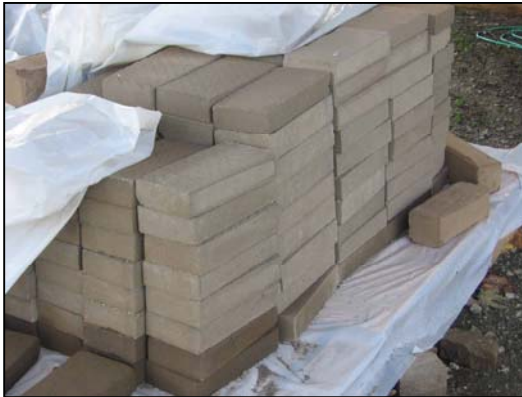
Figure 4: Bricks made by students

Each wall was constructed from adobe bricks 6"x12"x2.5". The mortar mix used was 7 parts sand to one part cement (characteristic proportions for the rural area) . Because foundations vary in the rural regions, from no foundation to a foundation of stone and mortar; an intermediate foundation was constructed by building the wall in contact with the ground, but starting the wall 5 courses below grade (Figure 5).

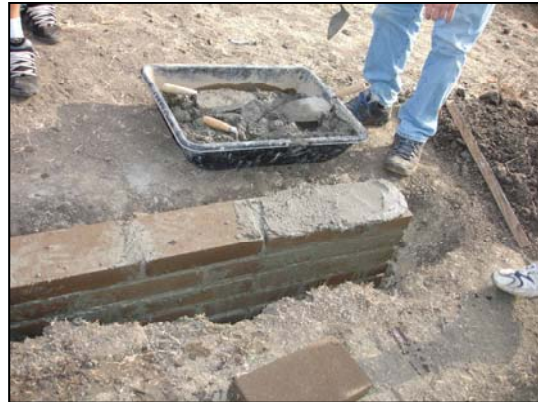
Figure 5: Brick wall laid directly on ground starting 5 course below grade

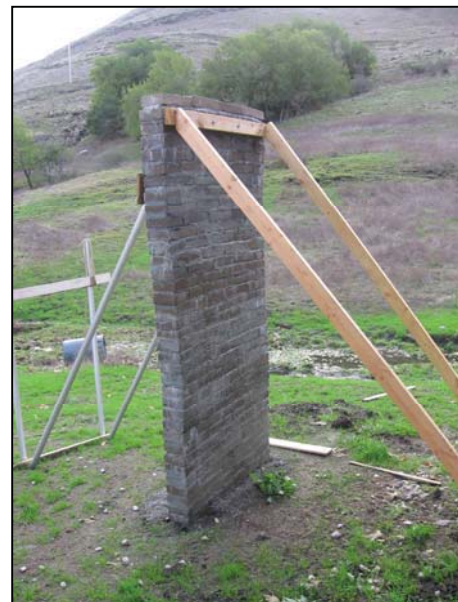
Figure 6: Flexible top of wall support

To represent the typical roof construction of wood framing with sheet metal, a wooden brace system was used to give similar flexibility in the top of wall support (Figure 6).

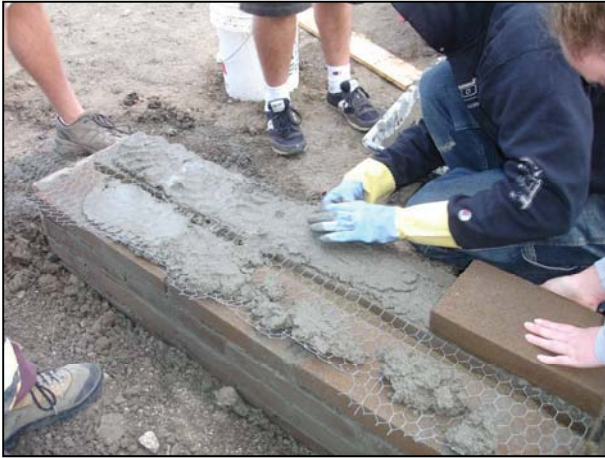
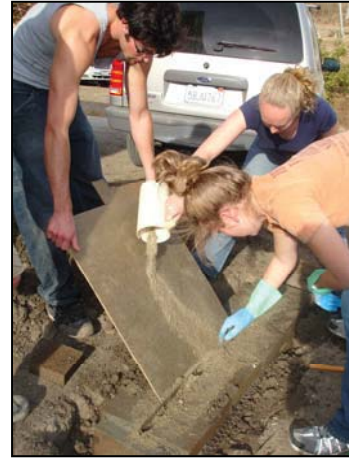
Figure 7: Chicken wire used to tie double wythe wall together.

Figure 8: Placement of sand in cavity of double wythe wall

In constructing the double wythe wall, chicken wire at every 5th course was used to tie the withes together. At every 5th course, prior to the placement of chicken wire, the cavity was filled with sand (Figures 7 and 8). The ends of the wall were capped with adobe brick.

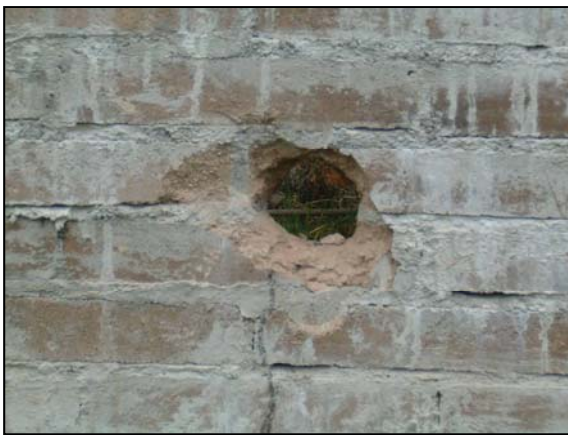
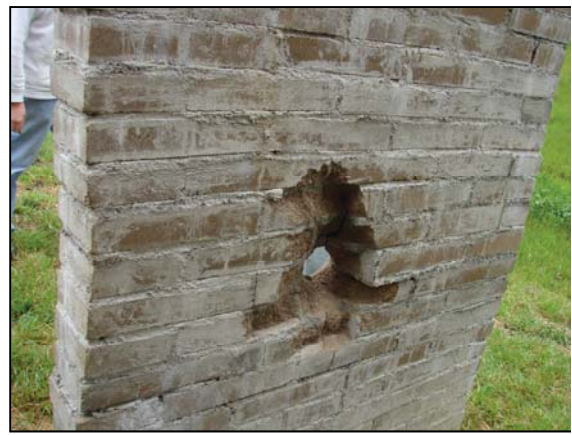
Figure 9: Single wythe wall and penetration, front face

Figure 10: Single wythe wall and penetration, back face

9 hammer blows were needed to break through the single wythe wall and the result was an explosive penetration. The 9 swings took less than 2 minutes to complete. The sledgehammer penetrated the front face (side of the wall being impacted by the hammer) by one inch at which time the back face exploded outward creating the hole (Figures 9 and 10).

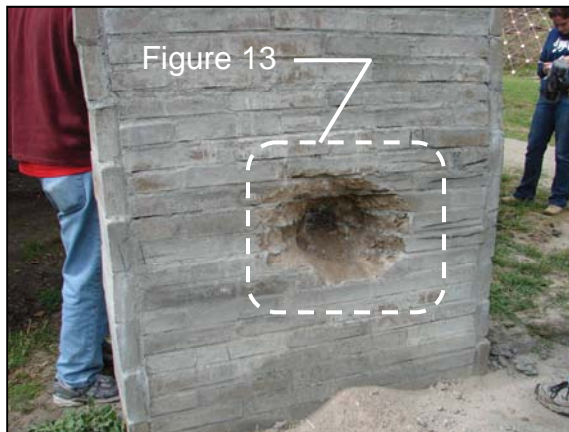
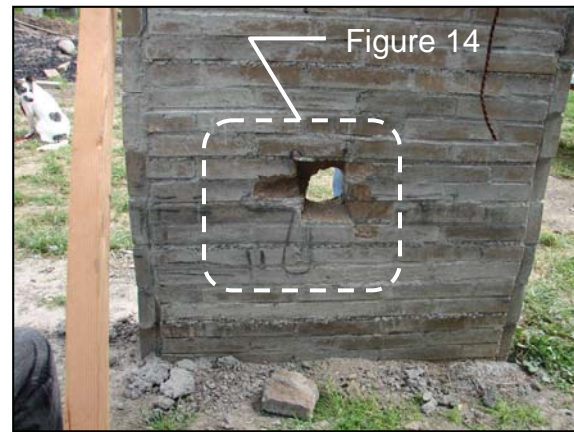
Figure 11: Double wythe wall and penetration by a chipping action of the hammer head, front face

Figure 12: Double wythe wall and penetration, back face

The double wythe wall took well over 100 hammer blows (139) to penetrate and the result was a chipping out of the wall with the hammer head. It took over 20 minutes to completely

break through the wall. The process of chipping away of the wall is non-explosive. During the process, the hammer head would occasionally become lodged in the hole or the sledgehammer shaft would hit the wall before the hammer head -- extending the amount time needed to penetrate. The hammerhead had to dig through the major part of the wall. There was approximately two inches of wall remaining when the hammer impact penetrated the wall (Figures 11 and 12)

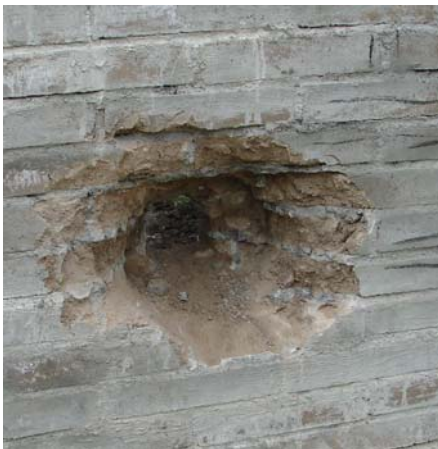
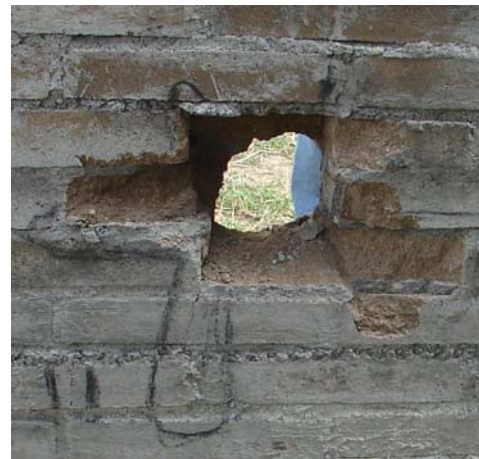
Figure 13: Double wythe wall and penetration by a chipping action of the hammer head, front face

Figure 14: Double wythe wall and penetration, back face
