# Characterization of the 15-5 Stainless Steel Electric Discharge Machining Recast Layer

A Senior Project

Sponsor: Aerojet Rocketdyne

June, 2017

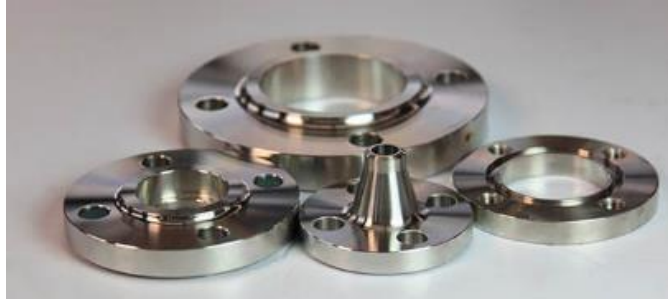
Figure 1: 15-5 is commonly used in flanges for aerospace components.<sup>2</sup>

15-5 (15% chromium, 5% nickel) is a martensitic, precipitation hardenable stainless steel useful for its high strength, good corrosion resistance, and relatively high temperature use. This alloy is similar to the most common precipitation hardenable stainless steel, 17-4, except it lacks the ferrite phase. Like 17-4, 15-5 is weldable with common fusion and resistance techniques. Its mechanical properties are generally favorable (Table I). As a result of its advantageous properties, 15-5 finds versatile use in the aerospace, chemical, and food processing industries (Figure 1).
