Final Report

City of Anaheim / Caltrans / FHWA

Advanced Traffic Control System Field Operational Test

Video Traffic Detection System

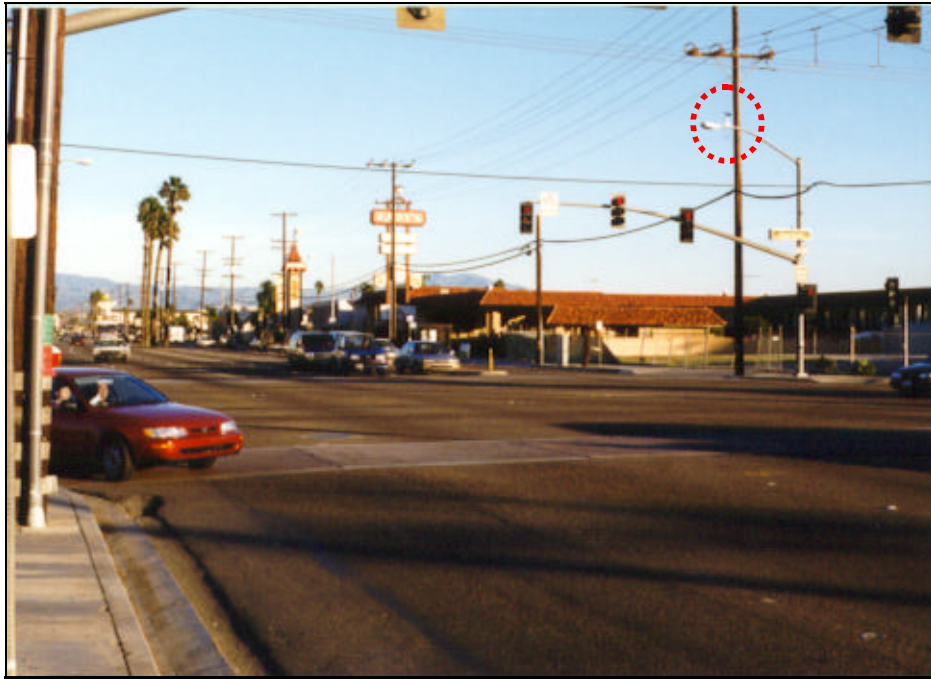
Figure 5. Harbor and Katella Test Intersection.

Figures 5 and 6 below are ground-level photographs of the Harbor/Katella and Clementine/Freedman test intersections, at which most of the test conditions were recorded. The positions of the VTDS cameras in each photograph are highlighted by dashed circles.

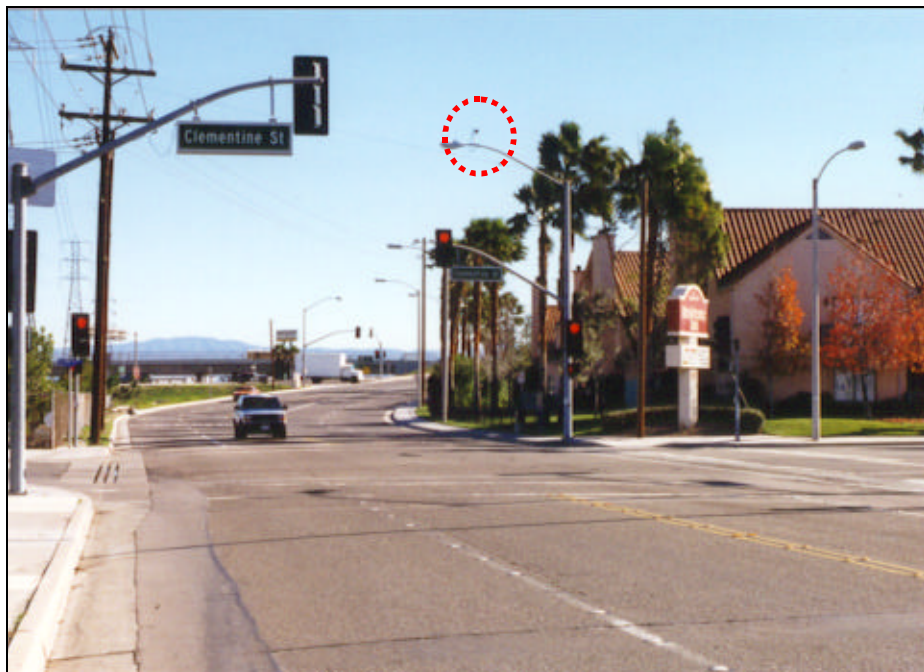
Figure 6. Clementine and Freedman Test Intersection.

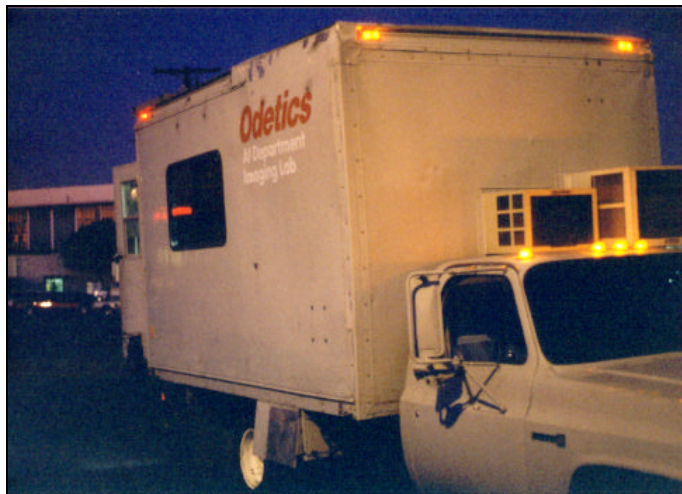
Figure 9. Mobile Laboratory Exterior.

At the Odetics facility we also inspected the mobile surveillance laboratory, as required under FOT Task 9. At the time of our inspection, the vehicle appeared to no longer be in use for this application. Two monitors, one VTR, and a few other unconnected equipment items in a rack mount frame and miscellaneous materials storage were observed. The interior and exterior of the vehicle were photographed for documentary purposes, and are shown respectively in Figures 9 and 10 below. It does not appear from our inspection that this trailer was being employed in the field testing of the VTDS Intersection Product. Since the vehicle can only be parked on the side of a roadway, it could not be used for acquisition of video sequences usable by the VTDS Intersection Product, which requires camera placements in the roadway centers of intersection approaches. It is suitable for and was probably utilized for the development of the earlier version of the VTDS, which was specified as a general purpose data collection and signal actuation detection system.

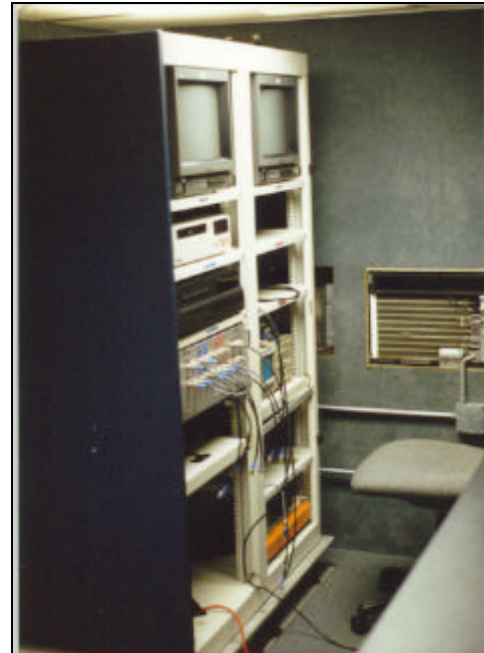
Figure 10. Mobile Laboratory Interior.

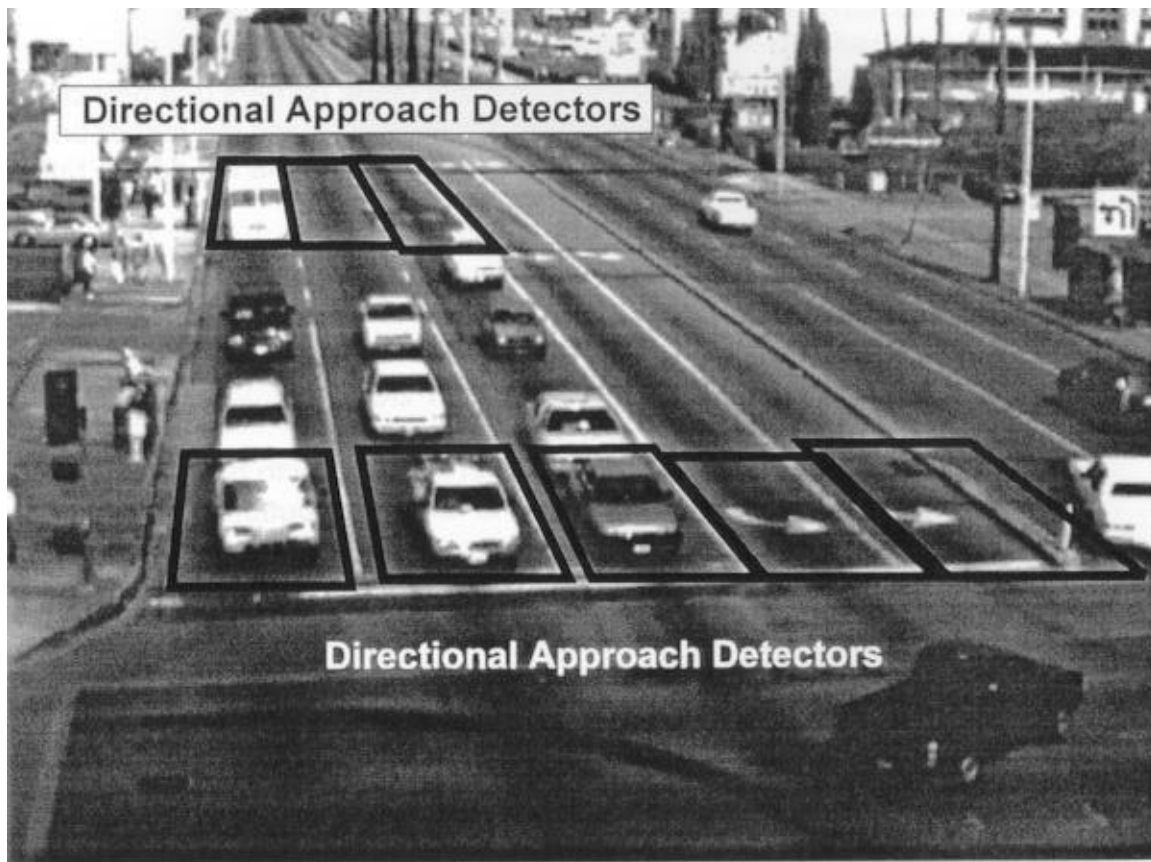
Figure 12. Example of Ideal Setup for Stop Bar and Advance Detection Windows, Reproduced from Operating Instructions for Odetics VTDS.

An typical detection zone placement for both types of windows is shown on Page 17 of the “Operating Instructions, Intersection Product, Vantage VTDS” [8], duplicated as Figure 12 below.

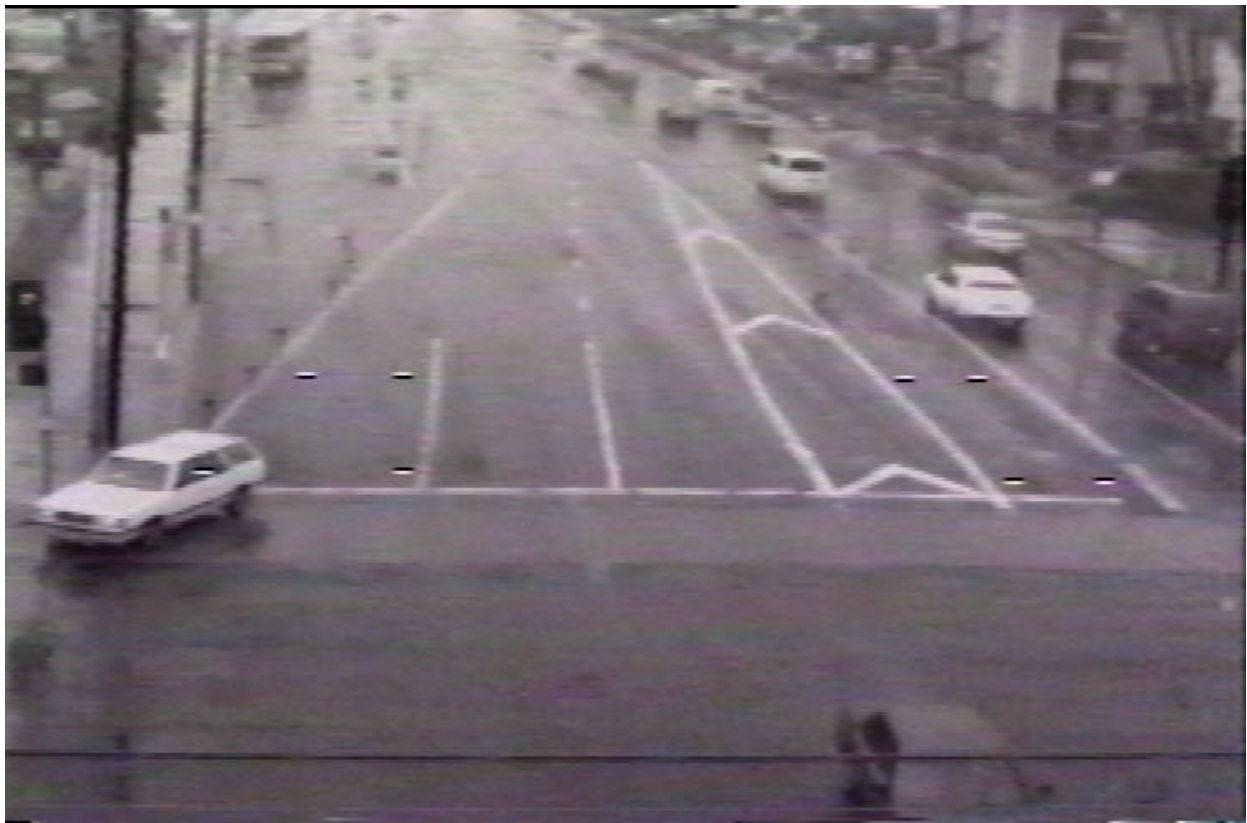
Event Class 2: Detection w/ Latch

Location: Harbor & Katella, NB

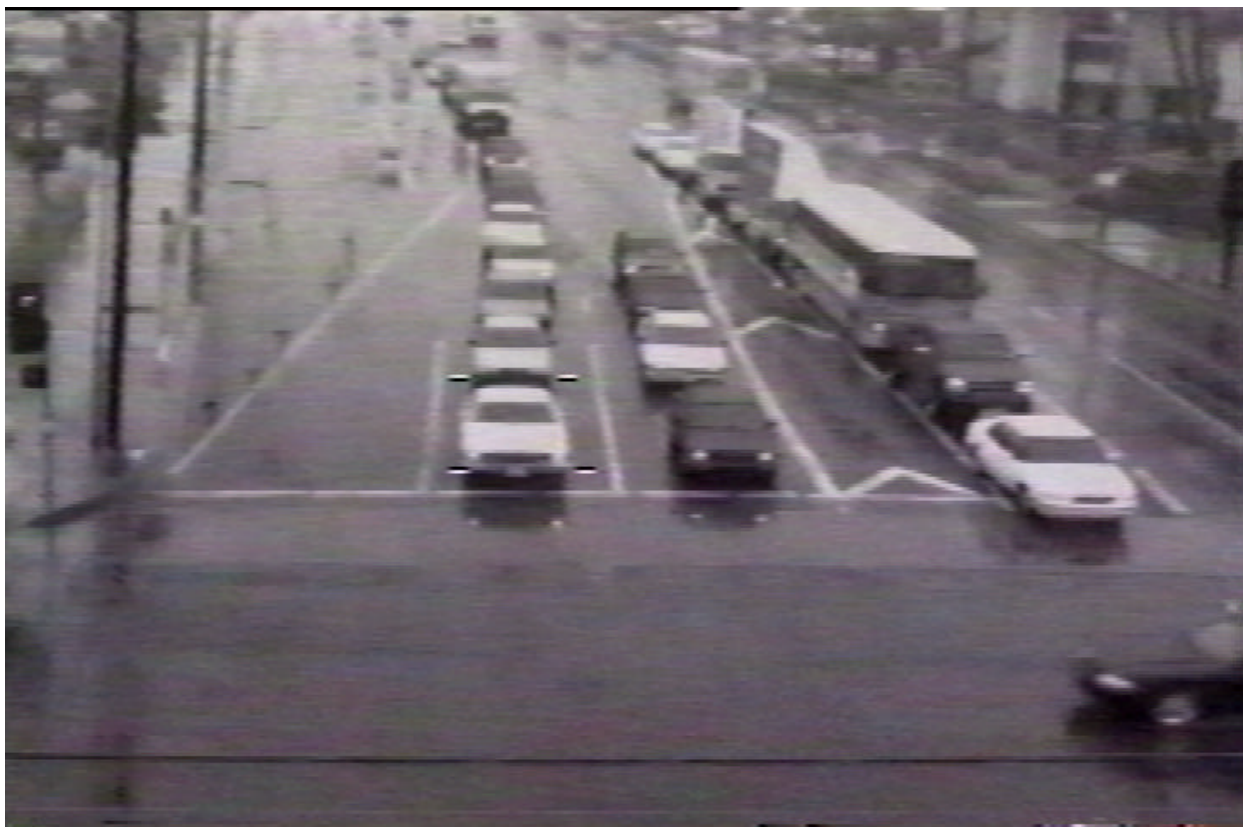
Event Class 5: Dropped After Detection

Location: Harbor & Katella, NB

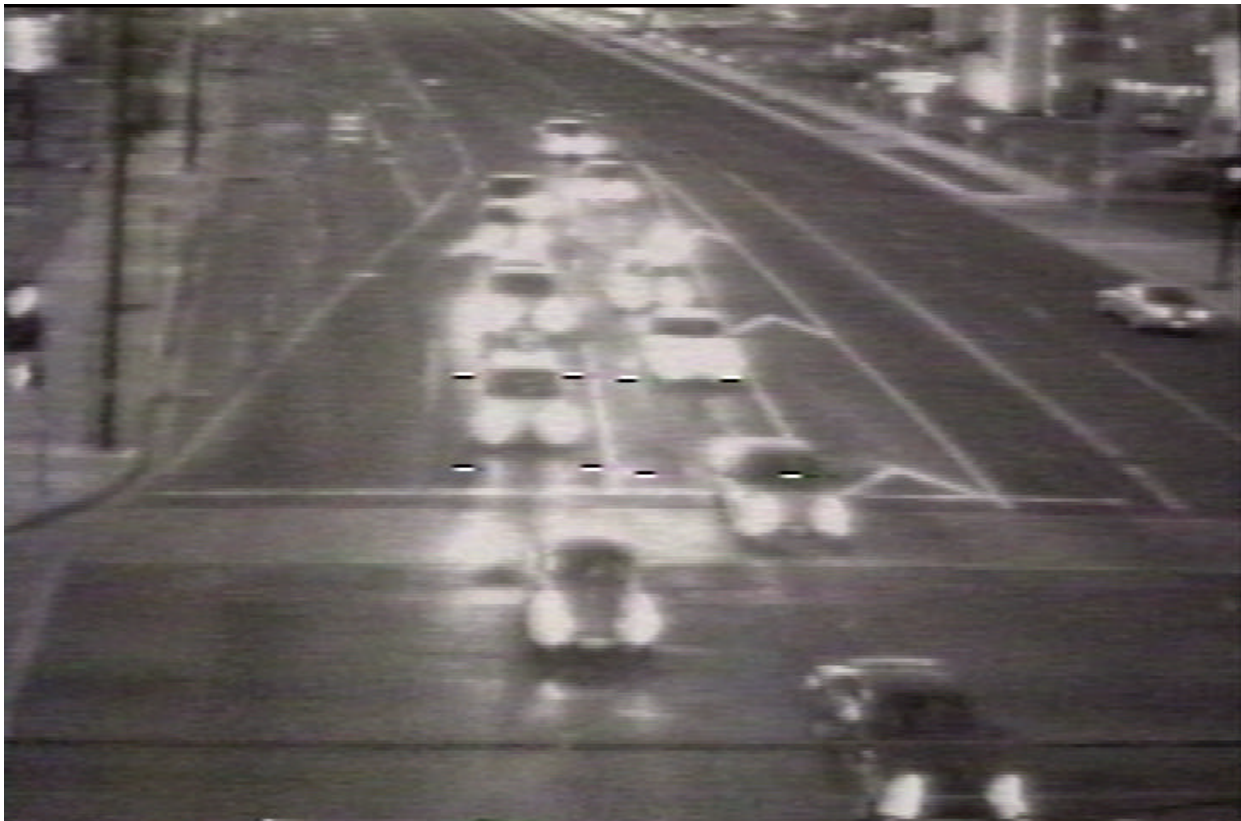
Event Class 6: Tailgate (Failure to Count Subsequent Vehicles)

Location: Harbor & Katella, NB

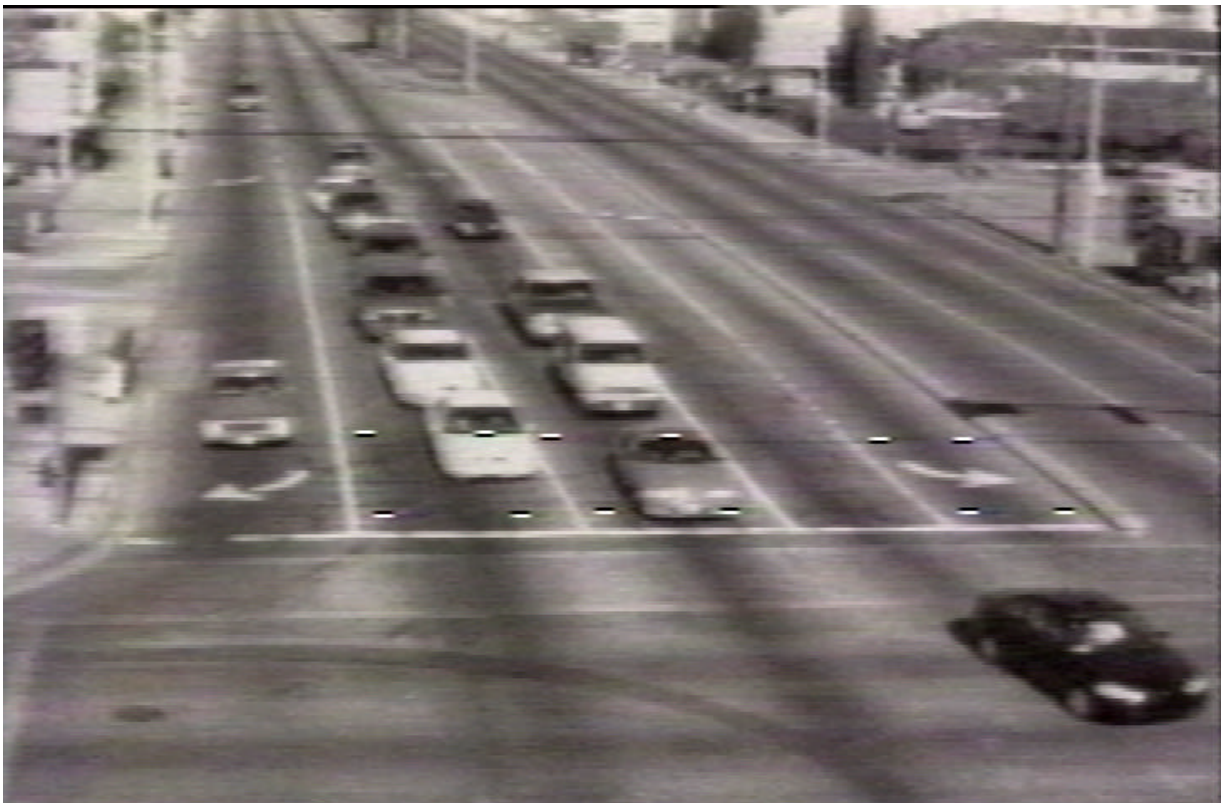
Event Class 7: Tailgate w/ Latch
(Tailgate with Latch after Final Vehicle)

Location: Harbor & Katella, SB

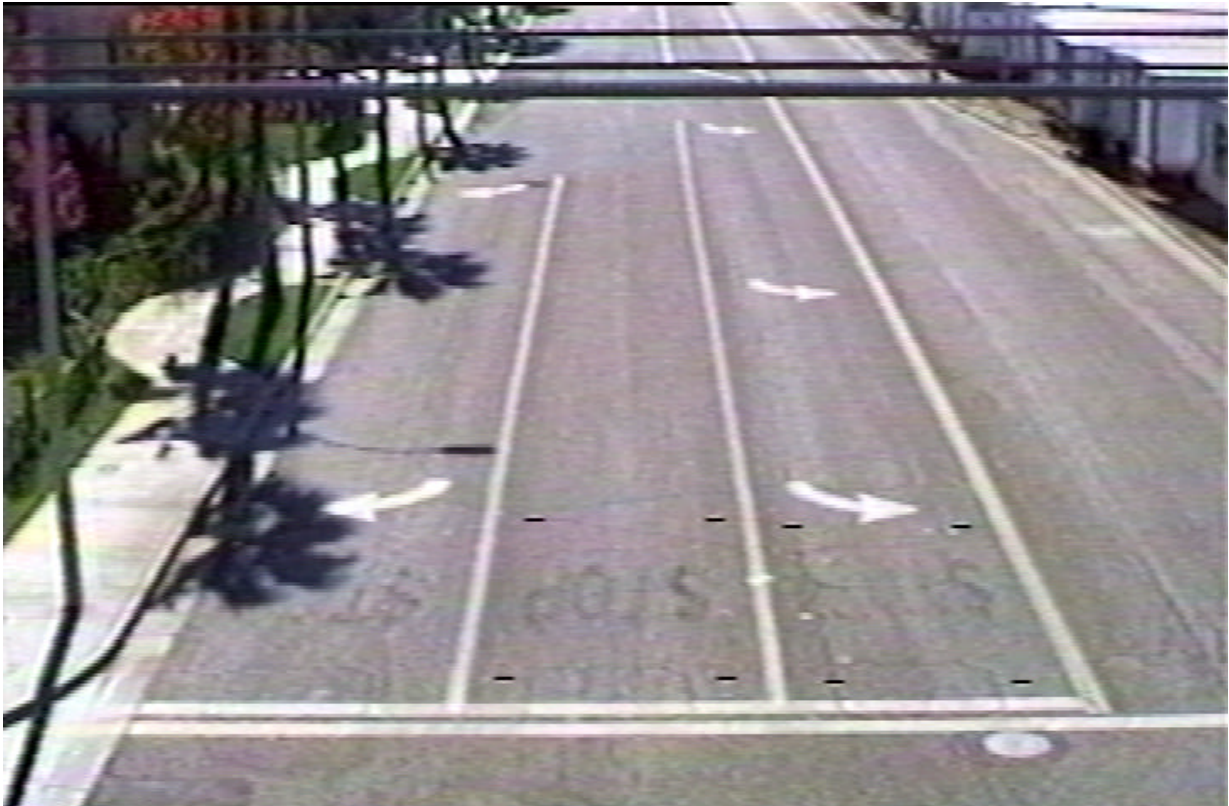
Event Class 8: False Detection

Location: Freedman & Clementine, NB

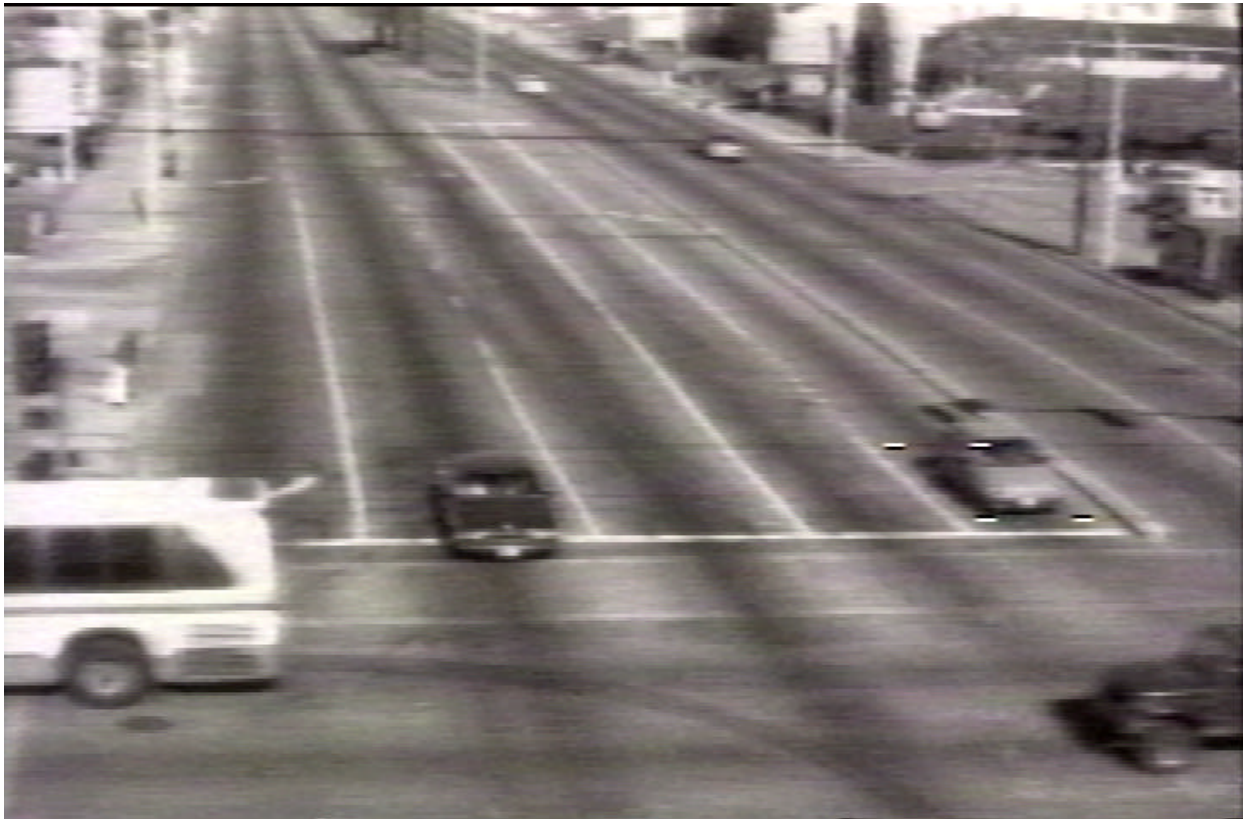
Phase Detection Class 2:
Red Interval (Call for R/G Transition)
Incorrect Actuation:
Failure to Actuate Correctly

Location: Harbor & Katella, SB

During red interval, first vehicle not detected within one second of arrival or, after initial detection, logical OR of detection zones for all waiting vehicles FALSE at any time prior to observed R/G transition.
