Executive Summary

The April 25, 2015 Gorkha (Nepal) Earthquake and its related aftershocks had a devastating impact on Nepal. The earthquake sequence resulted in nearly 9,000 deaths, tens of thousands of injuries, and has left hundreds of thousands of inhabitants homeless. With economic losses estimated at several billion US dollars, the financial impact to Nepal is severe and the rebuilding phase will likely span many years.

The Geotechnical Extreme Events Reconnaissance (GEER) Association assembled a reconnaissance team under the leadership of D. Scott Kieffer, Binod Tiwari and Youssef M.A. Hashash to evaluate geotechnical impacts of the April 25, 2015 Gorkha Earthquake and its related aftershocks. The focus of the reconnaissance was on time-sensitive (perishable) data, and the GEER team included a large group of experts in the areas of Geology, Engineering Geology, Seismology, Tectonics, Geotechnical Engineering, Geotechnical Earthquake Engineering, and Civil and Environmental Engineering. The GEER team worked in close collaboration with local and international organizations to document earthquake damage and identify targets for detailed follow up investigations.

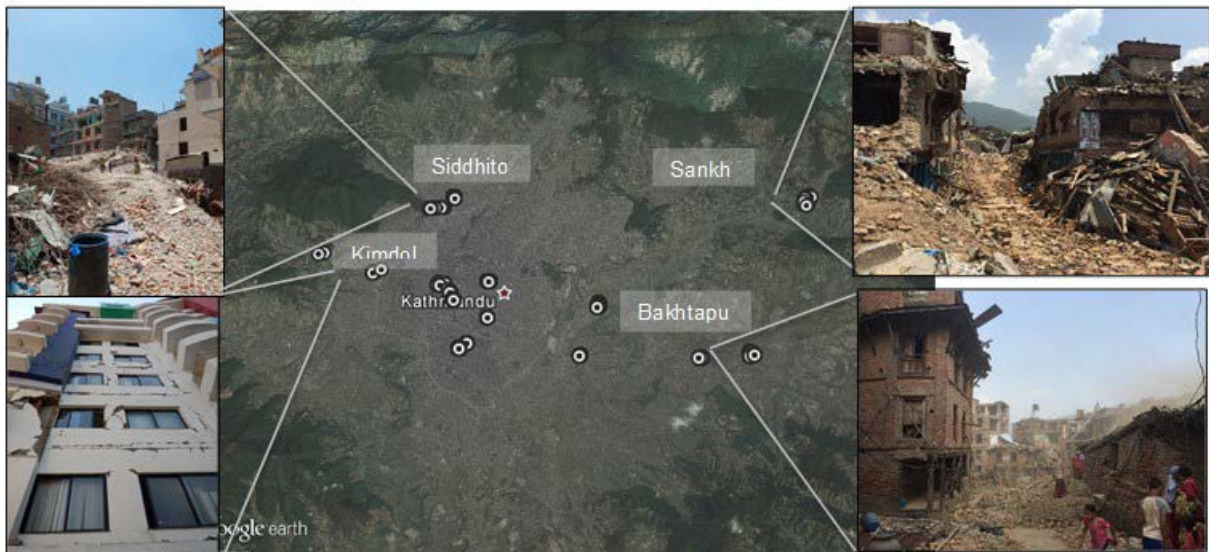
Similar to Northridge (1994) and Kobe (1999) earthquake, severe damage has been observed adjacent to basin edges around the Kathmandu Valley after April 25 M7.8 earthquake and subsequent aftershocks. In narrow and deep basins, such as Kathmandu Valley, during earthquakes body waves transform into surface waves creating two dimensional (2D) resonance especially at the basin edges (Iyisan and Hasal, 2011) which may result in significant amplification in the surface ground motion. The severe damage observed along the basin edges of Kathmandu Valley in Bhaktapur, Patan, and Sakhu indicates the potential amplification due to basin edge. Most of the building stock in Sakhu and Bhaktapur either collapsed or suffered severe damage after the Gorkha Earthquake. Figure 4-17a shows the observed damage distribution within the Kathmandu valley. The two main locations where the damage due to ground shaking is concentrated is in the center of the Kathmandu Valley, the damage in the center of the valley is most likely due to site amplification caused by the sedimentary basin. Significant damage has also been observed along the basin edges, especially around Bhaktapur and Sakhu where most of the old structures were collapsed. At these locations the observed damage and higher intensity of the ground shaking (Figure 4-17b) is most probably an indicator of the influence of the basin edge effects.

(a) Siddhito: $27^{\circ}44'7.32''\text{N}$ $85^{\circ}18'33.81''\text{E}$, Kimdol: $27^{\circ}42'35.55''\text{N}$ $85^{\circ}16'49.09''\text{E}$, Sankhu: $27^{\circ}43'49.5''\text{N}$ $85^{\circ}27'52''\text{E}$, Bakhtapu: $27^{\circ}40'13.2''\text{N}$ $85^{\circ}25'48.8''\text{E}$.

(b) Orange MMI=VII, Red MMI=VIII.

Figure 4-17 Damage distribution in the Kathmandu Valley (a) location of observed building damage, (b) Modified Mercalli Intensities assigned to main cities Kathmandu Valley (GeoNames.org).

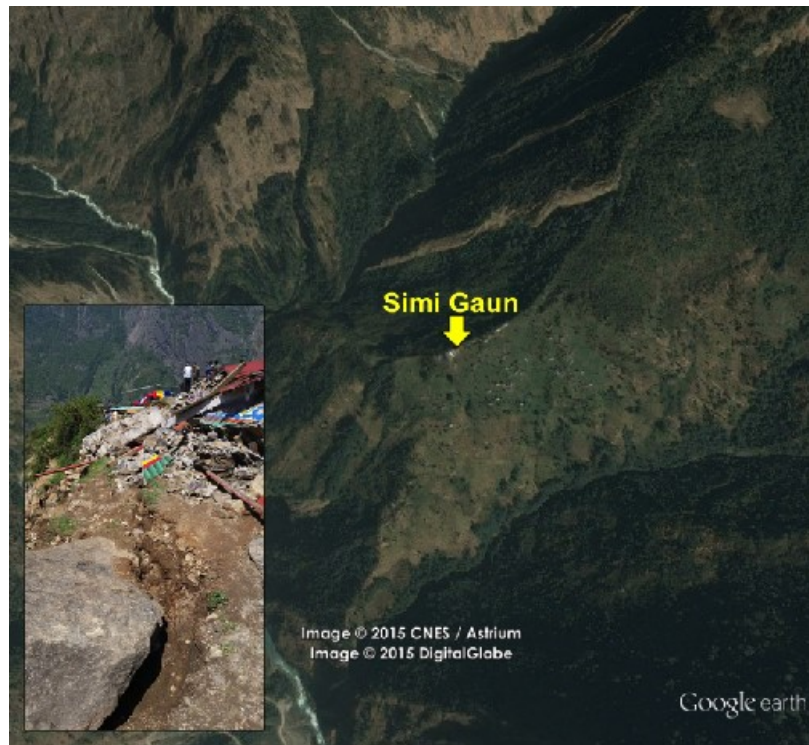
Figure 4-21 Ridge top damage and school collapse, Simi Gaun, near upper Tamakoshi Dam, (27 52' 22.5" N, 86 13' 50.6" E).

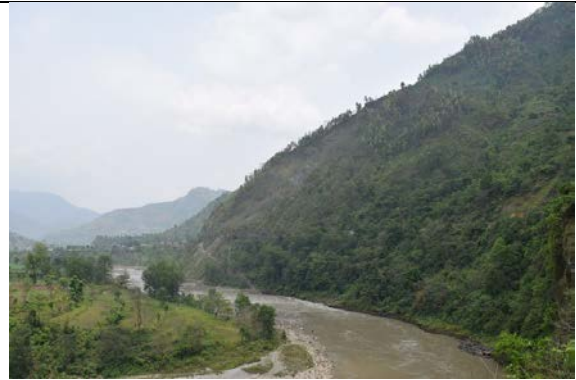
Along the Prithvi Highway only localized instances of earthquake-induced landsliding were observed (Figure 5-3). Figure 5-4 depicts the Krishnabhir Landslide, which existed prior to the earthquake but was not reactivated during the 2015 Gorkha Earthquake.

Figure 5-4 Pre-existing Krishnabhir Landslide, which performed well during the 2015 earthquake.

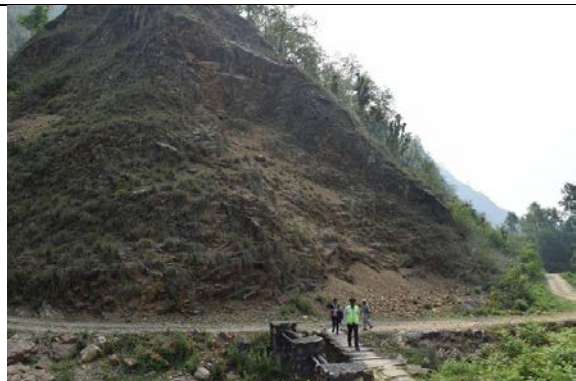
Check dams constructed to retain landslide debris adjacent to the Marshyandgi Hydropower project generally performed well (Figure 5-5); however, minor rockfalls along a road cut were observed (Figure 5-6). Additionally, irrigation channels were locally affected by earthquake induced landslides (Figure 5-7). The landslides mainly involved near-surface regolith and weathered bedrock, and appear to have mobilized primarily as raveling failures, rock slides, and rock falls.

Figure 5-6 Rockslides observed at the Marshyangdi Hydropower Project dam site during the 2015 earthquake mainshock.

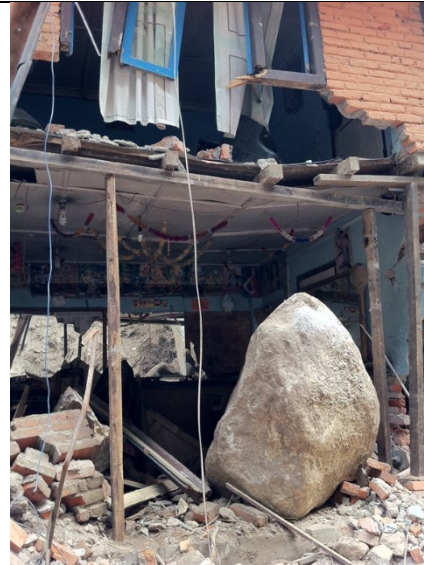
Landsliding and rock fall damage along the Araniko Highway was nearly continuous within several kilometers of Kodari and the Nepal-China border. The bridges that crossed the Sunkoshi River near Kodari, including the “Friendship Bridge” at the Nepal-China border, were mostly undamaged. The town of Kodari was destroyed by large rock falls from the near vertical slopes that resulted in boulders up to 4 m in diameter impacting buildings (Figure 5-9) and automobiles (Figure 5-10) along the narrow roadway.

Figure 5-9 Destroyed building along Araniko Highway in Kodari (27° 58' 17.61" N; 85° 57' 43.51" E).

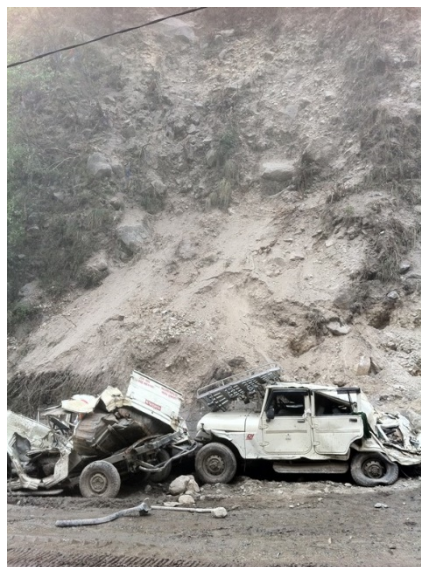
Figure 5-10 Destroyed vehicles along Araniko Highway in Kodari (27° 58' 21.55" N; 85° 57' 46.18" E)

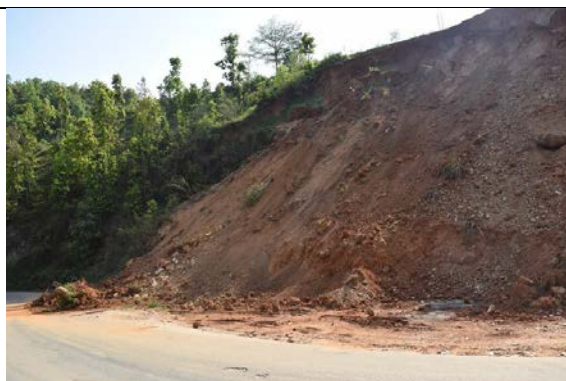
Figure 5-11 Typical landslide observed at the Panchkhal-Dolalghat sector of the Araniko Highway.

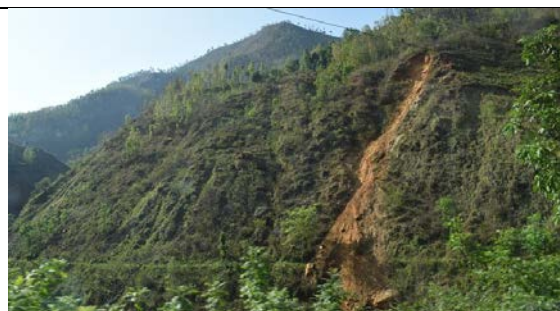
Figure 5-12 Extent of the landslides observed a few kilometers ahead of Dolalghat at Araniko Highway.

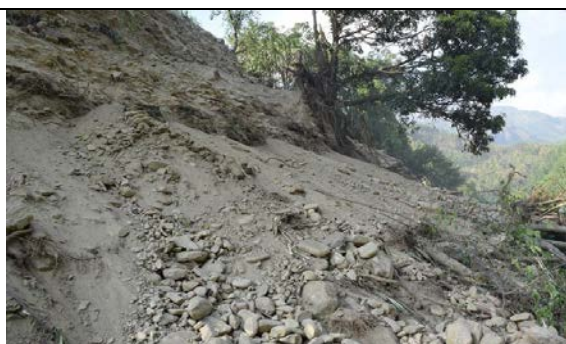
Figure 5-13 Typical rockslide mass observed along the Dolalghat-Lamo Sangu Sector of the Araniko Highway.

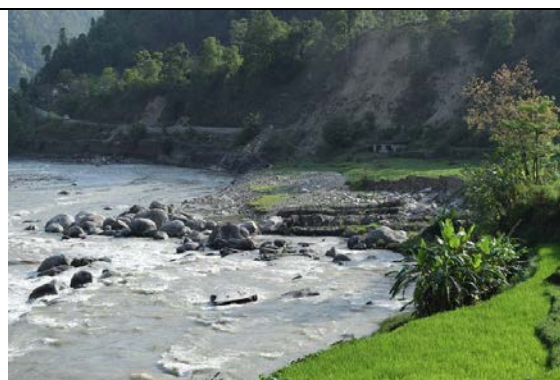
Figure 5-14 Reactivation of an existing landslide along the Araniko Highway that was triggered due to stream undercutting (27°44.7'0"N 85°47.5'0"E).

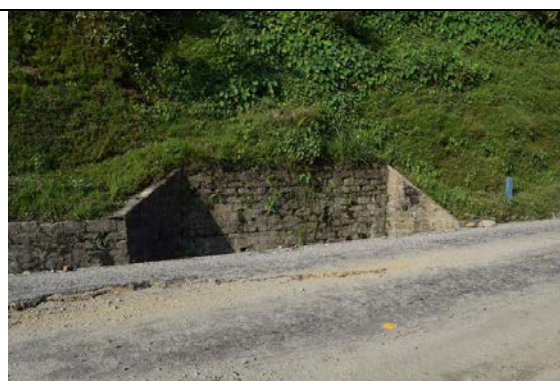
The road sector from Panchkhal to Tatopani was impacted significantly by new and reactivated landslides (Figure 5-11 through Figure 5-15). The majority of the landslide mitigation works such as gabion baskets and subsurface drainage improvements appeared to be functioning well (Figure 5-16) although localized damage to such structures was observed (Figure 5-17), together with shallow failure of roadside embankment fill, (Figure 5-18). Identified significant concern along this road sector relates to the potential for future large landslides and slope failures triggered high above the roadway. Such landslides may not only block and damage the road but, also potentially block the natural flow of Sunkoshi River (Figure 5-19). Additionally, several potential landslides appear to threaten the existing villages along the highway (Figure 5-20).

Figure 5-16 A subsurface drainage work installed at a landslide site along the Araniko Highway performed well during the earthquake.

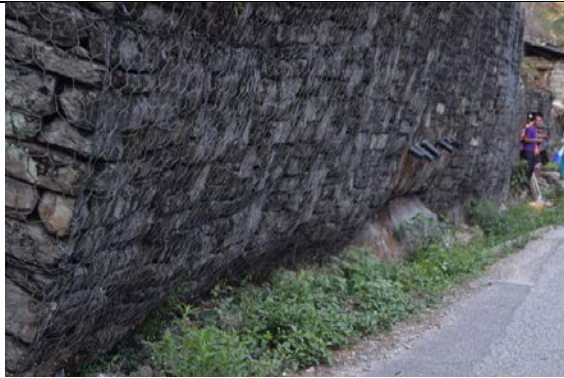
Figure 5-17 Gabion Retaining wall implemented as the landslide prevention work for existing landslide tilted after the 2015 earthquake.

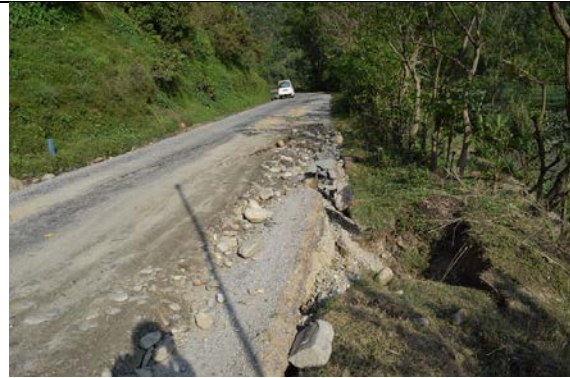
Figure 5-18 Typical road fill settlement observed along the Araniko Highway.

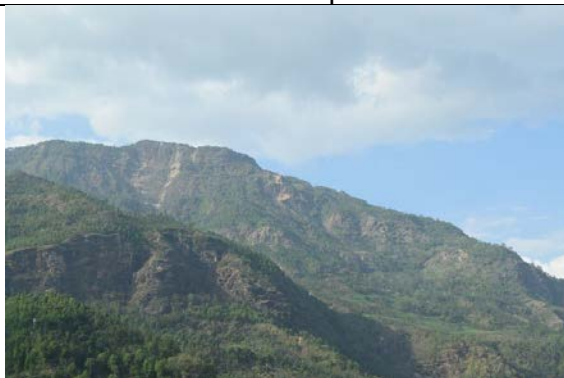
The road sector from Panchkhal to Tatopani was significantly affected by rockslides at multiple locations, landslides along the highway, and reactivation of old landslides (Figure 5-11 through Figure 5-15). Majority of the landslide prevention works such as gabion retaining walls and subsurface drainage networks implemented in previously triggered landslide sites appear to have functioned well (Figure 5-16) although a few of those structures got affected (Figure 5-17) by fresh landslides and road side fissures (Figure 5-18) created by the ground shaking. The major issue identified in this road sector is the potential for the initiation of large landslides and slope failures triggered on top of the ridge that may not only block and damage the road but also have the potential to block the natural flow of Sunkoshi River (Figure 5-19). Moreover,

Figure 5-19 Typical cracks observed on the ridge of the mountain which has potential to trigger large scale landslides and block the Sunkoshi River.

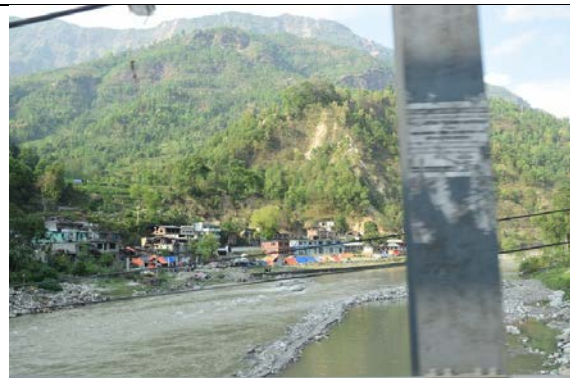
several such potential landslides threaten the current settlement along the highway (Figure 5-20).

Figure 5-20 Residential area along the Araniko Highway near Lamosangu exposed to potential landslides.

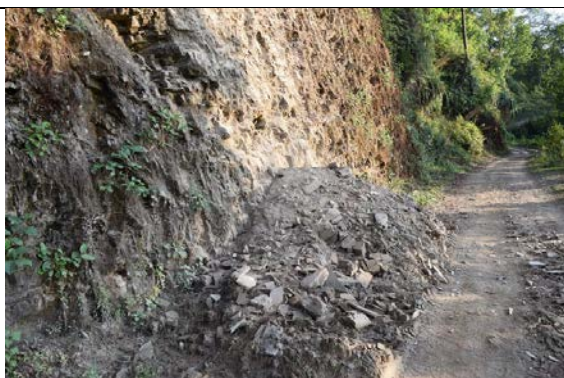
Due to the close proximity of the Lamosangu-Manthali Highway to the epicenter of the Mw7.3 aftershock, this highway was significantly affected by ground shaking. The characteristics of landslides were similar to those observed in other areas – rock falls that blocked several sections of the road (Figure 5-21 and Figure 5-22), raveling, and ground fissures and sloughing inducing settlement of road fills.

Figure 5-21 Typical rockfall observed along Lamosangu – Manthali Road

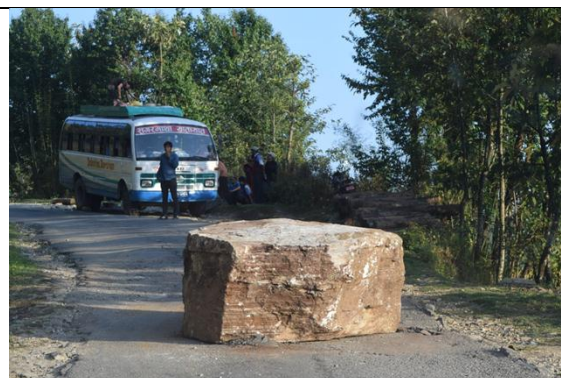
Figure 5-22 Boulder that rolled down from a ridge onto the road.

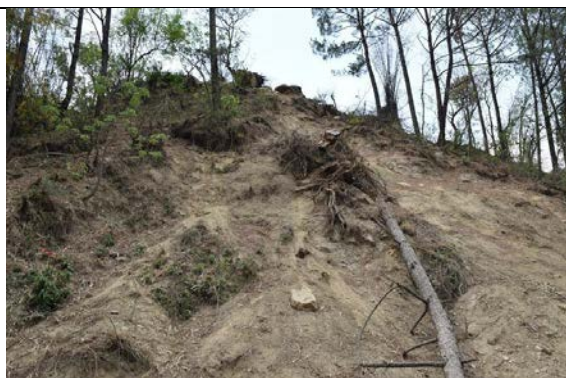
Figure 5-23 Typical rockfall source observed along the Melamchi Water Supply Project Access Road.

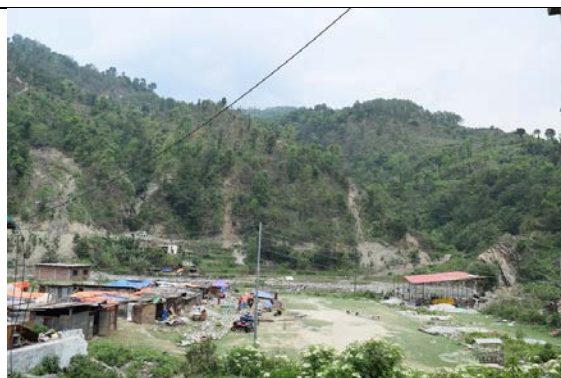
Figure 5-24 Dense landslides along the alignment of Melamchi Water Supply Project Access Road (27°49.8'0"N 85°34.5'0"E).

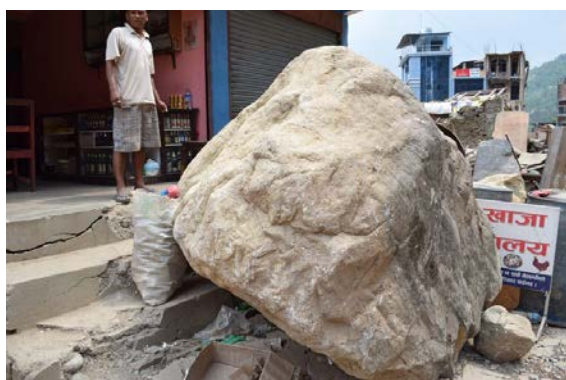
Figure 5-25 Boulder that rolled down a slope after the mainshock.

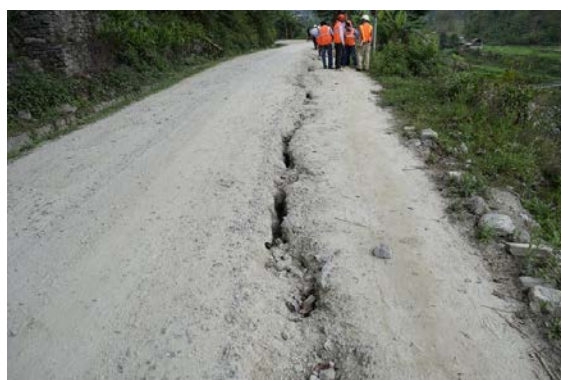
Figure 5-26 Settlement crack along the roadway.

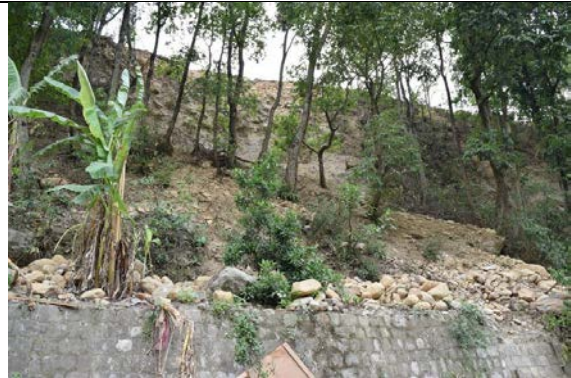
Figure 5-28 Walls performed well during ground shaking.

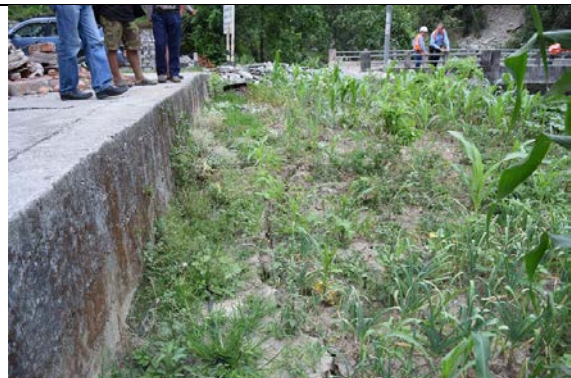
Figure 5-30 Settlement cracks observed along a bridge abutment.

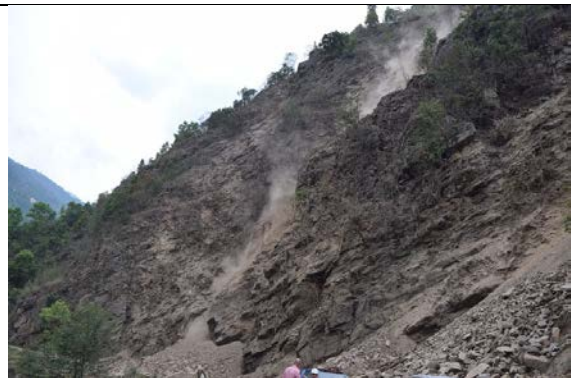
The Melamchi Water Supply Project access road was also affected by many landslides. Landslide characteristics were similar to other areas, including raveling failures (Figure 5-23 and Figure 5-24), and rock falls (Figure 5-25). Earthquake shaking induced sloughing of roadside fill materials (Figure 5-26). At several locations, loose boulders were observed near the head scarp of the landslide mass (Figure 5-27). Although many retaining structures were effective in retaining landslide debris (Figure 5-28), several such structures were damaged due to sloughing of road fill materials (Figure 5-29). Cracks were observed along the bank of the river near a bridge abutment, which can potentially result in further slope movement in future (Figure 5-30). A large scale rockslide observed could potentially block the river in future, considering that its head scarp extends several hundred meters above the roadway (Figure 5-31). This rock slide was still active during the field visit on May 16, 2015 (Figure 5-32).

Figure 5-32 Rockfall, as evidenced by the dust, observed during field reconnaissance (27°58.5'0"N 85°33.9'0"E).

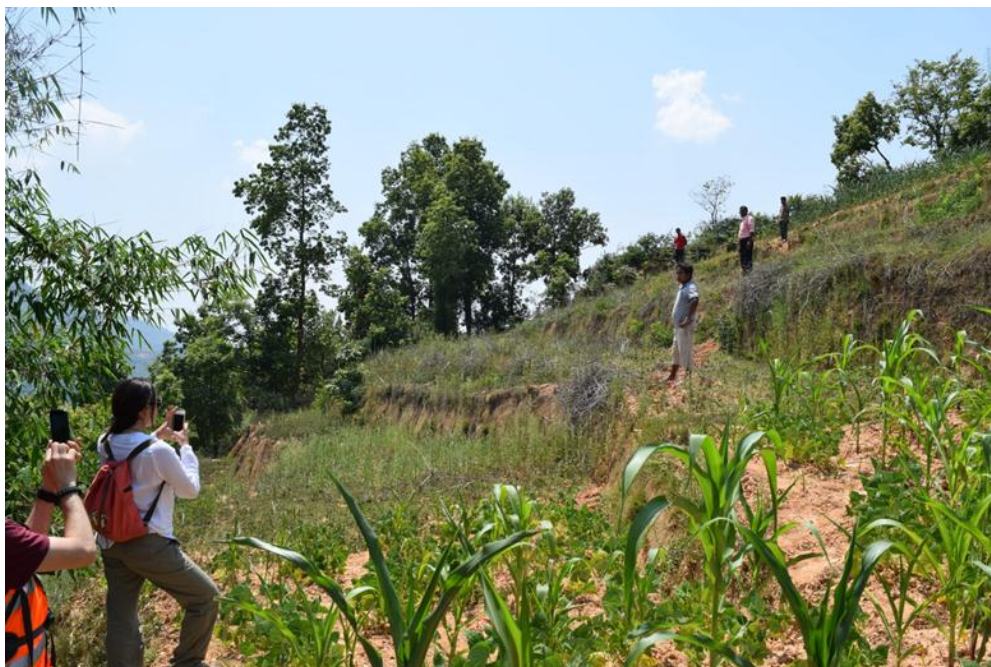
A landslide fissure was observed at the ridge of Ramkot Village, which is located at the edge of the Kathmandu Valley (Figure 5-33). The extensive fissure is more than 15 cm wide (Figure 5-34).

Figure 5-33 Head scarp observed on the ridge of the slope triggered by the 2015 earthquake.

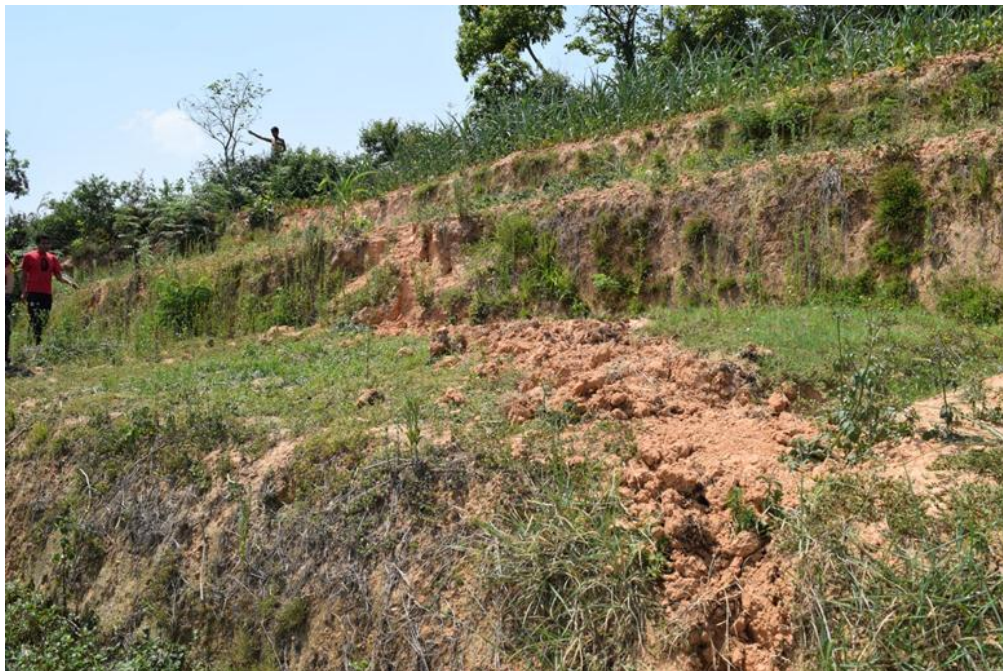
Figure 5-34 Head scarp crack was wider than 15 cm.

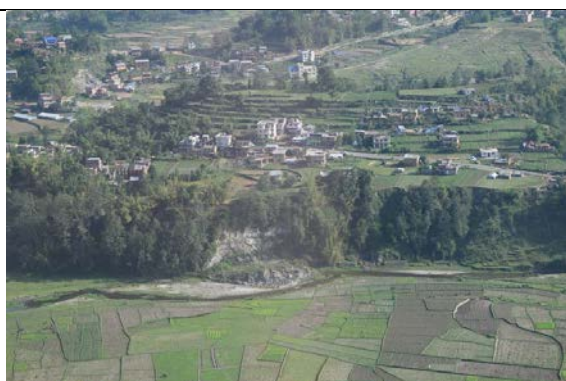
Several landslides were observed along the roads and river banks on the aerial reconnaissance route from Kathmandu to Lama Bagar (Figure 5-35) and along the river terrace slopes which might predated the earthquake (Figure 5-36). Several rural roads were affected by seismic induced landslides (Figure 5-37 through Figure 5-39). Ridge lines along the

Figure 5-36 Landslide along the river bank at Indrayani, near Kathmandu Valley.

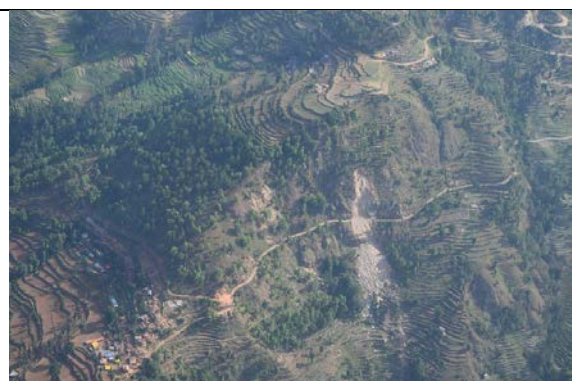
Figure 5-37 Mountain roads that have been affected by landslide triggered by the 2015 Earthquake.

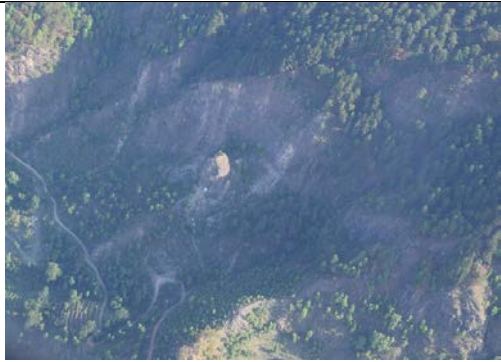
Figure 5-38 Landslides that have affected several mountain roads along the air-route.

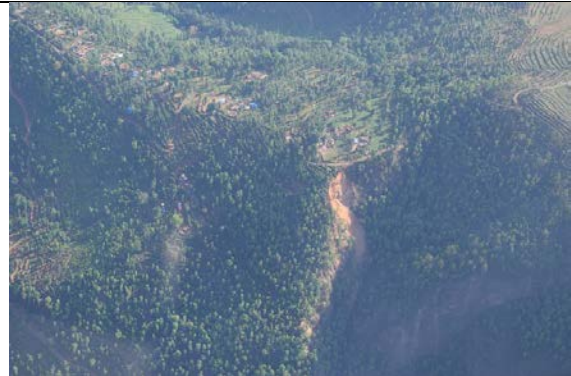
Figure 5-39 Small landslide triggered by the earthquake affected a road and a village along the air-route to Lamabagar.

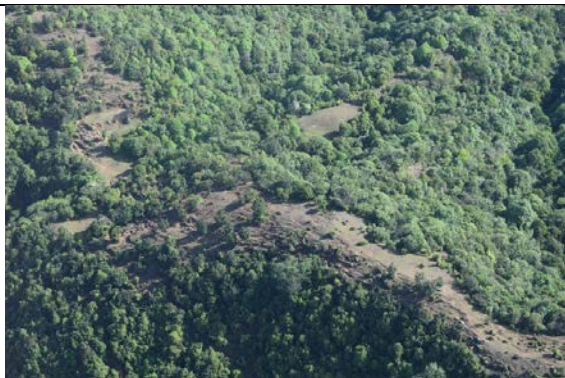
Sunkoshi River are locally highly fractured (Figure 5-40 through Figure 5-44) and may potentially experience additional significant activity during the monsoon season. Some of these landslide deposits contain large boulders (Figure 5-45 and Figure 5-46) can potentially be destabilized during the monsoon season or future seismic events.

Figure 5-40 Fissures created on the ridge of mountain due to the earthquake shaking.

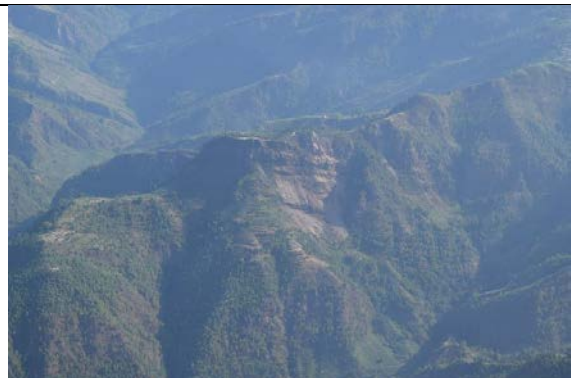
Figure 5-41 Seismically triggered landslide on a ridge.

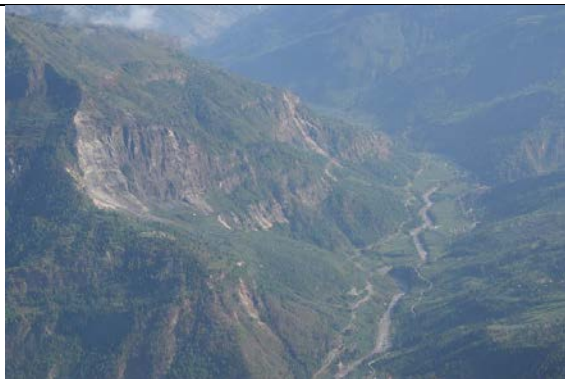
Figure 5-42 Slope vulnerable to post-earthquake rainfall induced landslides that could potentially block the natural stream.

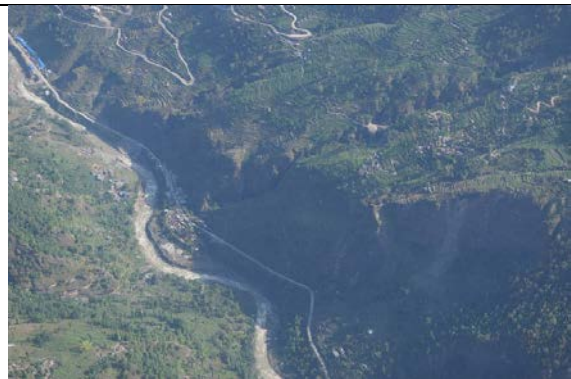
Figure 5-43 Settlement at along a bank near a potential landslide.

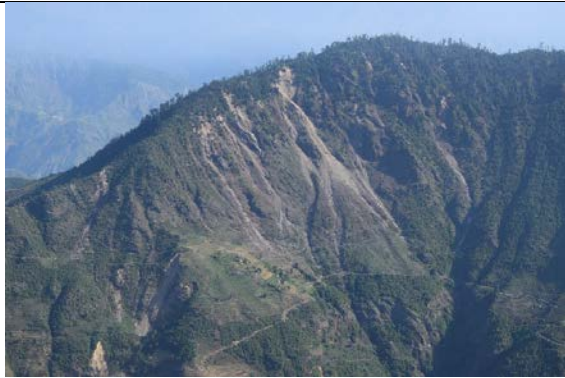
Figure 5-44 Landslide fissures triggered by the recent earthquake along the hillslope.

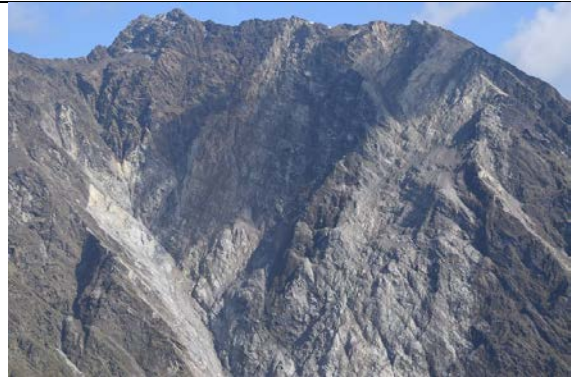
Figure 5-45 Potential large debris flow source during rainy season.

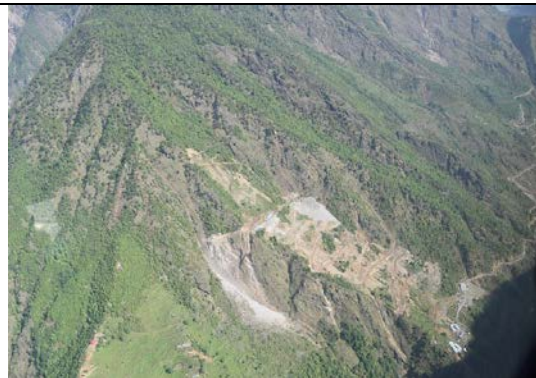
The access road to the Upper Tamakoshi Hydro Power project, in particular the Singati-Lama Bagar Sector (Figure 5-47 through Figure 5-52) is amongst the most heavily affected areas. The majority of the road alignment was rendered impassable due to landslide activity. The road is narrow and was constructed across very steep topography, exacerbating the impacts of the recent earthquake. Although gabion retaining walls generally performed well, with localized incidents of damage. Both the upstream and downstream areas from the dam site of the Hydro Power Project were affected by multiple rock fall events (Figure 5-53 through Figure 5-55). The boulder sizes, having travelled a distance of over 100 m, indicate high levels of ground shaking (Figure 5-56 and Figure 5-57). However, no ground motion observation data was available in the area.

Figure 5-47 Locations with large scale landslide potential along the Charikot-Lamabagar Road.

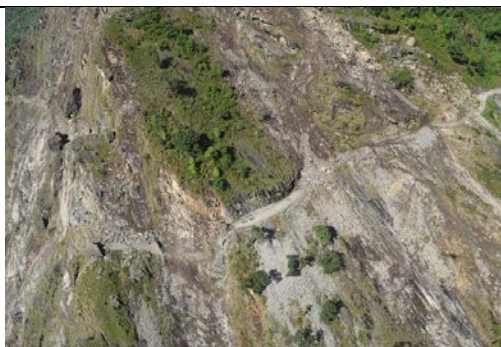
Figure 5-48 Charikot-Lamabagar road sector affected by landslides triggered due to the earthquake.

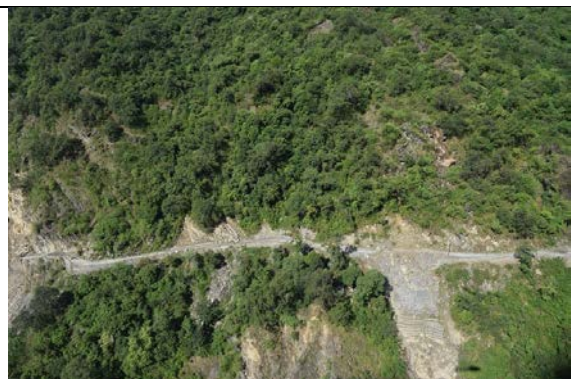
Figure 5-49 Gabion retaining walls that did not perform well along the Charikot-Lamabagar Road.

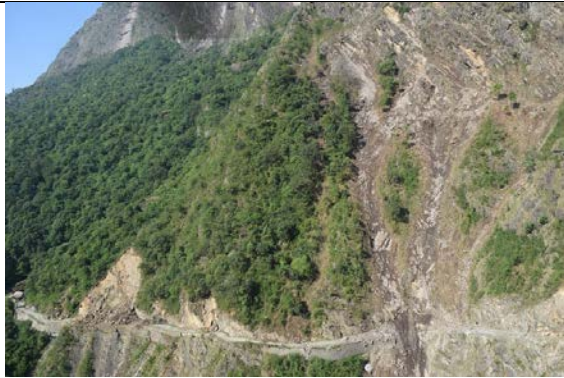
Figure 5-50 landslides observed along the road alignment constructed along steep terrain.

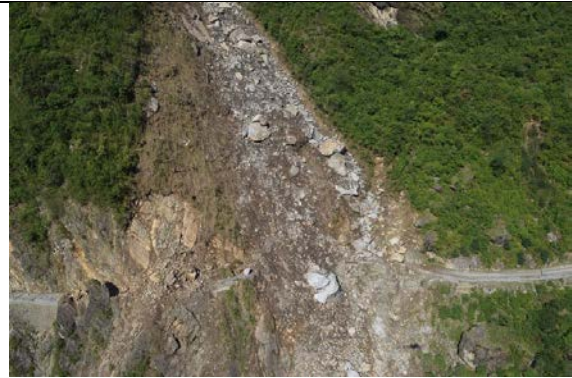
Figure 5-51. Large scale landslides that affected the Charikot-Lamabagar Road sector

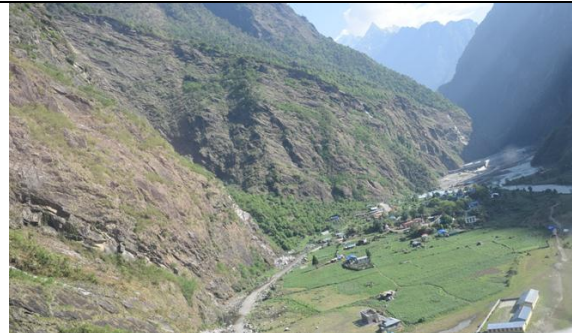
Figure 5-53 Landslides observed along dam site of the Upper Tamakoshi Hydropower project

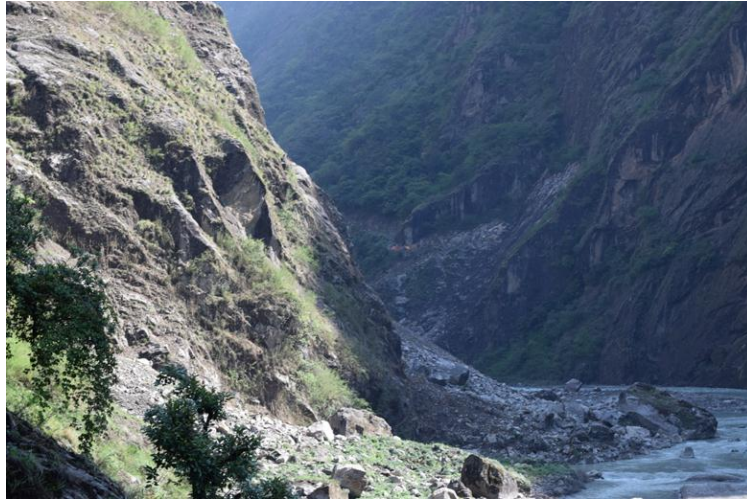
Figure 5-54 Rockfall upstream of the hydropower project.

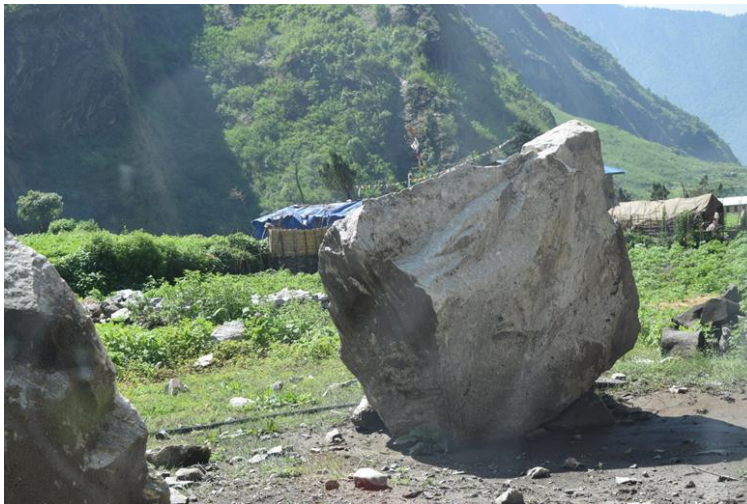
Figure 5-55 Large boulder from the top of the slope near the dam site.

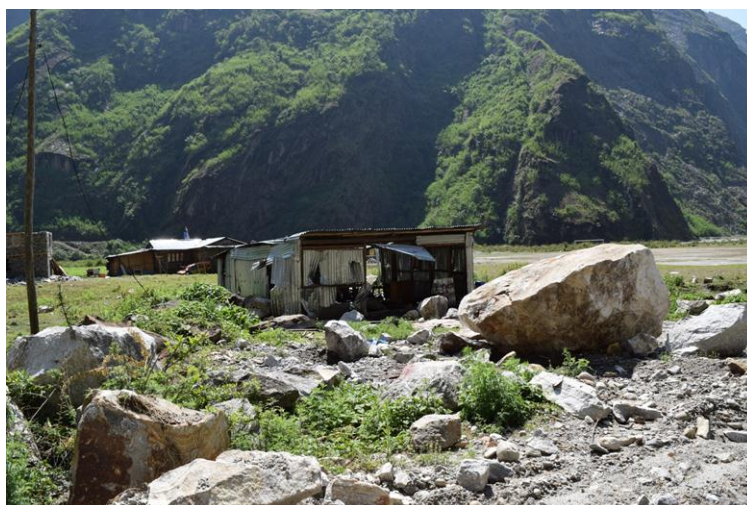
Figure 5-56 Local shop destroyed by the boulder.

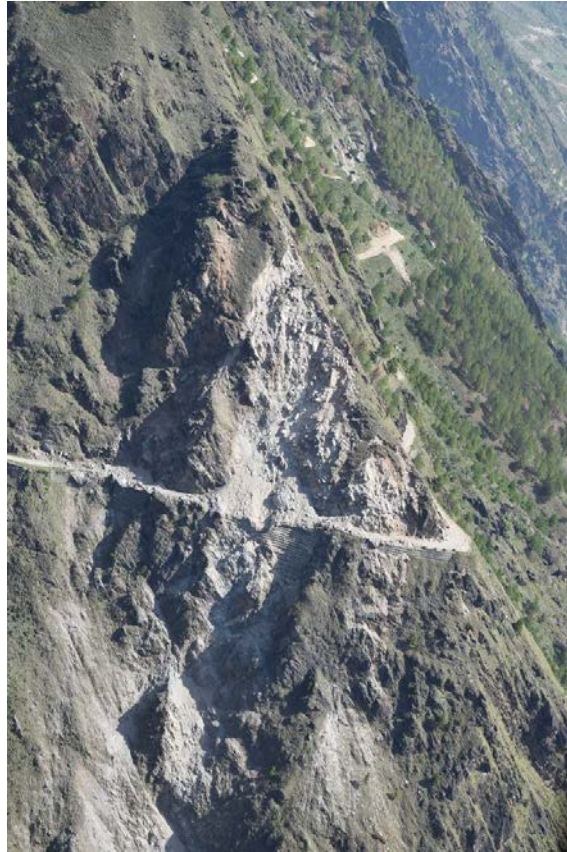
This area of Nepal (Figure 5-57) was also significantly affected by earthquake triggered landslides. In particular, the region between Nuwakot and Rasuwagadi exhibited many dry, raveling-type landslides (Figure 5-58 through Figure 5-60). Several of these landslides blocked the Trishuli River and its tributaries (Figure 5-61 through Figure 5-71) and also affected villages. Several hydropower projects, including the Chilime, Rasuwagadi and Trishuli were adversely impacted by the landslides (Figure 5-72 through Figure 5-74). Access roads to these hydropower projects and majority of the gabion retaining walls constructed along them were damaged by the landslides. Villages situated both above and below the landslides may be at risk due to the potential for landslide reactivation during the monsoon season or future ground shaking (Figure 5-75 through Figure 5-81). Large perched and precarious boulders were also observed above the villages. At several locations along the Trishuli River up to the Nepal - Chinaborder, massive landslides completely or partially blocked the Trishuli River (Figure 5-82).

Figure 5-58 Landslides triggered by the earthquake along steep slope along the Trishuli-Dhunce Road.

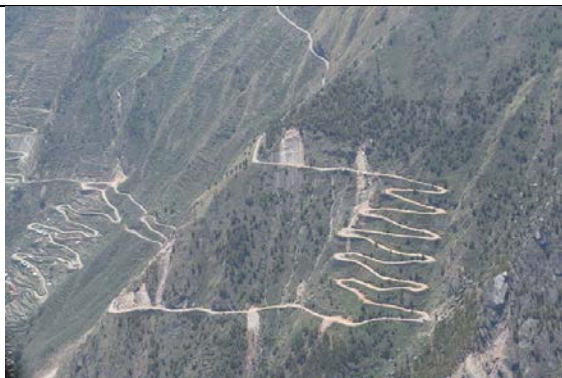
Figure 5-59 Local feeder road to the Trishuli-Rashuwagadi Road impacted by the landslide.

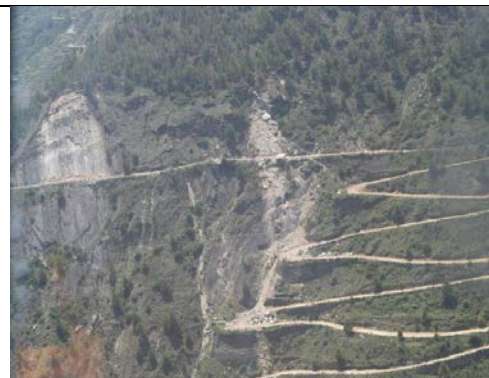
Figure 5-60 Gabion retaining walls on the feeder road to the Trishuli-Rashuwagadi Road damaged by the earthquake.

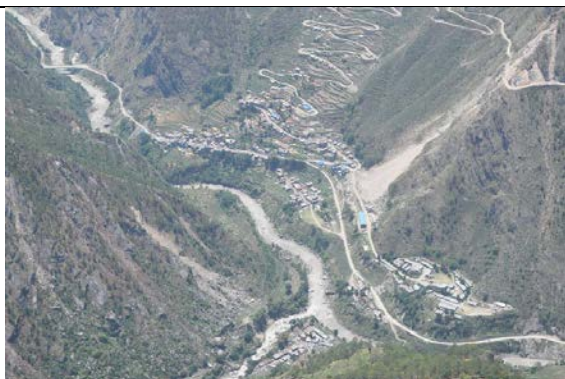
Figure 5-61 Access road to a Hydropower project being affected by the earthquake induced landslides.

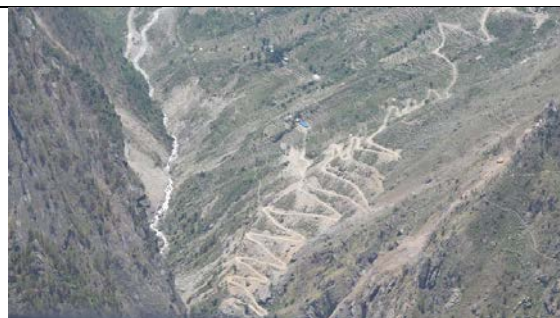
Figure 5-62 Tributary of the Trishuli Rivers partially blocked by the earthquake induced landslide debris.

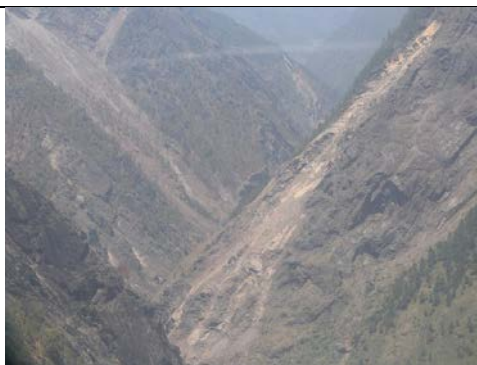
Figure 5-63 Slopes along both banks of the Trishuli River being affected by the seismically triggered landslides.

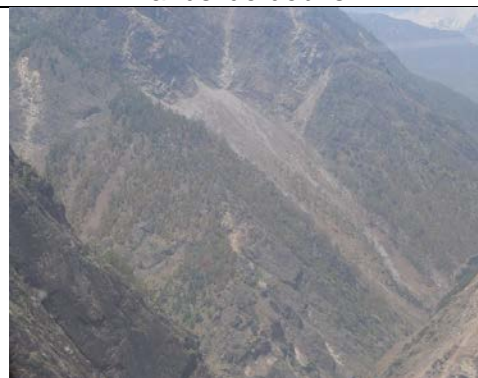
Figure 5-64 Large landslide along the Trishuli River.

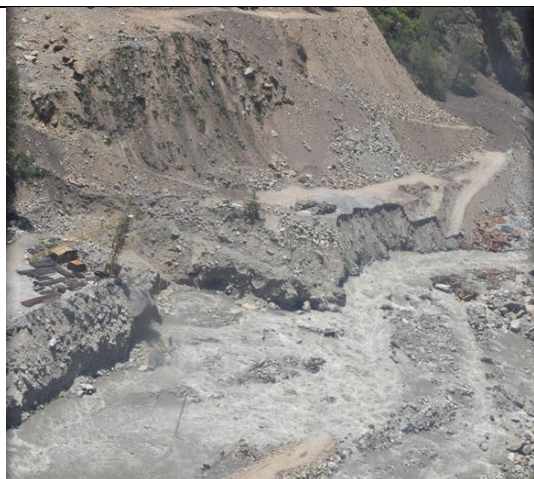
Figure 5-65 Landslide debris partially blocks the Trishuli River near a hydropower project.

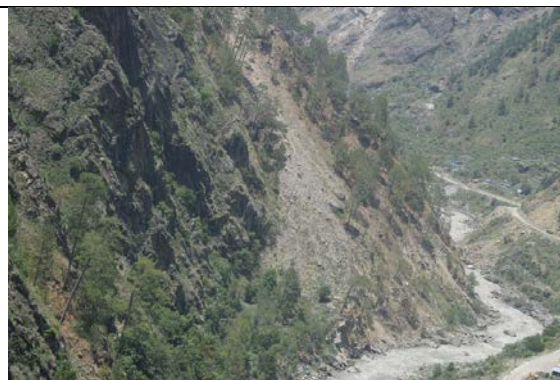
Figure 5-66 Landslide debris adjacent to the Trishuli River.

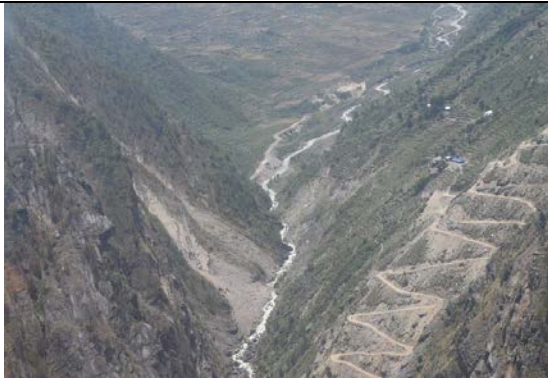
Figure 5-67 Tributary of the Trishuli River partially blocked by the landslides triggered on both sides.

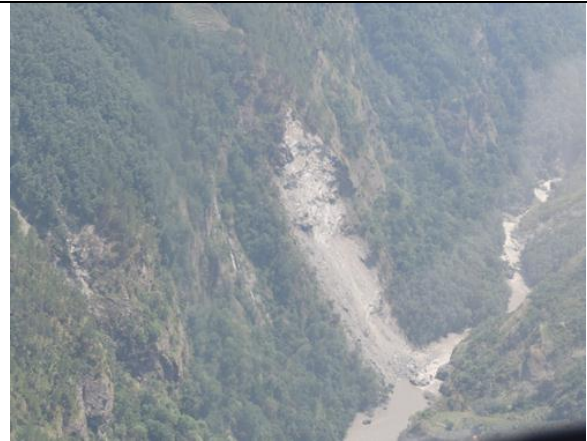
Figure 5-68 A large scale seismically induced landslide that partially blocked the Trishuli River.

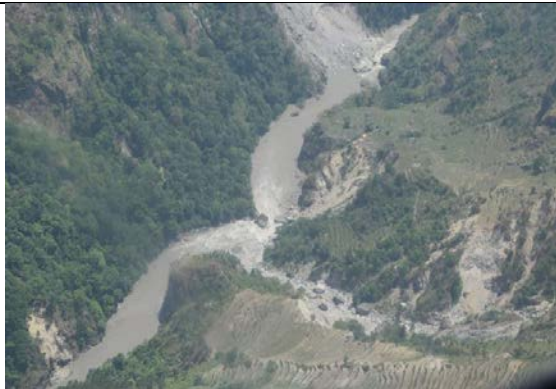
Figure 5-69 Water inundation along Trishuli River due to landslide induced natural dam formation.

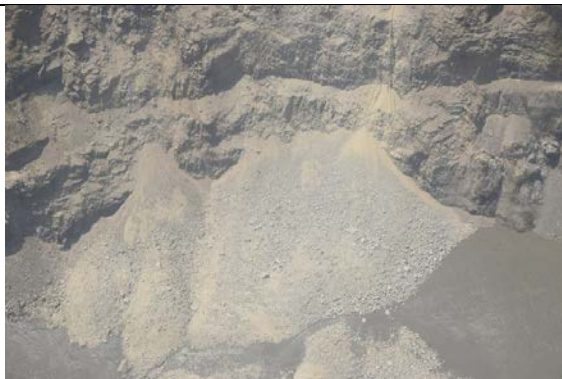
Figure 5-71 Closer view of the landslide dam at the Trishuli River (28°14.9'0"N 85°27.6'0"E)

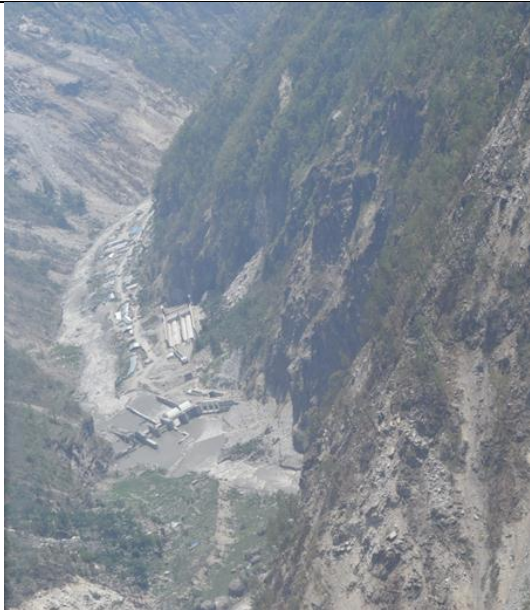
Figure 5-73 Upstream side of a hydropower project affected by large scale landslides.

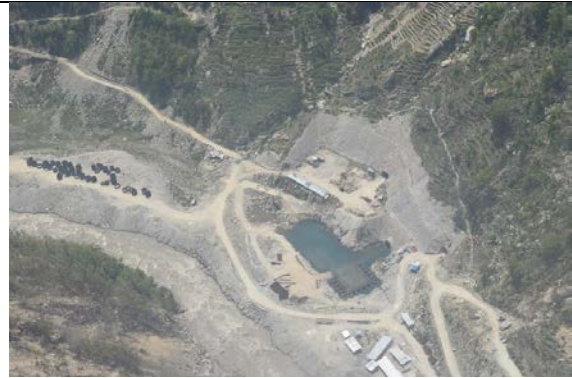
Figure 5-74 Landslides damaging the desilting basin area of a hydropower project.

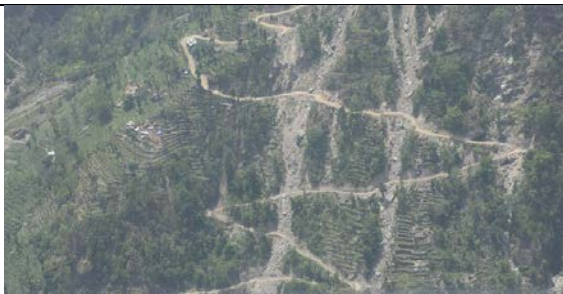
Figure 5-75 Regular road sector of the Trishuli-Rasuwagadi Road affected by landslides.

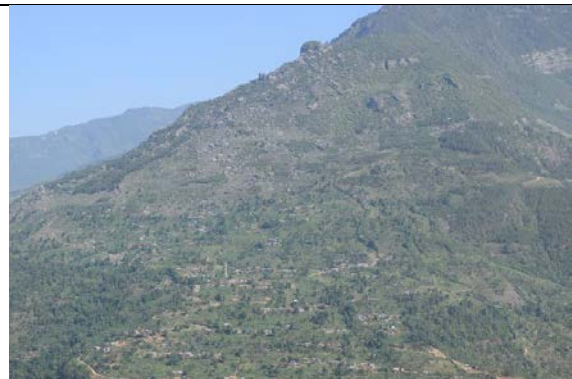
Figure 5-76 Boulders above villages.

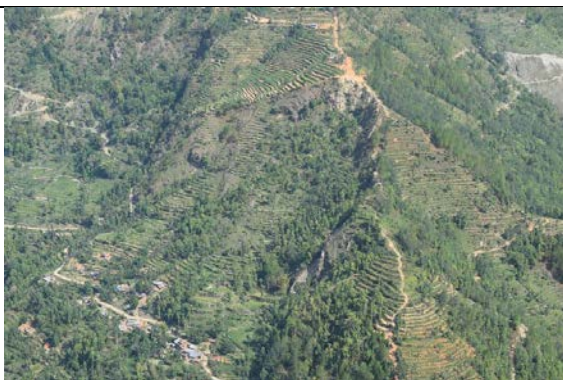
Figure 5-77 Villages below a large pre-existing landslides.

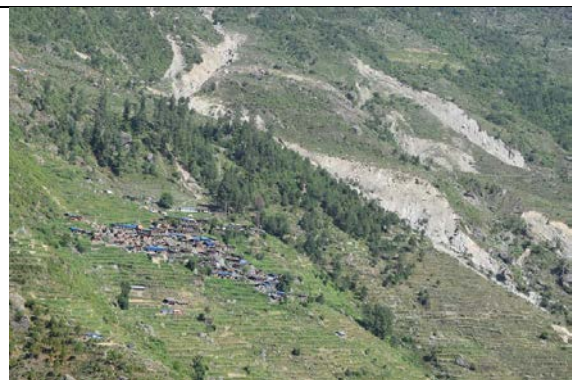
Figure 5-78 A village close to a large landslide site that could potentially block the Trishuli River.

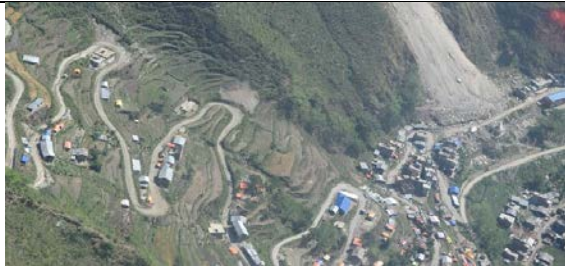
Figure 5-79 Access road sector of a hydropower project affected by an earthquake induced landslide.

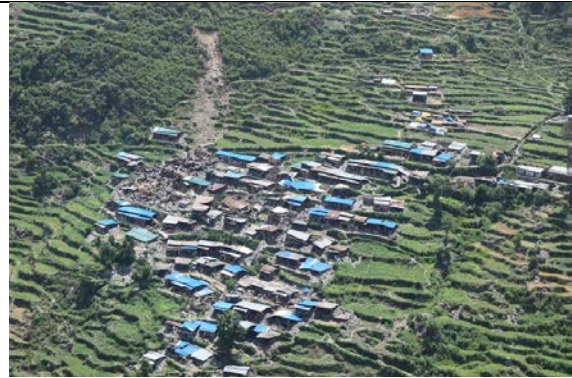
Figure 5-80 A village near Dhunche heavily damaged by the landslide debris originating from a slope above the village.

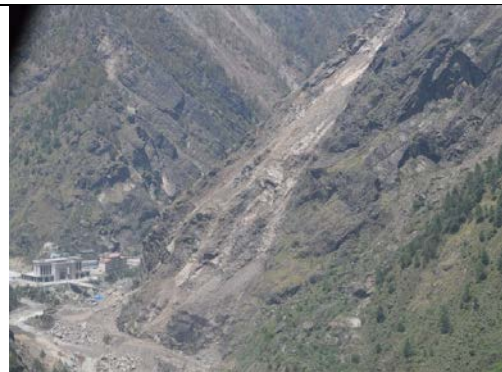
Figure 5-82 Trishuli River near the Chinese border at Rasuwagadi partially blocked by large landslides.

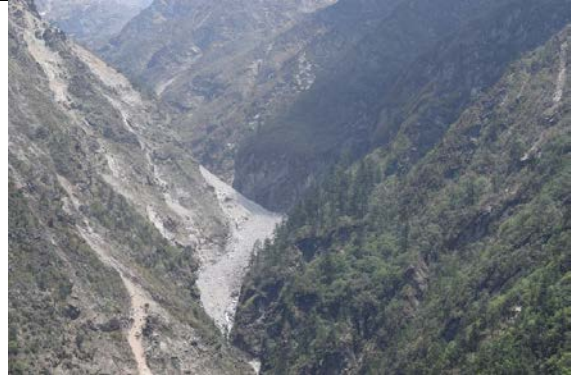
Figure 5-84 Another location where Langtang River is blocked by landslide debris.

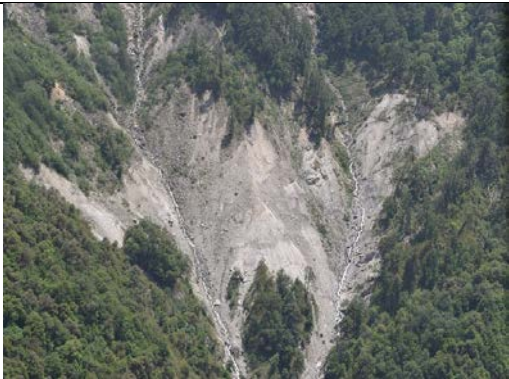
Figure 5-85 Several large scale landslides along the bank of the Langtang River.

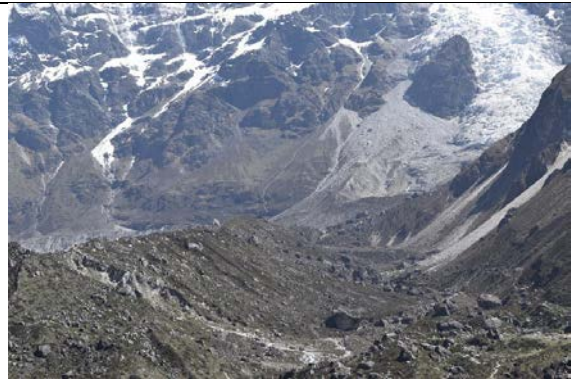
Figure 5-86 Typical loose debris observed along a slope in the Langtang Valley.

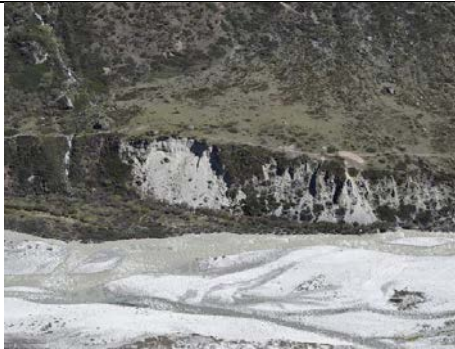
Figure 5-87 Upstream of the Langtang River with sediments from loose debris mass that slid after the earthquake.

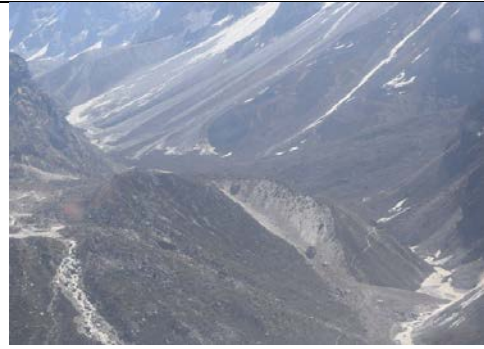
Figure 5-88 Langtang River blocked by landslide debris at multiple locations.

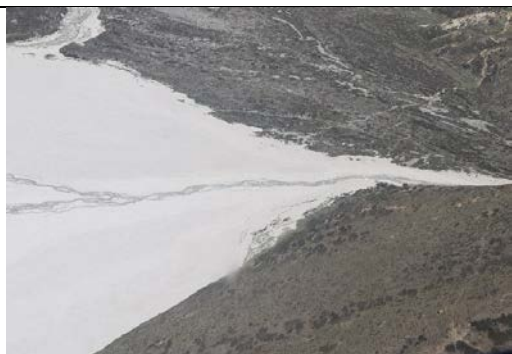
Figure 5-89 Debris fan observed at the upstream of Langtang River near Kyamgjon Kharka ($28^{\circ}12.2'0''\text{N}$ $85^{\circ}35.2'0''\text{E}$).

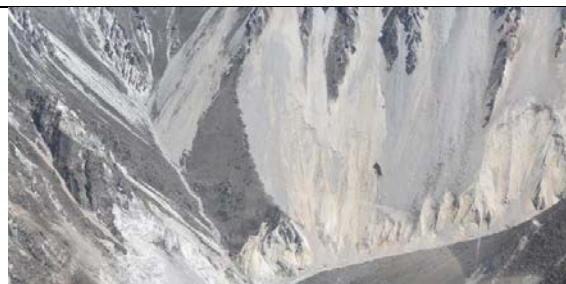
Figure 5-90 Langtang River blocked at multiple locations ($28^{\circ}12.5'0''\text{N}$ $85^{\circ}35.1'0''\text{E}$).
