Executive Summary

The April 25, 2015 Gorkha (Nepal) Earthquake and its related aftershocks had a devastating impact on Nepal. The earthquake sequence resulted in nearly 9,000 deaths, tens of thousands of injuries, and has left hundreds of thousands of inhabitants homeless. With economic losses estimated at several billion US dollars, the financial impact to Nepal is severe and the rebuilding phase will likely span many years.

The Geotechnical Extreme Events Reconnaissance (GEER) Association assembled a reconnaissance team under the leadership of D. Scott Kieffer, Binod Tiwari and Youssef M.A. Hashash to evaluate geotechnical impacts of the April 25, 2015 Gorkha Earthquake and its related aftershocks. The focus of the reconnaissance was on time-sensitive (perishable) data, and the GEER team included a large group of experts in the areas of Geology, Engineering Geology, Seismology, Tectonics, Geotechnical Engineering, Geotechnical Earthquake Engineering, and Civil and Environmental Engineering. The GEER team worked in close collaboration with local and international organizations to document earthquake damage and identify targets for detailed follow up investigations.

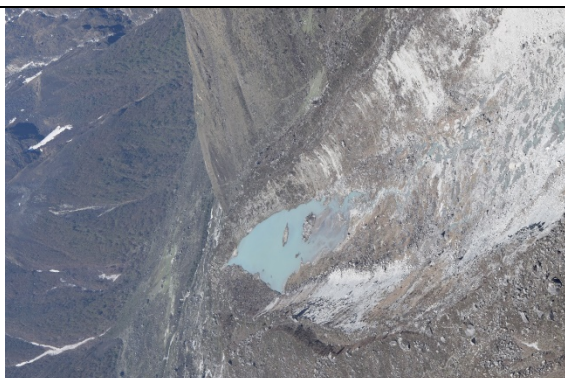
Figure 5-91 Ground fissure observed at the edge of a glacier lake above Kyamgjon Kharka.

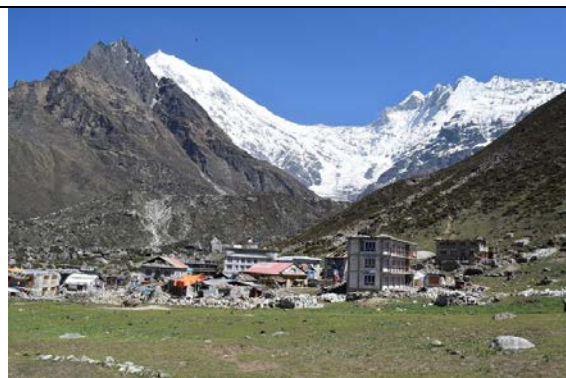
Figure 5-92 Kyamgjon Kharka village downstream the glacier lake ($28^{\circ}12.7'0''\text{N}$ $85^{\circ}34.1'0''\text{E}$).

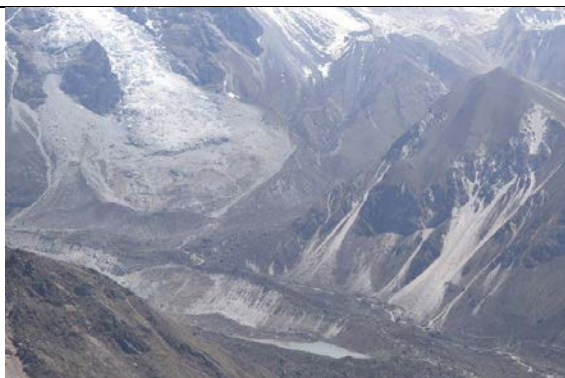
Figure 5-93 Loose sediments observed along mountain slopes.

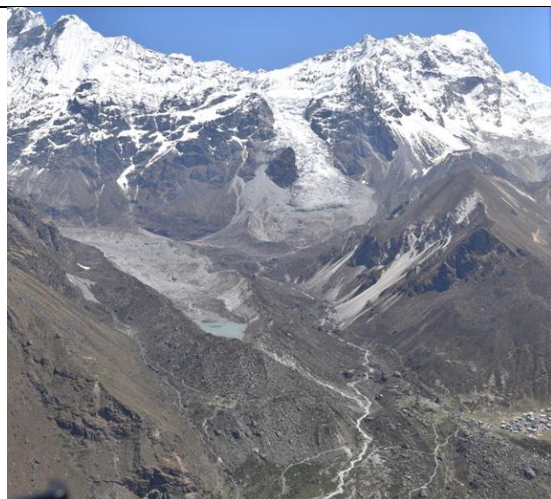
Figure 5-94 Loose sediments observed near the glacier lake.

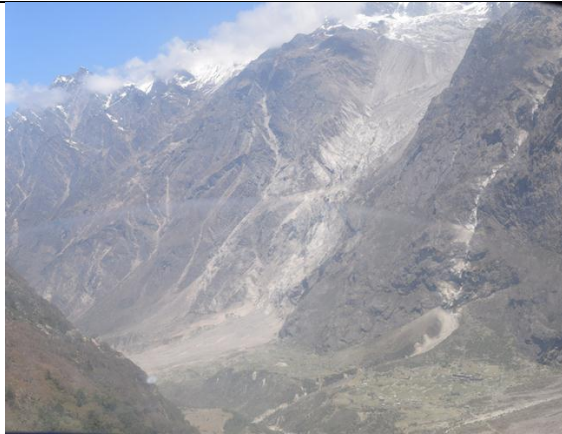
Within days of the $M_w 7.8$ Gorkha Earthquake, a large debris avalanche buried over 200 people in the Langtang Village located at the Latitude of $28^\circ 12' 55.43''N$; Long – $85^\circ 30' 8.95''E$; Alt 3297 m above msl. Google Earth images of the debris avalanche area prior to and after the avalanche are depicted in Figure 5-95 and Figure 5-96, respectively. Although Langtang Village is not clearly visible in the Google Earth image, higher resolution images are presented in Figure 5-97 through Figure 5-99, and a detailed view of the village area is shown in Figure 5-98. The estimated length and width of the debris is 400 m x 900 m, respectively. Based on an average estimated depth of about 5m, the overall debris avalanche volume is estimated at about 2 million m^3 . The source of the debris mass is estimated to be 2 km from the current debris deposit, representing a relief on the order of 1,600m (Figure 5-97 and Figure 5-98). Part of Langtang Village was buried under the landslide debris, with the remainder destroyed by associated air blast effects. The air blast flattened forested areas along the left bank of the river (Figure 5-101). Structures beyond the distal reaches of the debris avalanche also succumbed to violent air blast (Figure 5-102 and Figure 5-103). Where the debris mass completely blocked the Langtang River channel, the river passed under the debris mass and thus avoided ponding of surface water (Figure 5-104). The debris materials were very loose and wet at the time of visit (Figure 5-105). More than 95% of the debris materials were finer than 0.5m (Figure 5-106).

Figure 5-97 Aerial view of the debris avalanche (28°12.7'0"N 85°34.1'0"E).

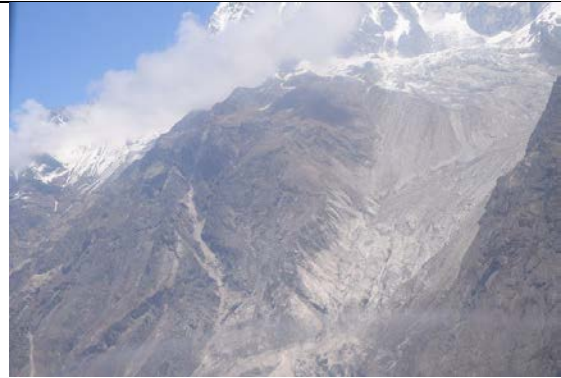
Figure 5-98 Aerial view of the source area of the debris avalanche (28°12.5'0"N 85°32.1'0"E).

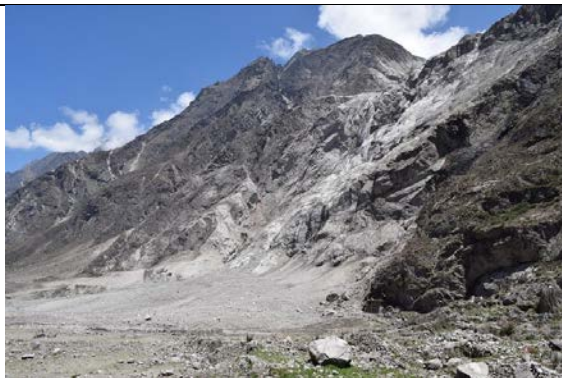
Figure 5-99 Overall view of the debris flow area from Langtang Village (28°12.5'0"N 85°31.8'0"E).

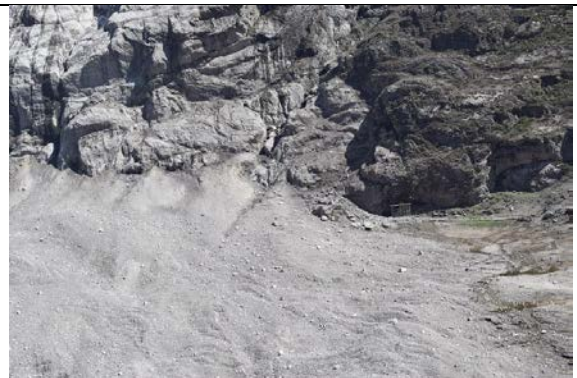
Figure 5-100 Foot of the debris shoot (a 3 story building on the middle left was the only building undamaged in the area).

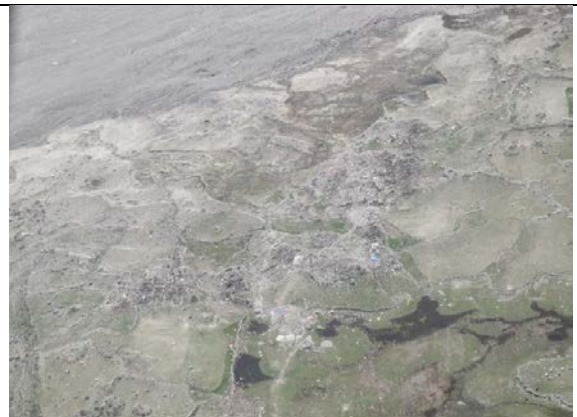
Figure 5-102 Aerial view of Langtang Village that was destroyed by the debris avalanche air blast.

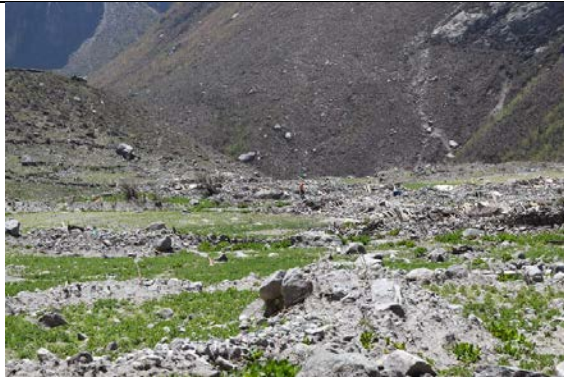
Figure 5-103 Closeup view of the debris field in the Langtang Valley. The buildings were flattened towards the direction of air blast induced by the avalanche.

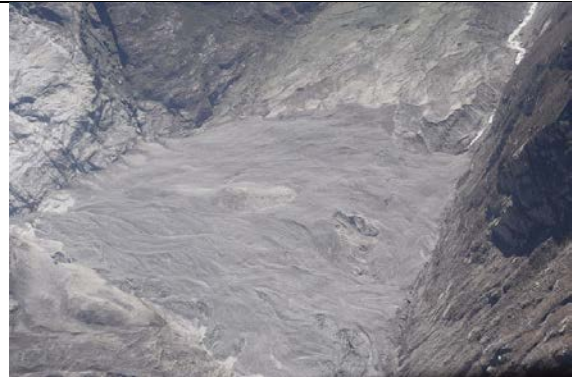
Figure 5-104 Langtang River blocked by the debris avalanche.

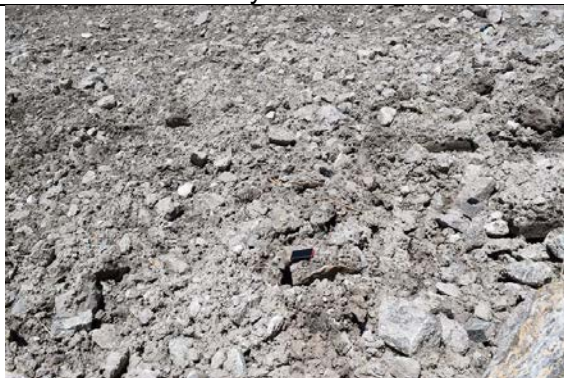
Figure 5-105 Typical sizes of the debris avalanche mass materials (28°13'0"N 85°30.2'0"E).

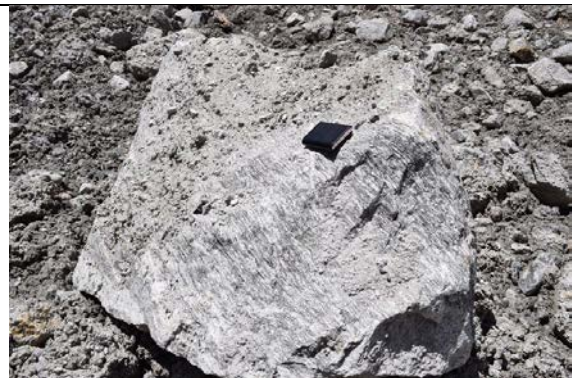
Figure 5-106 Few large sized boulders observed in the area.

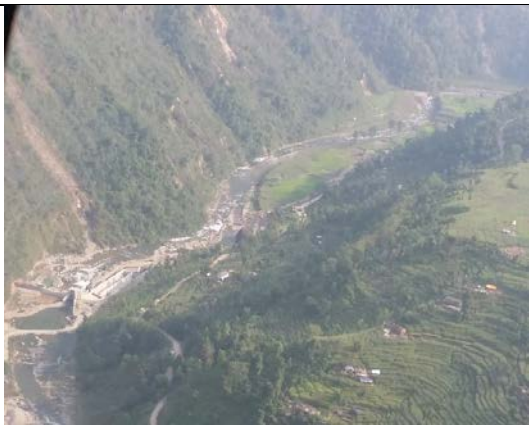
Figure 5-108 Dam site of a hydropower station near Barpak is vulnerable to potential landslide in the next rainy season or earthquake event.

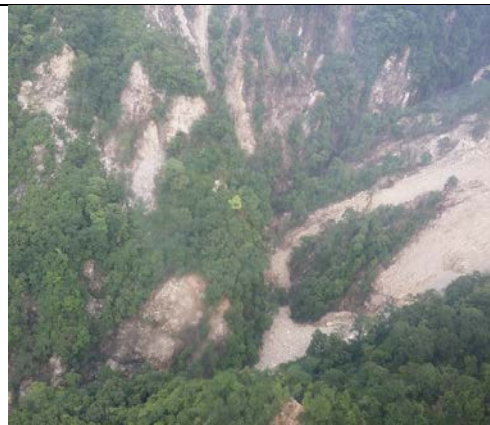
Figure 5-109 Seismically induced landslides near Barpak blocked the natural flow of a stream.

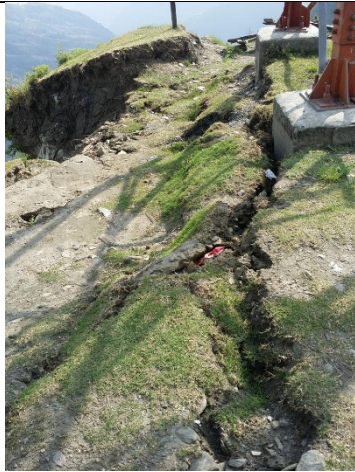
Figure 5-110 Main scarp of a seismically induced landslide observed at the north east edge of the Barpak Village, epicenter of the April 2015 Gorkha earthquake.

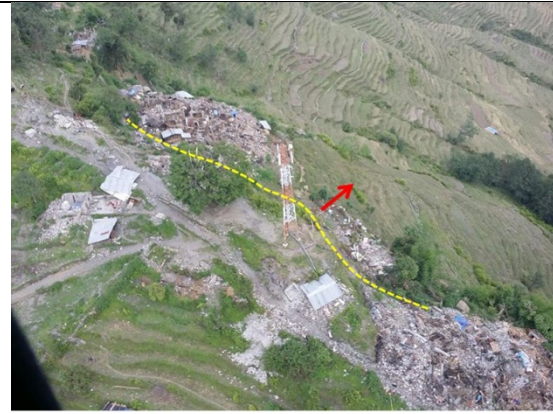
Figure 5-111 Aerial view of the landslide scarp.

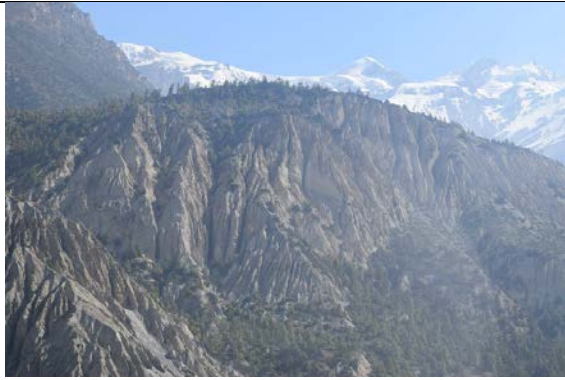
The aerial route covered in this section is shown in Figure 5-112. The Manang area, especially at elevations higher than Chame, is composed of very loose sediment and weathered materials (Figure 5-113). The 2015 Gorkha Earthquake destabilized the sediments locally and dammed the Marshayngdi River a few kilometers downstream of Higde Airport (Figure 5-114). Very loose debris masses that have potential to slide down and block the Marshangdi River were observed extending to Lake Tilicho (Figure 5-115). Many landslides were also observed along the banks of Budi Gandaki River in the direction of Prok (Figure 5-116). Those landslides partially blocked the river and damaged the road connecting Arughat to Arukhet at several locations (Figure 5-117). There were many large scale landslides between Arukhet and Prok that partially blocked the Budi Gandaki River (Figure 5-118). A tributary of Budi Gandaki River near Prok was also blocked at several locations due to earthquake induced landsliding.

Figure 5-113 View of Manang.

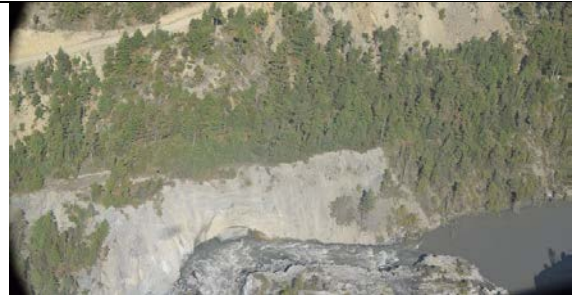
Figure 5-114 A landslide that blocked Marshangdi River temporarily right after the 2015 Gorkha Earthquake.

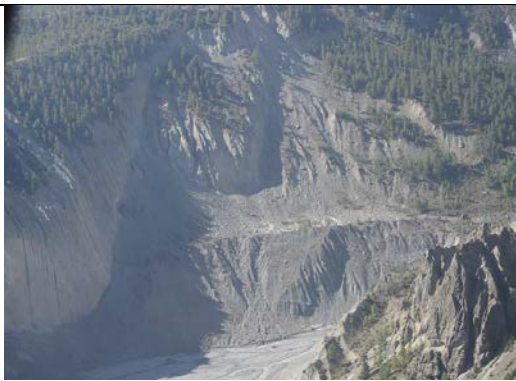
Figure 5-115 Loose sediment mass along the trekking route from Manang to Lake Tilicho (28°4.97'0"N 85°13.8'0"E).

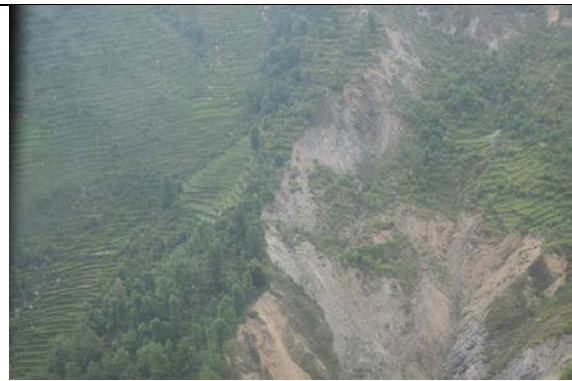
Figure 5-116 Landslides that damaged the road along Arughat-Arukhet road sector.

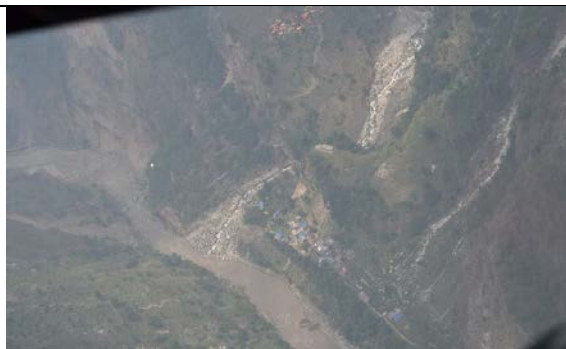
Figure 5-117 A landslide along the bank of Budi Gandaki River.

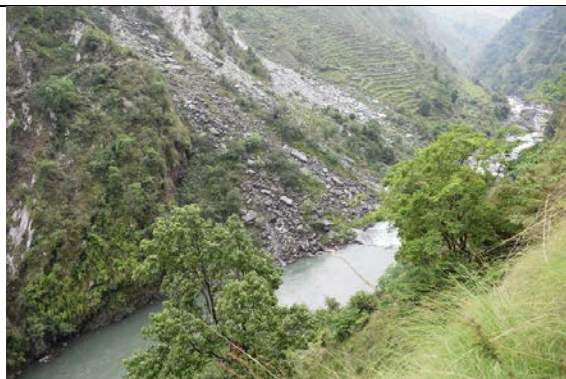
A landslide dam was observed at Pandise, located in the Sertung Village Development Committee of the Dhading District (Figure 5-119). The landslide occurred at Ankhu Khola, a tributary of the Budi Gandaki River. The slope gradient of the tributary was approximately 30-35°, and large boulders traveled down the tributary of Ankhu Khola, blocking the river channel for about a week (Figure 5-120). The landslide dam was breached naturally.

Figure 5-119 A landslide dam at the tributary of Ankhu Khola right after the 2015 Gorkha earthquake main shock (28°40.6'0"N 83°59.8'0"E).

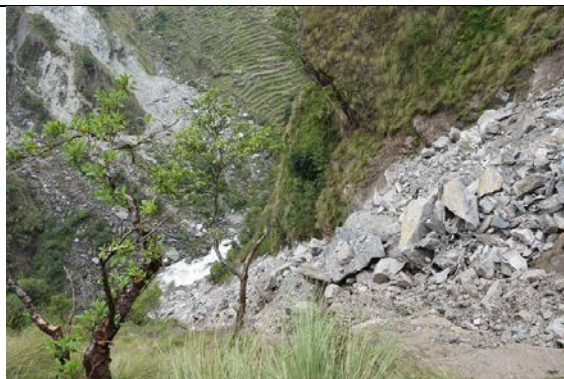
Figure 5-120 Debris mass from the left bank of the river that caused the landslide damming.

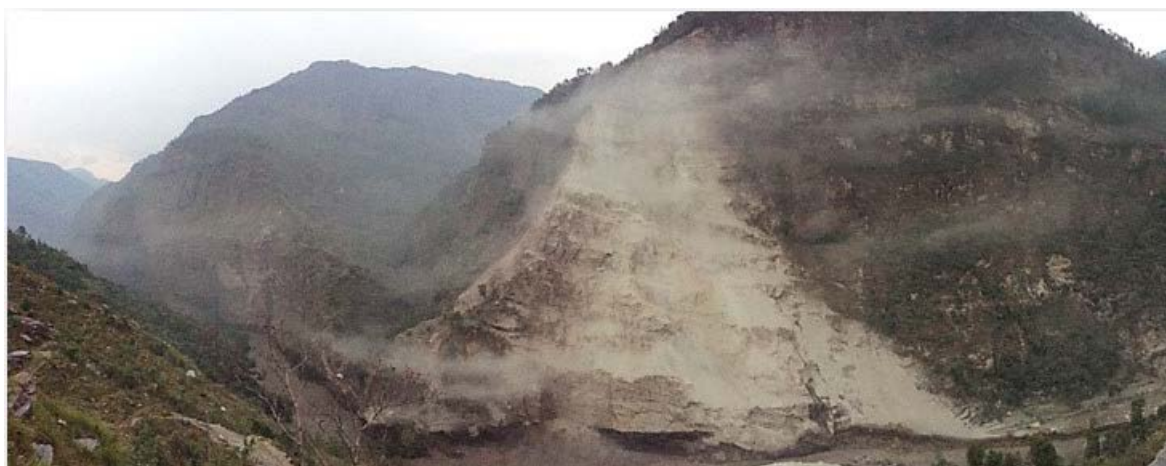
Figure 5-121 Kali Gandaki Landslide

A significant landslide occurred in the early morning of May 24, 2015 on Kali Gandaki River in the Myagdi District, which is located to the northwest of Kathmandu. The Kali Gandaki landslide is a dry, raveling-type landslide that was presumably weakened by the April 25 main shock and subsequent aftershocks. The landslide buried a village with 25 houses but did not cause any human casualties, as the area had already been evacuated before the landslide. Rock's toppling in the day before the landslide and observations of surface cracks at the top of the slope after the April 25, 2015 $M_w 7.8$ main shock and subsequent aftershocks provided sufficient warning to evacuate the village below the landslide. The massive landslide blocked the Kali Gandaki River forming an artificial earth dam. The water level rose rapidly behind the landslide dam and formed lake upstream of the dam. According to local reports, the lake extended approximately 1 to 3 km upstream within 12 hours of the landslide dam formation.

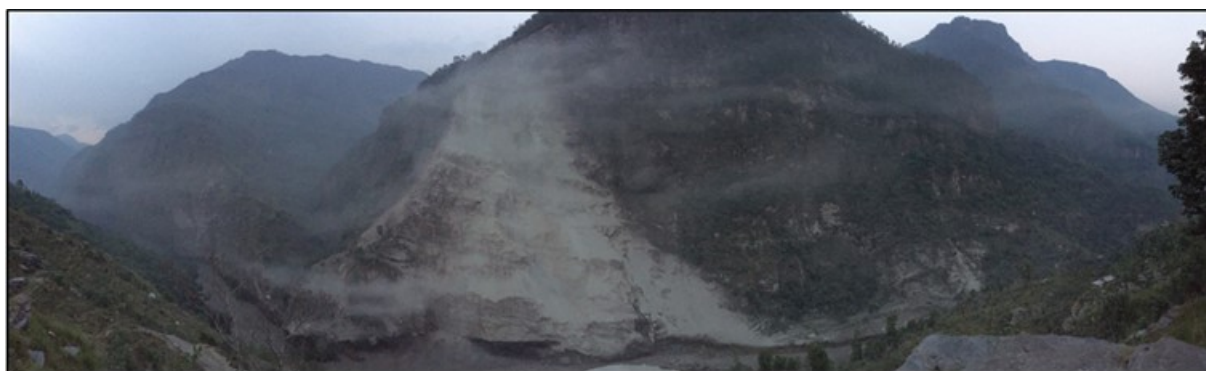
Warnings were provided by local radio and government officials to people living upstream and downstream of the artificial dam to stay alert and to move higher ground. The Nepal Electricity Authority suspended operations in their 144 MW Kali Gandaki Hydropower project, located 45 km downstream of the landslide area, due to the potential risk of flooding. Water started overflowing the dam 16 hours after the landslide, around 5:30 pm local time according to Nepalese Army technicians (Nepal Republica Media). After overflowing the dam, the water kept a steady flow without causing major damage or casualties in the downstream towns.

Figure 5-123 The landslide blocked the Kali Gandaki River forming approximately 2 km long and 150 m deep artificial lake, 28 24' 8.48"N 83 35' 47.5"E.

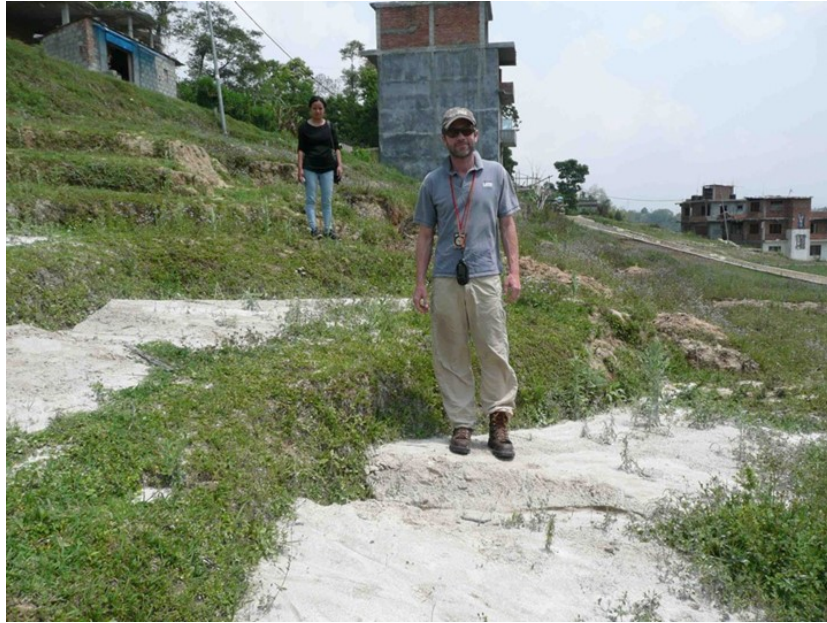
Ramkot is located on the western edge of the Kathmandu Valley. Liquefaction of very fine material was observed on steep terraces (Figure 6-5 and Figure 6-6). No lateral deformation of terraces was found. Ejecta located in the terraces and on lower fields was confined to a narrow swath of the hillside (see Figure 6-5). Similar features were found down by the creek (Figure 6-6), but the biggest sand boils were on the steep (20 degree) slopes. Locals reported that the boils issued for 2+ hours following the M7.8 earthquake. Foundation damage of two small poorly constructed houses correlated with this narrow swath of liquefaction. Other taller more modern structures experienced no damage. Increased driving stress due to taller building may have inhibited liquefaction by locking up the soil. Slope failures were observed in the surrounding hills but were not associated with liquefaction. Structural damage was heavy in the town of Ramkot but not associated with liquefaction.

Figure 6-5. Liquefaction ejecta on steep terraced slopes (27.711025° N 085.262290° E). No lateral movement was observed. No damage to the building in the background.

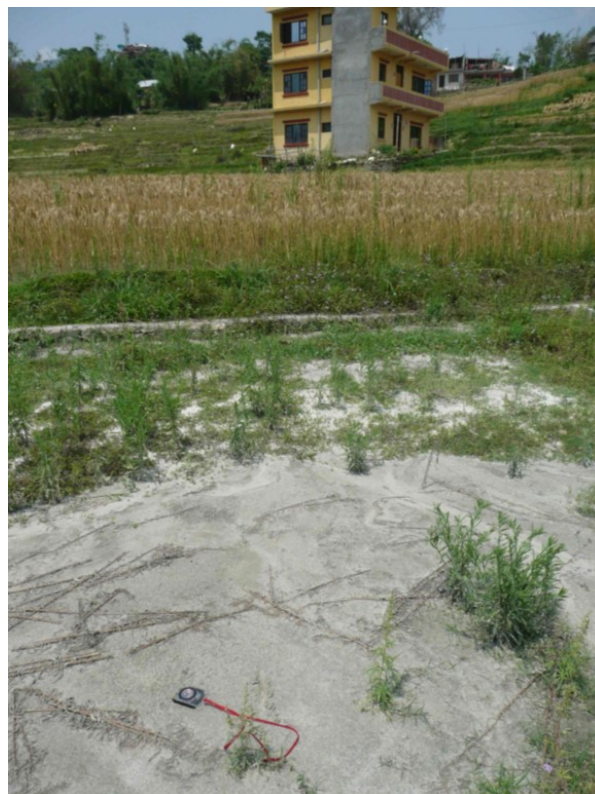
Figure 6-6. Liquefaction ejecta in agricultural field. Material was very fine, primarily silt with some sand. No damage to the building in the background (27.711025°N, 085.262290°E).

Sand boils were observed in an empty plot of land (Figure 6-6). This site is located about 90 m northeast of a meandering river; it is elevated above the floodplain. According to the locals, the ground flooded during the earthquake and remained flooded for two days. Locals also claimed that other plots in the vicinity liquefied, but we could not find surface effects of liquefaction elsewhere. After auguring on this site, we found that the soil profile generally

consists of interbedded layers of loose fine sand and silt up to 2.5m depth. The water table was located ~3m below the ground surface.

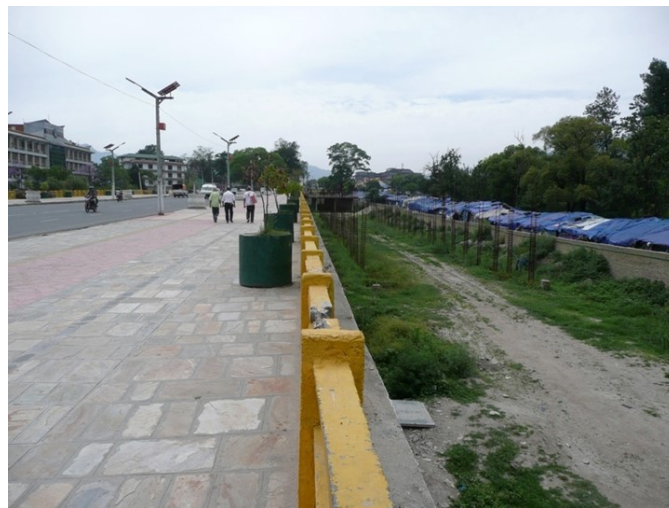
One bridge case history of interest is the Singa Durbar Bridge in the center of Kathmandu (Figure 6-7). This bridge was undamaged after the M7.8 and first aftershock, but sustained damage in the M7.3 event. There appears to be a soft soil failure that aligns with the width of the creek deposits under the bridge. Lateral cracks in the raised concrete sidewalk sections run on both sides of the bridge parallel to the creek and are separated by roughly 100m along the length of the bridge. Talking with a local who is currently building a deep foundation in the affected area, he says the subsurface conditions are fill over “black cotton” silty clays, the same lake deposit found throughout the Kathmandu valley. It is anticipated that there are underlying sandy soils as well but currently there are not subsurface investigations to confirm this. The mode of soil failure, liquefaction or cyclic failure, at this site is undetermined at this moment.

Figure 6-7. Singa Durbar Bridge (27.698793°N, 85.320060° E). To the right of the bridge can be seen the deep foundation that is currently being installed for a building.

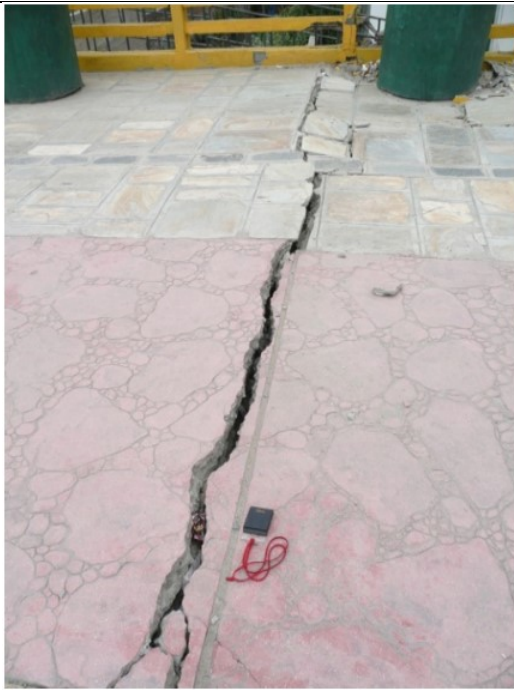
Figure 6-8. Cracking in concrete section of bridge (27.698793° 85.320060°). Cracks on both sides of the bridge line up with the creek below. No cracking in the asphalt over fill section, it behaved in a ductile manner

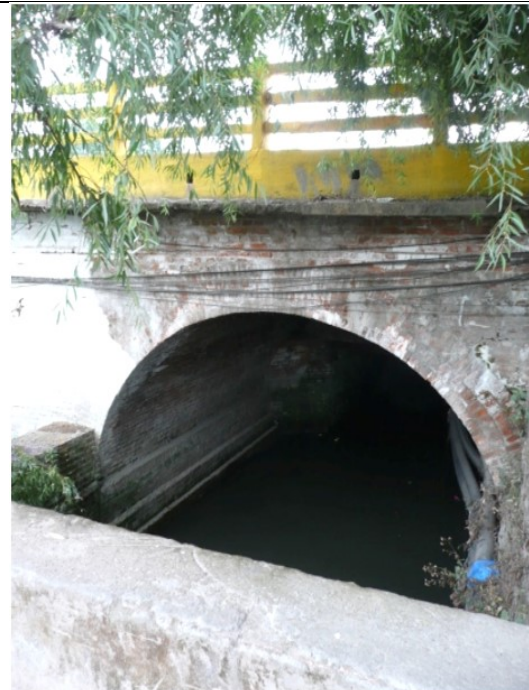
Figure 6-9. Creek below the bridge (27.698793° 85.320060°). The flood plain of this creek defines the extent of the cracking, with the cracks parallel to the creek alignment.

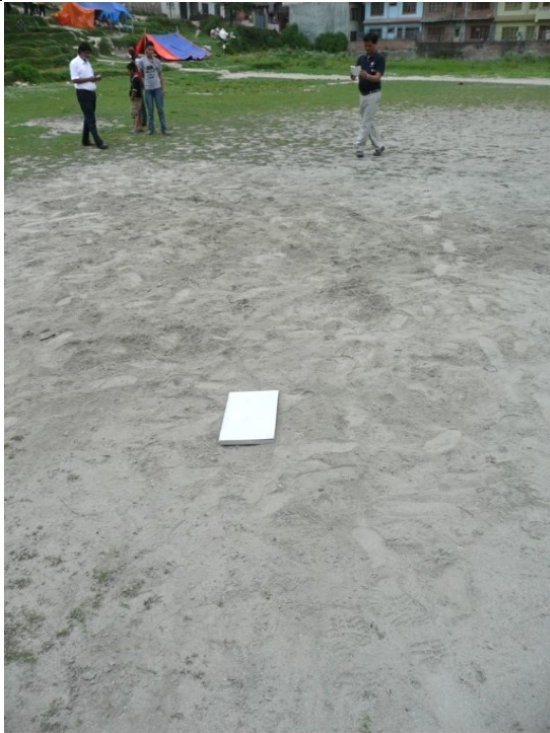
Liquefaction was observed in free field conditions as well as under building foundations at Manamaiju (Figure 6-10 and Figure 6-11). The location is an old abandoned river channel. There were sand boils of fine micaceous sand (see lab tests, Figure 6-12), some minor building tilting/punching, and a possible incipient lateral spread along a free face. Locals stated that sand boils ejected material up to 1 m above the ground surface. Here liquefaction was triggered but not enough shaking occurred to get large displacements. This would be called a “marginal” liquefaction site in Seed et al. (1985) terminology, and if the ground shaking can be properly quantified at this site, it would provide a datapoint right near the triggering threshold. A bag sample of ejecta was collected and tested at Tribhuvan University for FC, gradation, and PI. Follow up studies should include acquiring any existing bore logs from nearby site, make detailed measurements of the free face, make more detailed measurements of foundation settlement (on the order of a few cm) and building tilt (less than 2 degrees), and arrange for some penetration measurements (preferably CPT).

Figure 6-10. Large sand boil in a field at Manamaiju. The ejecta was a micaceous silty fine sand. (27.745523° N, 85.302223° E).

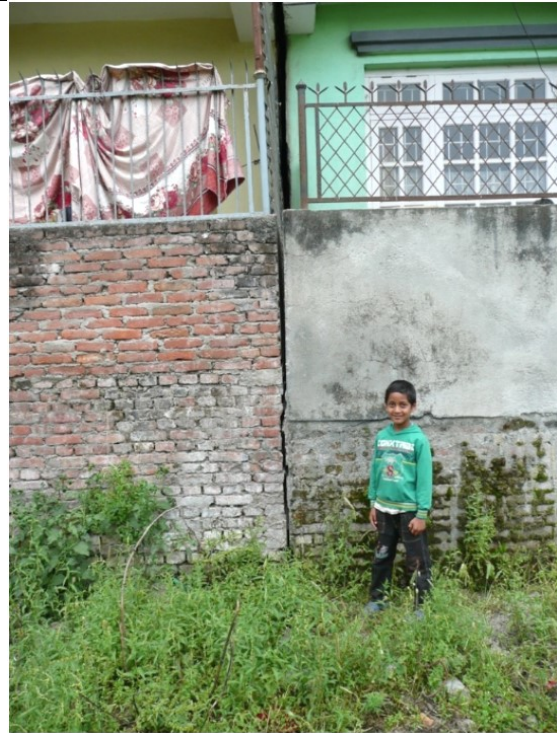
Figure 6-11. Tilt of left building away from right building, measured at roughly 2 degrees (27.745523° N, 85.302223° E).

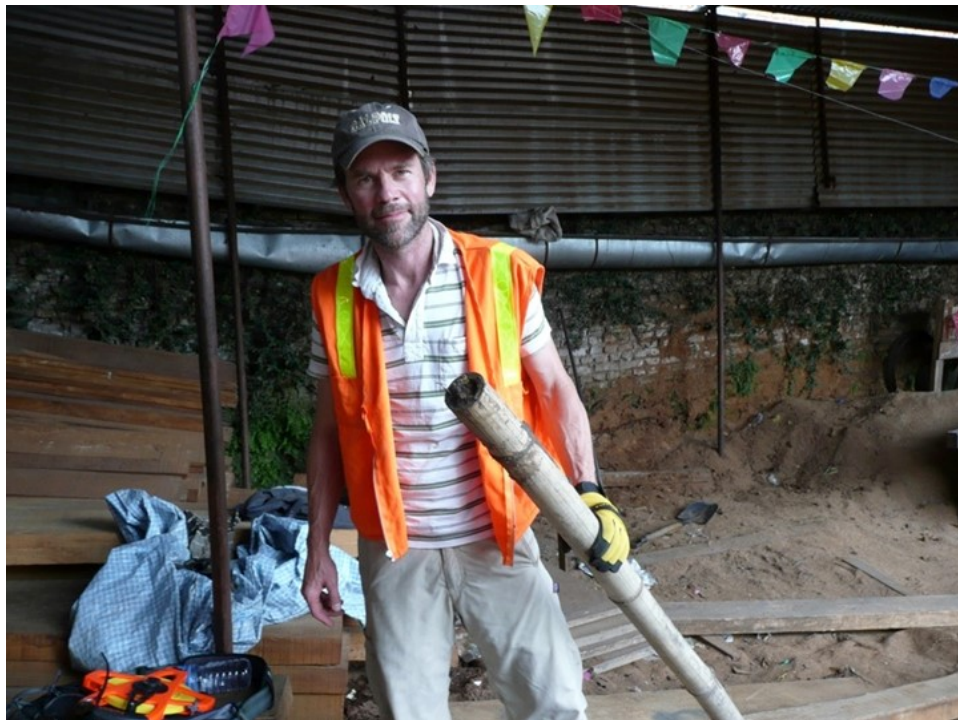
At one location a silty clay with low PI (see lab tests), was sampled with a (bamboo) sampler at the bottom of the fissures. At a nearby location a 2 m deep hand-dug trench within one of the fissures was excavated to acquire bulk samples of the same soil. Adjacent to the trench buildings had experienced 0.75 m vertical displacement and bulk samples of the silty clay were acquired from the excavated foundation. The deformations were reported by the home owners as co-seismic with small displacements from the main $M_w 7.8$ and then the bulk of the displacements due to the first aftershock that was $M_w 6.7$.

Figure 6-16. Bamboo sample of silty clay soil called “black cotton” in the Kathmandu Valley. (27.674816° 85.362646°).

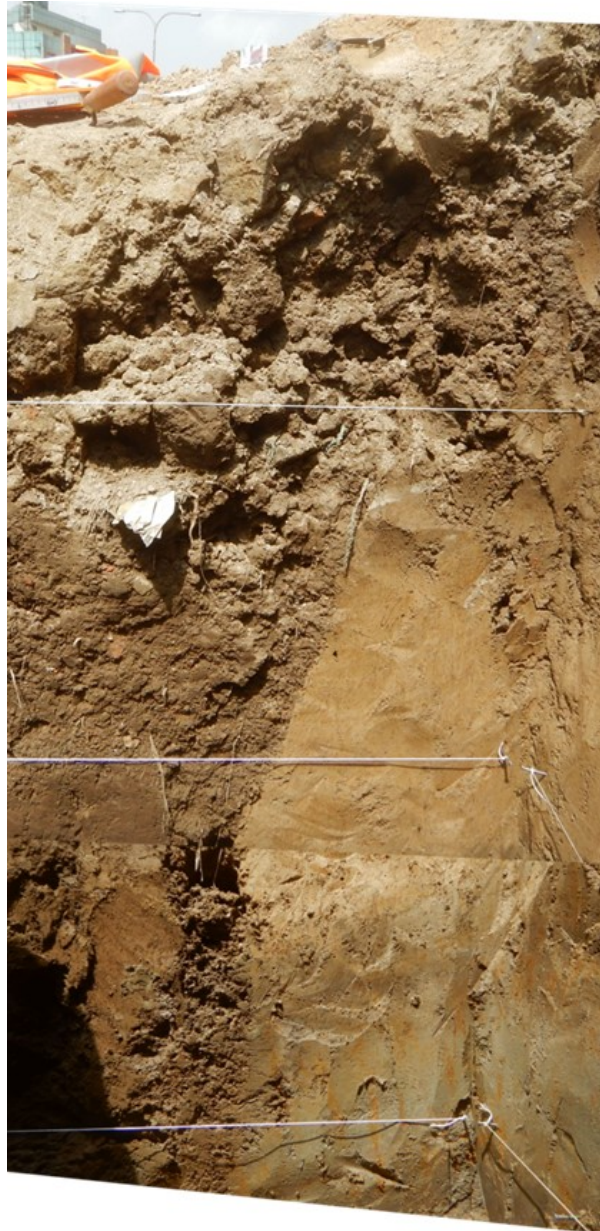
Initial investigations observed that the failure planes entered a silty clay/clayey silt with low PI. Near the location of maximum slip (27.67439 N, 85.36267 E) we dug a pit about 2 m deep (depending on which side of the scarp is considered the ground surface). We used the shear vane to measure the peak shear strength of 150 kPa and residual shear strength of 112 kPa at 1 m below the base of the trench (sensitivity of about 1.3). However, these values should be used with caution since we could not confirm that the silty clay at this depth was fully saturated. Based on the observations described above, as well as the length of the fissures and local accounts that the failures progressed slowly, the failure mechanism was initially attributed to cyclic failure in the clay.

Figure 6-20. Cross section of failure plane on wall of trench at EMT04. Horizontal string is separated vertically by 0.5 m (27.67439 N, 85.36267 E).

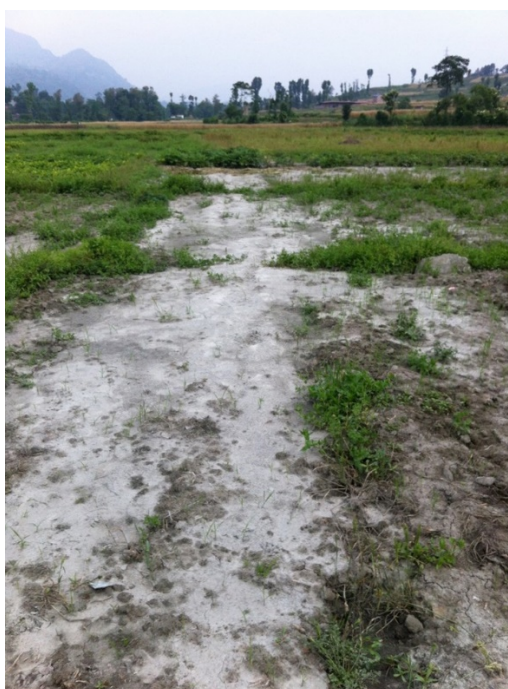
Sand boils occurred on the floodplain about 200 m from the Bagmati River (Figure 6-23). The ground water table was measured at about 1.3 m. We hand augered to get the stratigraphy along a 23 m long transect. The stratigraphy was relatively consistent: 0.5 m of micaceous brown silty clay topsoil, followed by Black Cotton Clay to about 1.5 m, followed by fine sand that coarsened with depth. It is likely that this saturated sand layer liquefied, but of course we are unable to determine what is present at greater depths. The local residents told us that water ejected from the ground surface approximately 1 m in height for 30 minutes after strong shaking had ceased, and that the flooding lasted 2 to 3 days. In addition, residents mentioned that nearby agricultural fields along the Bagmati River had also shown surficial signs of liquefaction after the April 25 earthquake. The land owner mentioned that the Nepal Government plans to build a super highway through this site within the next 25 years.

Figure 6-23. Sand boils in Bungamati (photo courtesy of Dewakur Khadka, 27.62863 N, 85.29665 E).

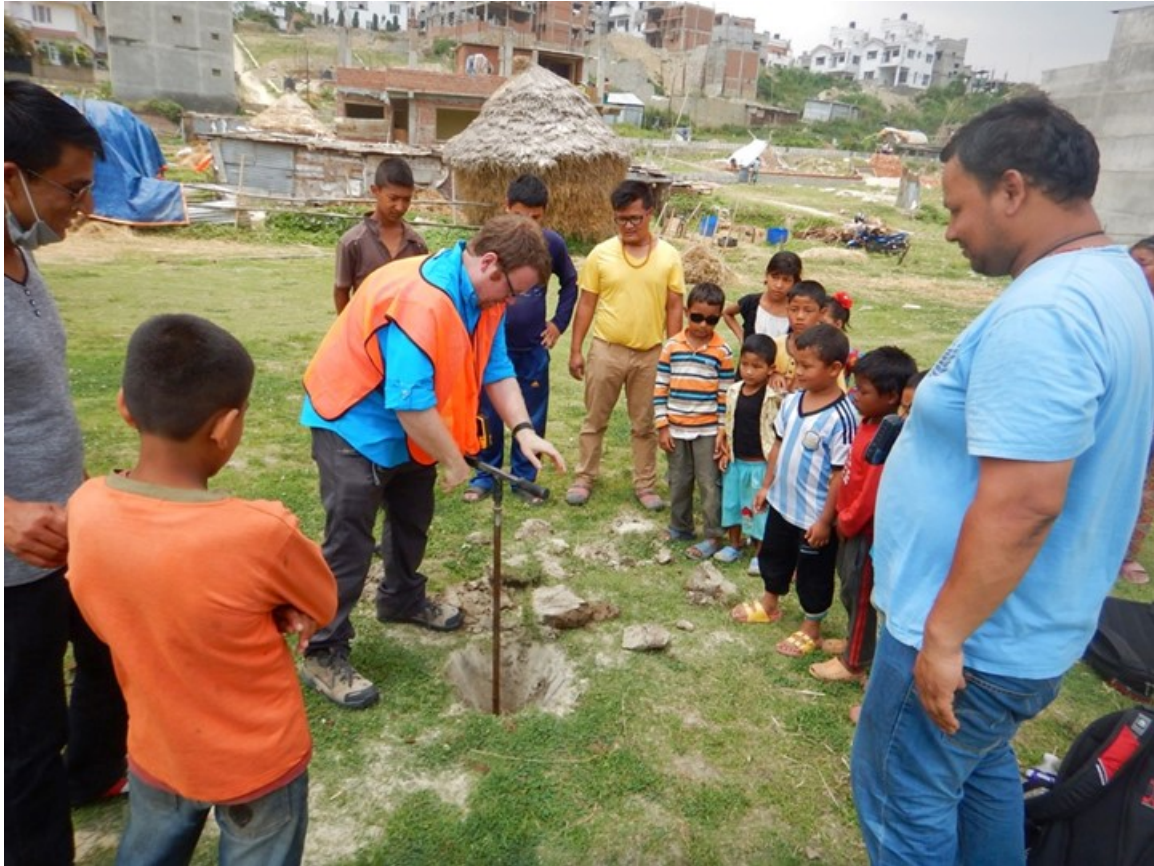
Numerous sand boils were observed at the Hattiban site. Unlike other liquefaction sites that the GEER team visited, this site was not a borrow pit for sand. We performed an auger (Figure 6-27). At the auger location, about 25 mm of fine sand ejecta was on the surface. Below the ejecta, we found that the site was characterized by a low plasticity silt or silty clay in the top 1.9 m. Dykes of fine sand were found in the auger samples from approximately 0.9 to 1.6 m. Below the silt and silty clay layers was a 0.5 m thick layer of black cotton clay. Below the black cotton layer was a fine sand layer, and the groundwater table was found at 2.5 m below the ground surface.

Figure 6-27. Hand augering a sand boil in Hattiban, 85.33441 N, 27.65567 E.

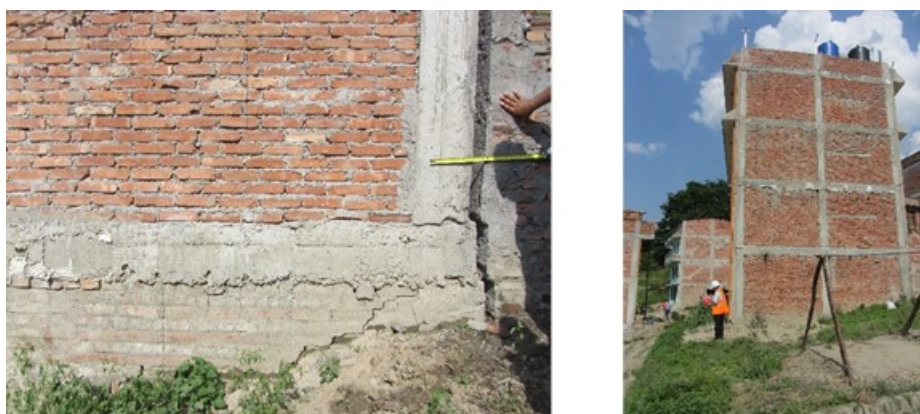
Figure 6-31 (a) Observed cracked in the wall of a RC building due to lateral deformation of ground (b) no damage on a building within the same location as cracks could not passes through the foundation (Location: 27°40'43.22" N, 85°26'10.52" E)

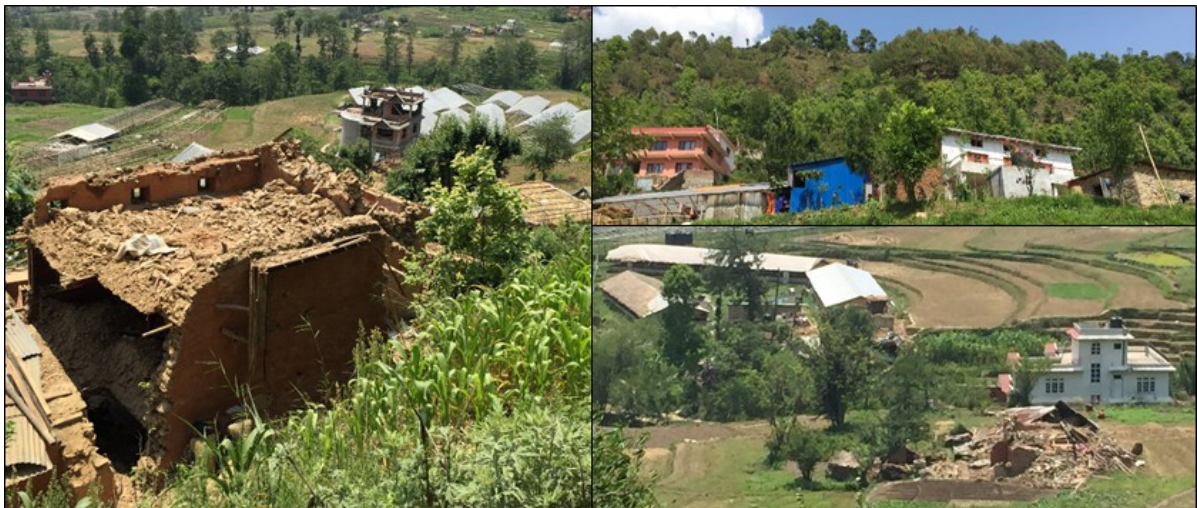
Figure 6-34 Building damage around the surface crack observed in Nagarjun

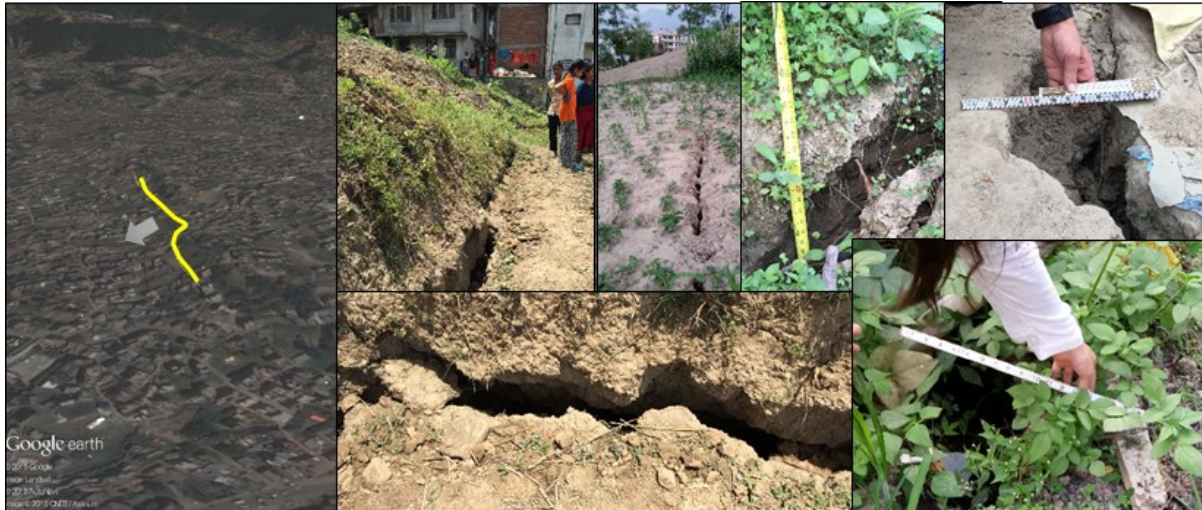
The second site visited by the GEER Team was at Syuchatar. The team walked along the exposed surface crack following the directions of the locals living in the vicinity. The surface crack is found to be on a mildly sloping hill that is occupied by few one to two story, mostly reinforced concrete frame structures (Figure 6-35). Some of the mud-mortar and masonry concrete houses in the area were damaged, however most of the reinforced concrete frame structures did not experience major damage (Figure 6-36). At some locations where the surface crack crosses through the structure a crack on the foundation slab and on the walls were observed (Figure 6-37). The surface crack at this location is estimated to be approximately 1800 ft long, at some locations the depth of the crack is observed to be up to 14 ft. and width of the crack is overserved to be up to to 1 ft. wide (Figure 6-35). The mechanism of the failure is predicted to be lateral spreading. In order to better understand the subsurface soil conditions, GEER Team returned to the site to collect samples and perform in-situ shear strength tests. At three different locations along the crack, team collected soil samples using hand-auguring and performed strength test using in-situ vane shear in collaboration with USGS (Figure 6-38). Collected samples has shown presence of silty sand layer that might have liquefied and caused lateral spreading.

Figure 6-35 Observed surface ~1800 ft. long, ~1 ft. wide, 14ft. deep surface crack in Syuchatar.

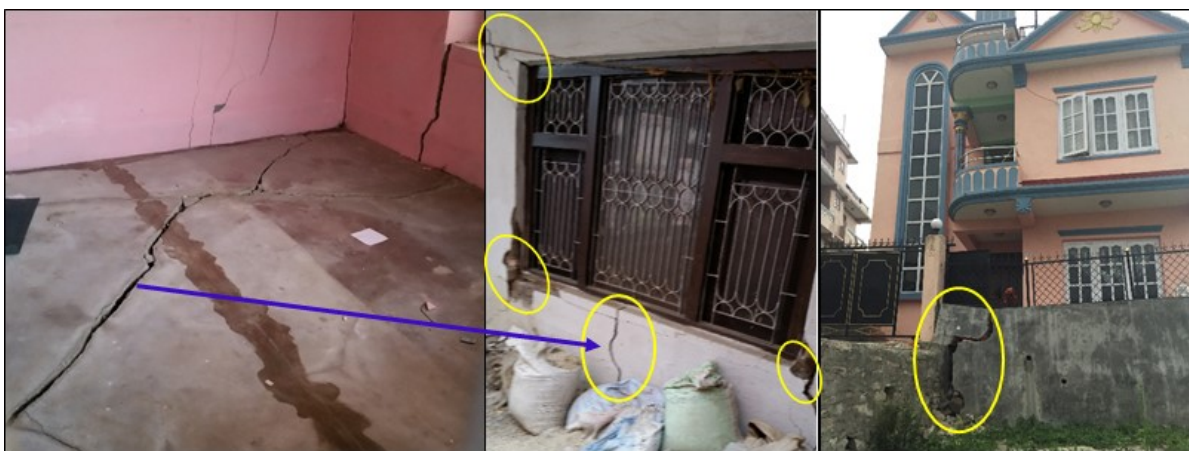
Figure 6-37 Cracks on the floor and walls due to lateral spreading in Syuchatar.

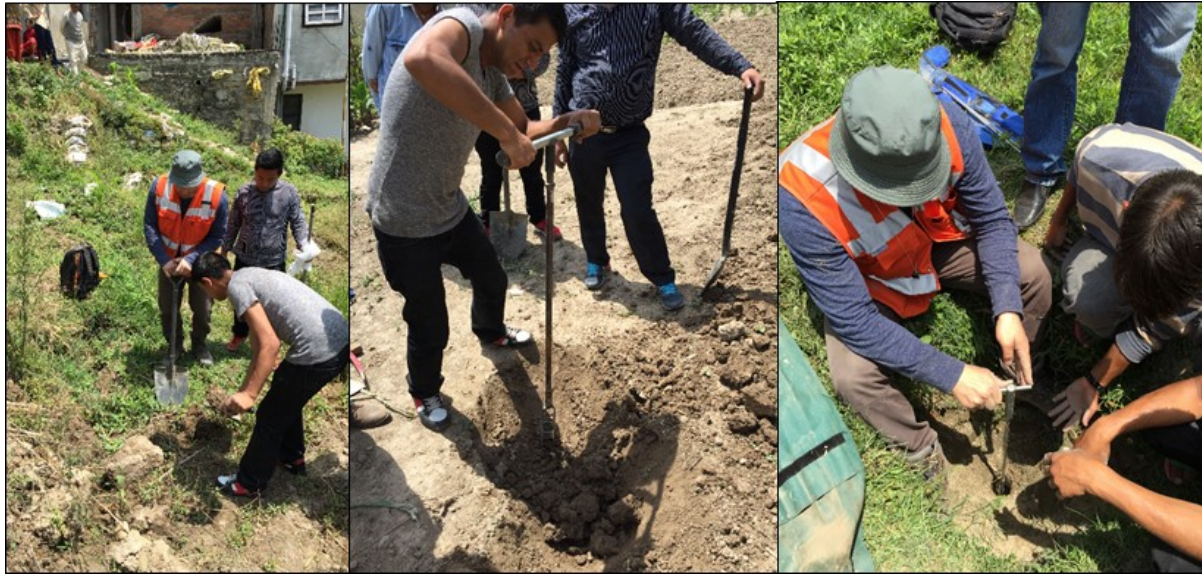
Figure 6-38 Soil sampling and field strength testing performed in Syuchatar.

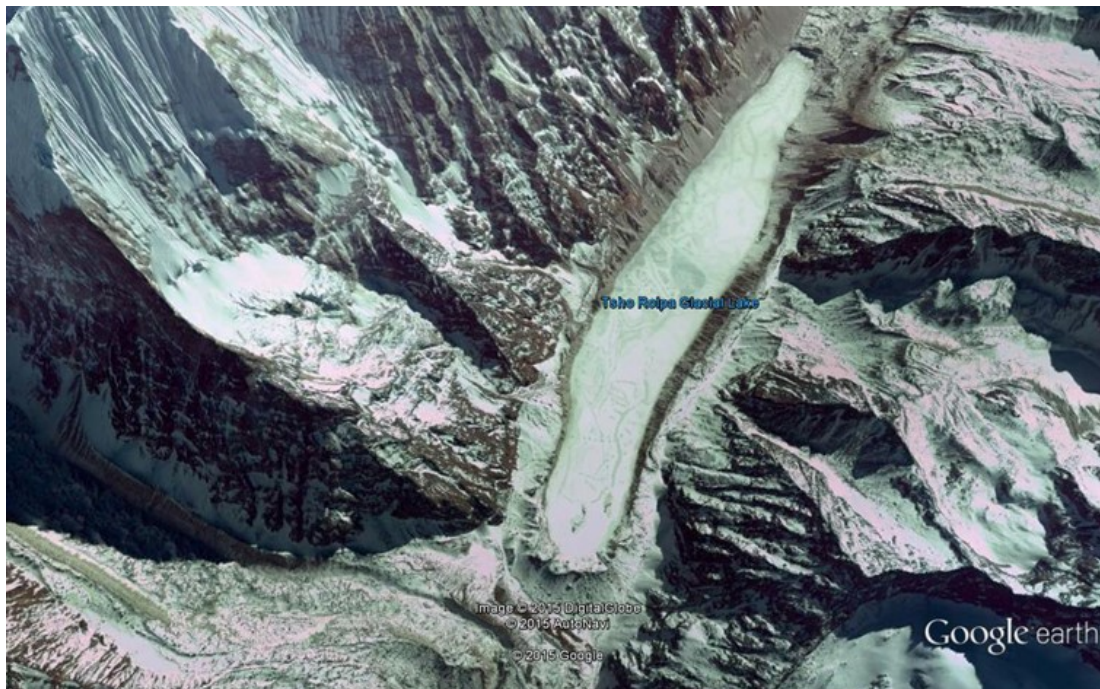
The Tsho Lorpa glacial lake dam is a natural lake located at an El 14,500 (4,535m, Figure 6-39). A spillway was built to control the water level in the lake and prevent overtopping and possible breaching of the natural dam. The site was visited by helicopter to examine the integrity of the natural dam material around the lake, Figure 6-40, as well as the spillway, Figure 6-41. The natural dam material showed now cracking or slumping. At the spillway lateral spreading was observed on the lake side. Significant lateral and vertical displacement, Figure 6-42, are observed in excess of a total of about 1.5 m laterally and about 0.5 m vertically.

Figure 6-39 Plan view of Tsho Lorpa Glacial Lake Dam ($27^{\circ} 52' 9.57''\text{N}$, $86^{\circ} 27' 44''\text{E}$).

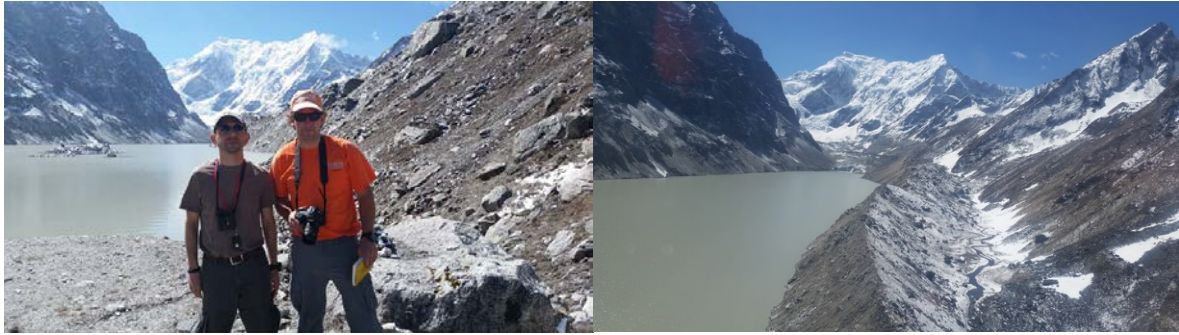
Figure 6-40 Glacial Lake ($27^{\circ} 52' 9.57''\text{N}$, $86^{\circ} 27' 44''\text{E}$).

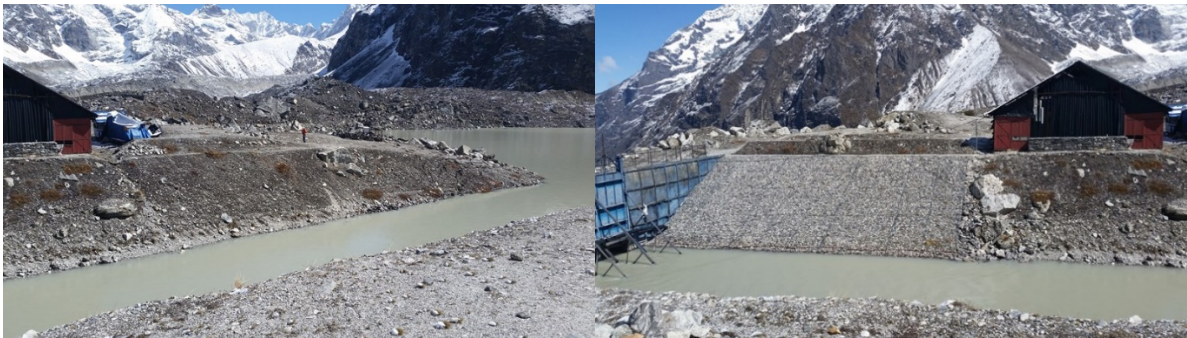
Figure 6-41 Spillway of Glacial Lake ($27^{\circ} 52' 9.57''\text{N}$, $86^{\circ} 27' 44''\text{E}$).

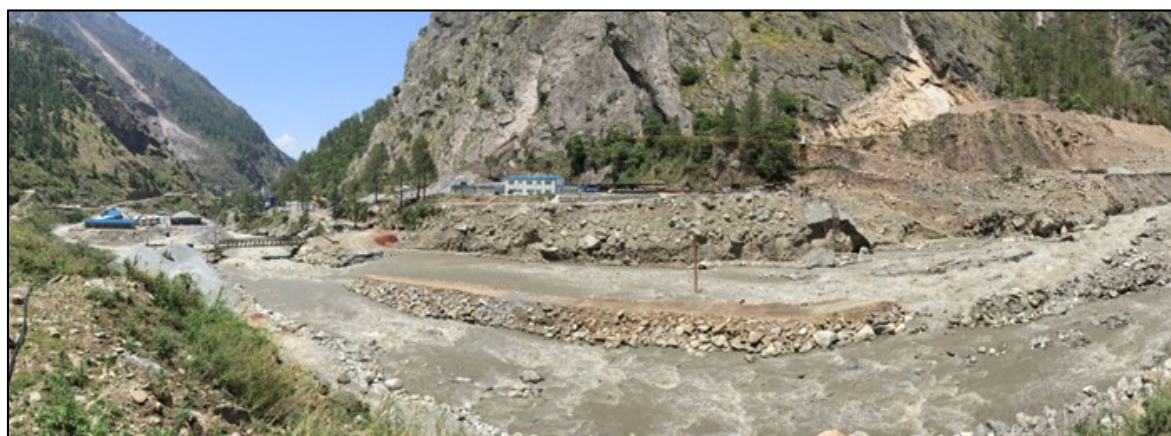
In the headworks area, several rockfalls on the north side of the river damaged construction equipment, including a crane (Figure 7-2). A large rockfall on the south side of the river buried the road to the border and diverted channel flow causing a breach in a temporary coffer dam

and inundating portions of the headwork construction area downstream (Figure 7-2). The same rockfall buried the Nepal welcome center at the Nepal/Chinese border, reportedly killing over 20 people.

Figure 7-2 Site access roads, infrastructure and equipment including a crane in the Rasawugadhi headworks area were damaged by rockfalls. A temporary coffer dam was damaged by the rockfalls and then breached when flow of the river was diverted around the rockfall, directly toward the dam, causing overtopping and erosion (28°16'27.03" N, 85°22'41.59" E).
