Executive Summary

The April 25, 2015 Gorkha (Nepal) Earthquake and its related aftershocks had a devastating impact on Nepal. The earthquake sequence resulted in nearly 9,000 deaths, tens of thousands of injuries, and has left hundreds of thousands of inhabitants homeless. With economic losses estimated at several billion US dollars, the financial impact to Nepal is severe and the rebuilding phase will likely span many years.

The Geotechnical Extreme Events Reconnaissance (GEER) Association assembled a reconnaissance team under the leadership of D. Scott Kieffer, Binod Tiwari and Youssef M.A. Hashash to evaluate geotechnical impacts of the April 25, 2015 Gorkha Earthquake and its related aftershocks. The focus of the reconnaissance was on time-sensitive (perishable) data, and the GEER team included a large group of experts in the areas of Geology, Engineering Geology, Seismology, Tectonics, Geotechnical Engineering, Geotechnical Earthquake Engineering, and Civil and Environmental Engineering. The GEER team worked in close collaboration with local and international organizations to document earthquake damage and identify targets for detailed follow up investigations.

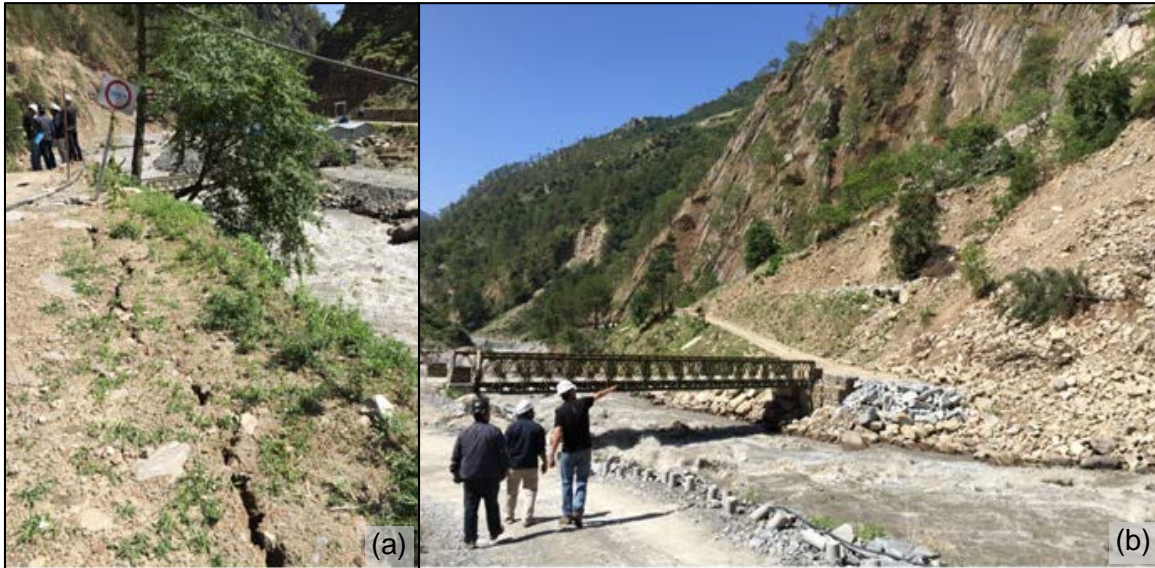
Downstream of the headworks, near the dam office and powerhouse access tunnel, roads and fluvial terraces above oversteepened slopes locally exhibited tension cracks (Figure 7-3). The access road to the surge chamber was blocked by small accumulations of rock debris shed from roadcuts upslope. Rockfalls continued throughout the project area during our site visit.

Figure 7-3 Tension cracks were observed along roads built on cut-fill slopes near the powerhouse access tunnel. Rockfall debris locally blocked access roads to this area, especially on steepened slopes. (a) $28^{\circ}14'23.91''$ N, $85^{\circ}21'28.67''$ E, (b) $28^{\circ}14'28.46''$ N, $85^{\circ}21'30.18''$ E

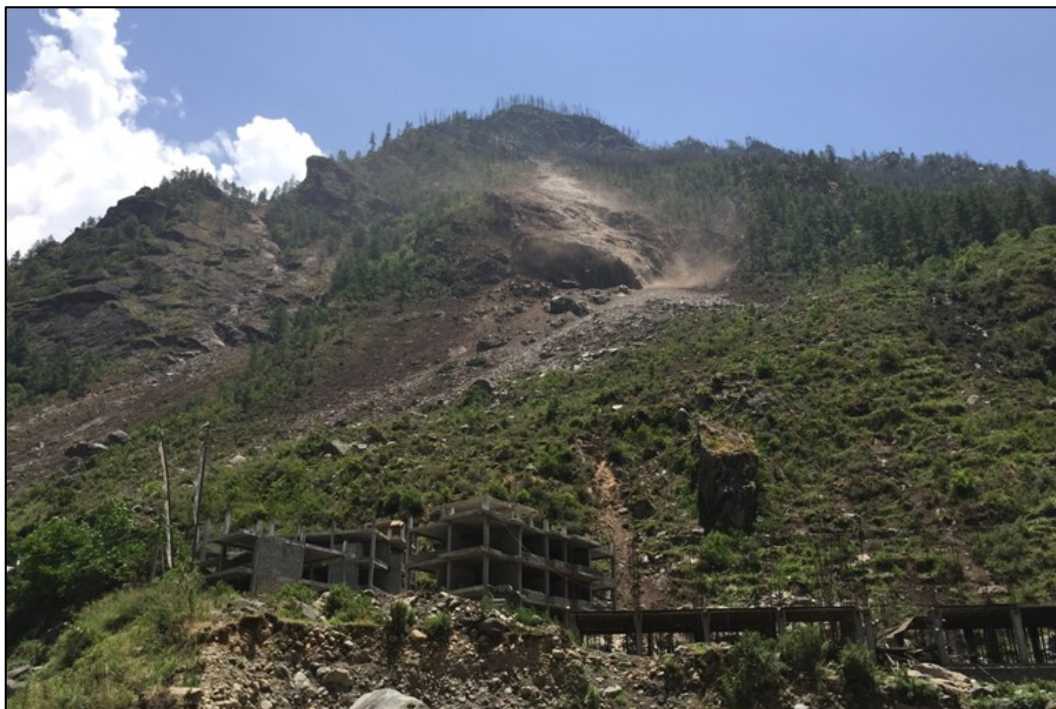
Although many portions of the hydro project are not directly in the path of rockfalls, some areas are directly below debris chutes, such as the new site for the dam workers colony that is currently under construction (Figure 7-4).

Figure 7-4 New hydro camp buildings located between the headworks and powerhouse have been impacted by some rock fall debris from above ($28^{\circ}15'55.10''$ N, $85^{\circ}22'30.11''$ E).

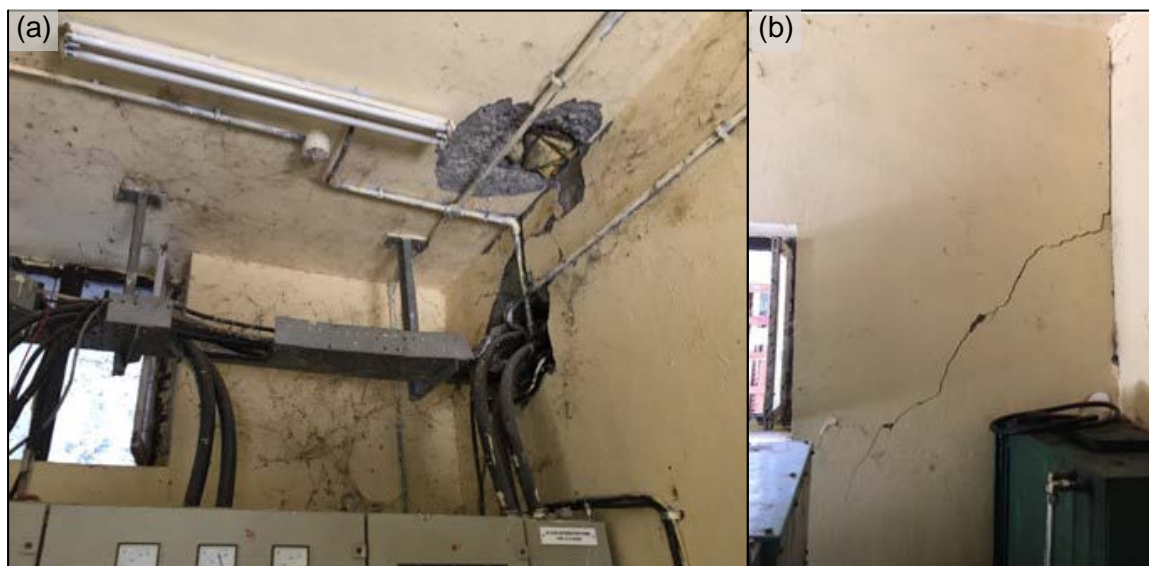
The 22 MW Chilime hydropower project sustained minimal damage from the earthquake and was operational at the time of our visit. The GEER team visited the underground powerhouse on the right bank of the river in the town of Chilime and the powerhouse yard. The powerhouse was operating during our visit. Storage buildings housing the backup diesel generator and other equipment sustained localized cracking from shaking and holes in their roofs where individual rocks measuring up to 0.25 m or more fell from overlying cliffs (Figure 7-5).

Figure 7-5 Secondary buildings at Chilime exhibited minor shaking. Damage was limited to cracks in infill walls and holes in the roofs of some structures. (a) 28°9'27.30" N, 85°16'54.38" E, (b) 28°9'27.30" N, 85°19'54.38" E

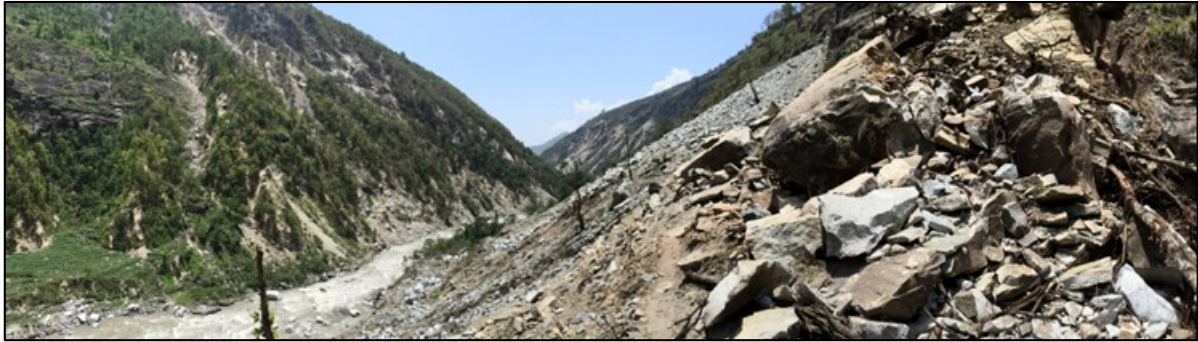
The Upper Trishuli 3A Project is under construction and will have a generating capacity of 60 MW when completed. At the time of the GEER team visit, access to the site was cut off where several kilometers of rockfall debris covered over the main access road to the site (Figure 7-6). GEER personnel accessed the site on foot and surveyed, from upstream to downstream, the headworks area, tunnel portal, workers colony, and concrete batching plant.

Figure 7-6 Continuous rockfalls block the main access road to the Upper Trishuli 3A headworks. The large pile of boulders on the right marks the location of the road. A walking path has been worn into the rockfall debris by villagers and dam workers. Tallus slopes in the background are all from fresh rockfalls. Vegetated debris cones on the left side provide evidence for previous rockfalls that were not reactivated during the 2015 earthquake. View is to the southwest (28°2'53.76" N, 85°12'4.27" E).

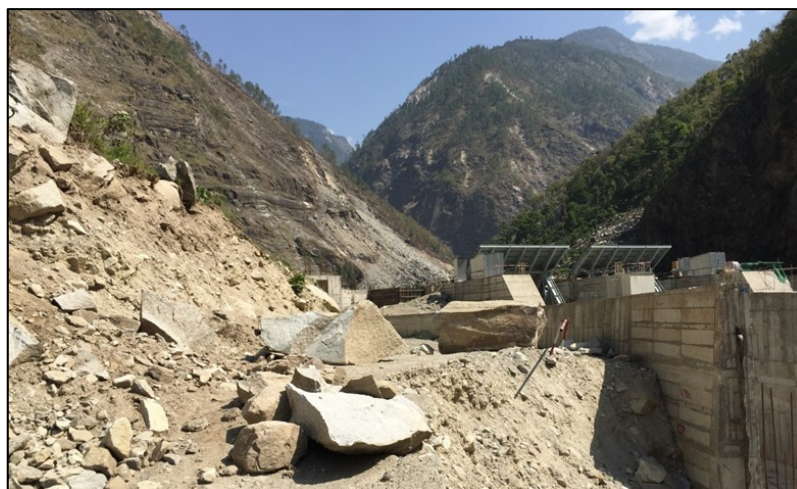
Figure 7-7 Road blocked by rockfalls through the headworks area (28°3'47.21" N, 85°12'23.25" E).

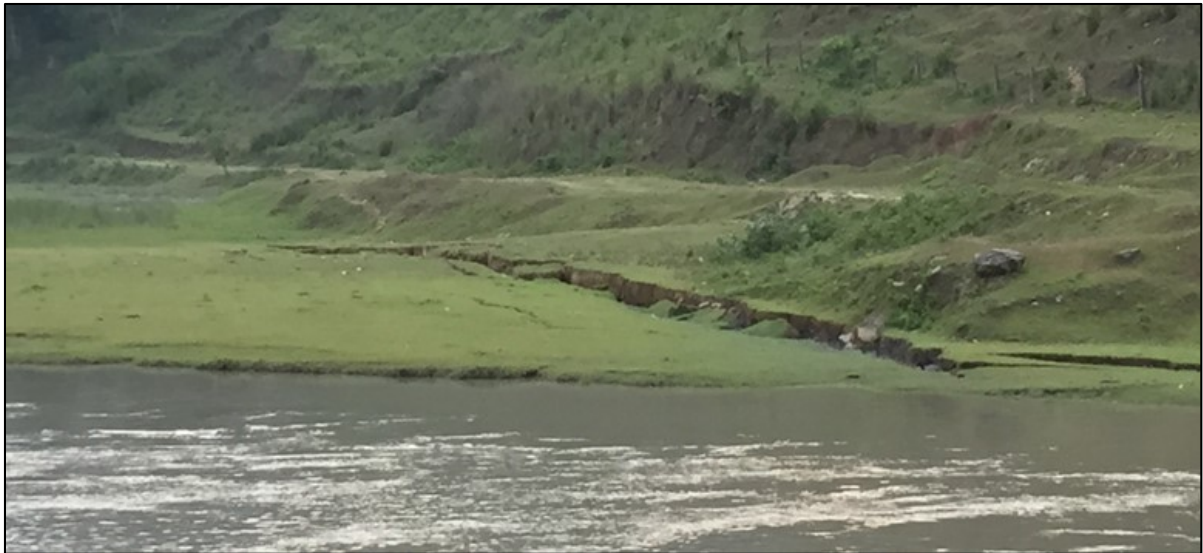
Dam personnel took the team to a section of the canal where several instances of cracking of the canal liner, and in one case piping of water from slopes beneath the canal had been observed. Cracking occurred along the edges of two large settling ponds, one lined and the other unlined. Cracks in the lined settling pond were patched with pitch. Cracks in the walls of unlined pond were patched with mud likely derived from the silt and clay caps on older terrace deposits in the vicinity. The unlined settling pond also experienced lateral spreading (Figure 7-13).

Figure 7-13 Lateral spreading around a settling pond along the canal system between the Trishuli headworks and powerhouse (27°56'15.18" N, 85°9'22.28" E).

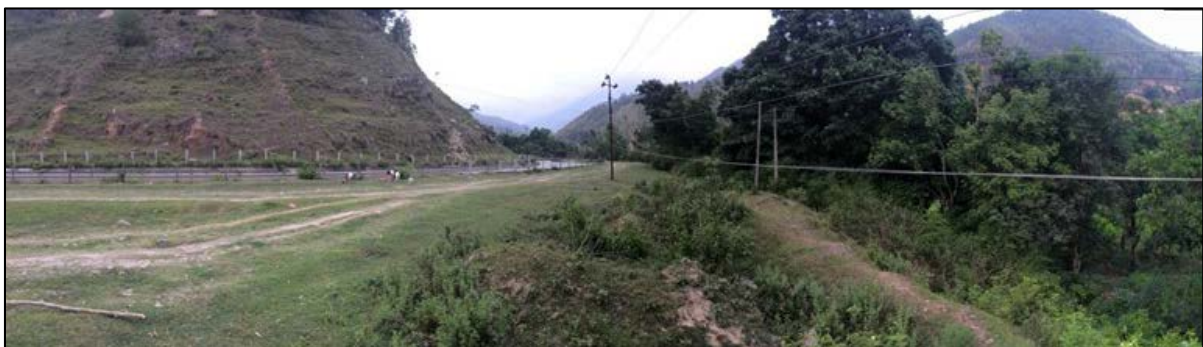
Another section of canal upstream of the settling ponds had cracks in the liner where water escaped and flowed out of the terrace riser below. The leaks stopped when the cracks were patched with pitch. The close proximity of landslide headscarps below the canal wall in this area suggests that the cracking may have been caused by lateral movement of the area adjacent to the canal (Figure 7-14). This area will require monitoring during the monsoon season to assess whether cracks reappear along this section of the canal. The powerhouse and penstocks for the Trishuli Project were not damaged by the earthquake.

Figure 7-14 Section of Trishuli canal that leaked after the April 25th earthquake. Fresh head scarps (hummocky vegetated area left of power lines) along the outer edge of the fluvial terrace to the right of the canal suggest that this area is unstable and may have mobilized during the earthquake, possibly causing extension along cold joints in the canal liner (27°56'49.48"N, 85° 9'37.79"E).

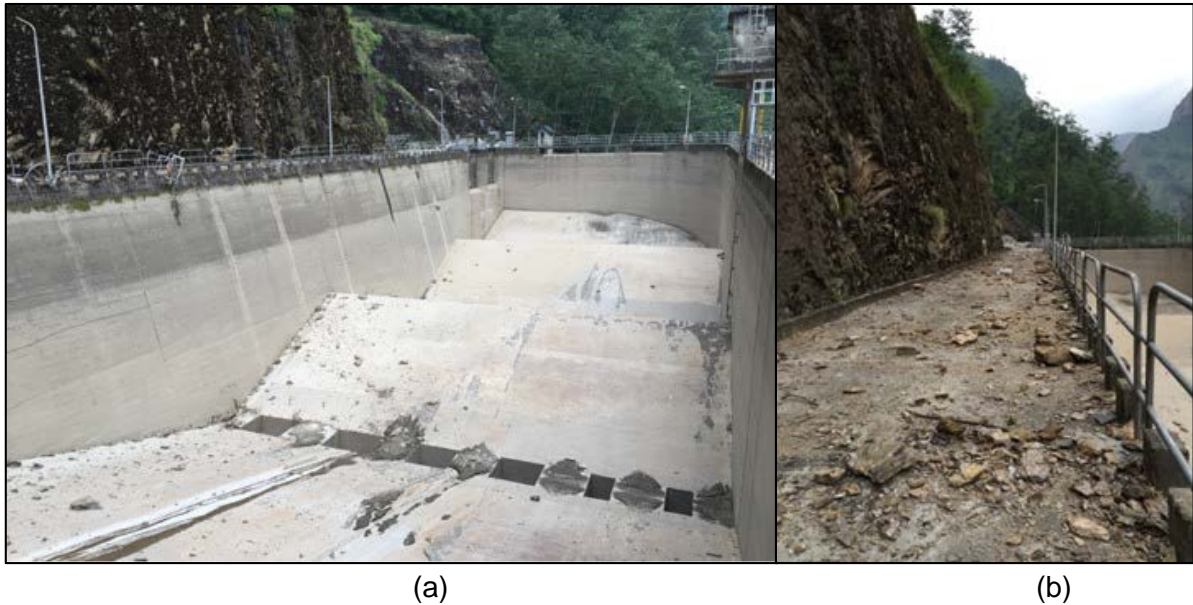
The diversion dam at the headworks was in good condition. The earthquake dislodged only small scattered rocks from the cliffs above the left abutment of the dam, with only railings and light installations damaged by rock impacts (Figure 7-15).

Figure 7-15 The Upper Bhotekoshi Headworks - Handrail damage, surficial debris impact and debris inundation from rock fall was observed at the gravel catchers. Remaining risks of damage and danger to life safety in this area are remaining risks. (a) 27°56'17.80" N, 85°56'42.88" E, (b) 27°56'17.39" N, 85°56'43.10" E

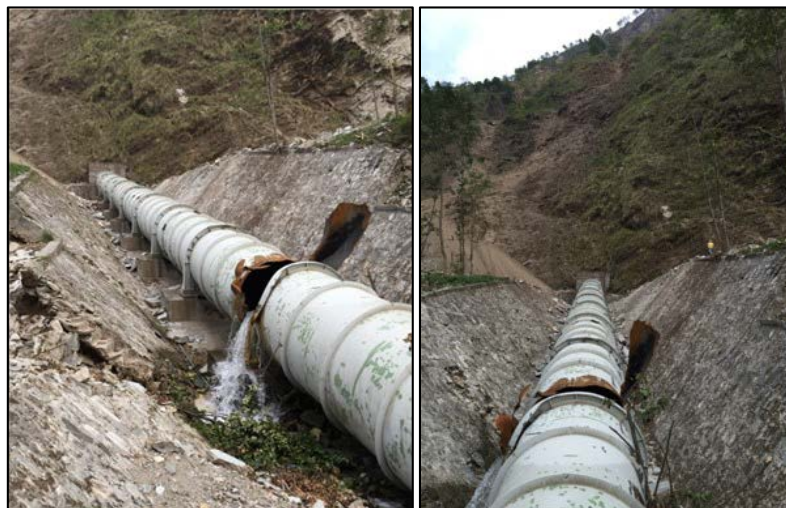
Larger rockfalls affected the powerhouse area, causing significant damage. On the left (southeast) side of the canyon, scattered blocks rained down on the penstock where it exited the canyon wall above the powerhouse. A direct hit by one of these blocks ruptured the penstock at a seam (Figure 7-16).

Figure 7-16 Penstock punctured by rock fall (a) 27°54'48.89" N, 85°55'38.25" E, (b) 27°54'46.11" N, 85°55' 38.28" E.

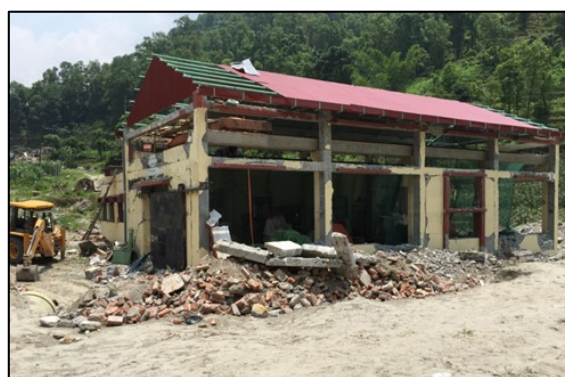
The powerhouse sustained heavy shaking damage from the May 12 aftershock after having reportedly survived the April 25th mainshock relatively unscathed. Shaking from the aftershock caused the infill walls to collapse (Figure 7-23). This may have been caused by amplification of shaking in the young, poorly consolidated alluvium on which the powerhouse was constructed.

Figure 7-23 Shaking damage to powerhouse building observed. Infill walls collapsed. Concrete reinforced frame appeared to suffer little damage. Some liquefaction also evident in the area around the structure. ($27^{\circ}46'36.05''\text{N}$, $85^{\circ}53'25.62''\text{E}$)

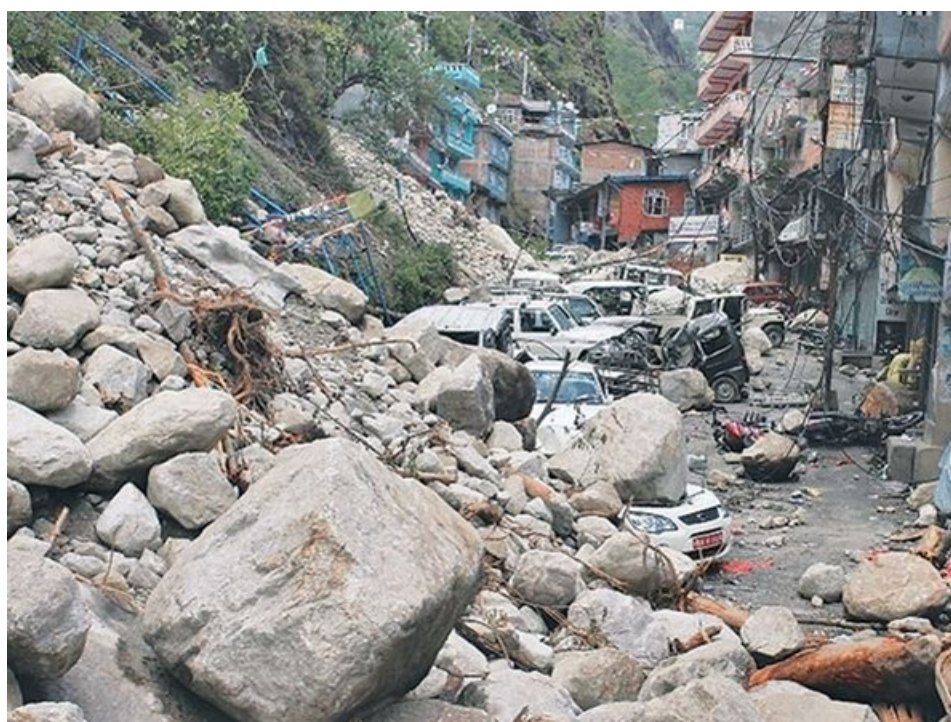
Figure 8-3 Rock falls triggered by the earthquake interrupted transportation along the Arniko Highway in Sindhupalchock. (Ref: <http://www.ekantipur.com/>)

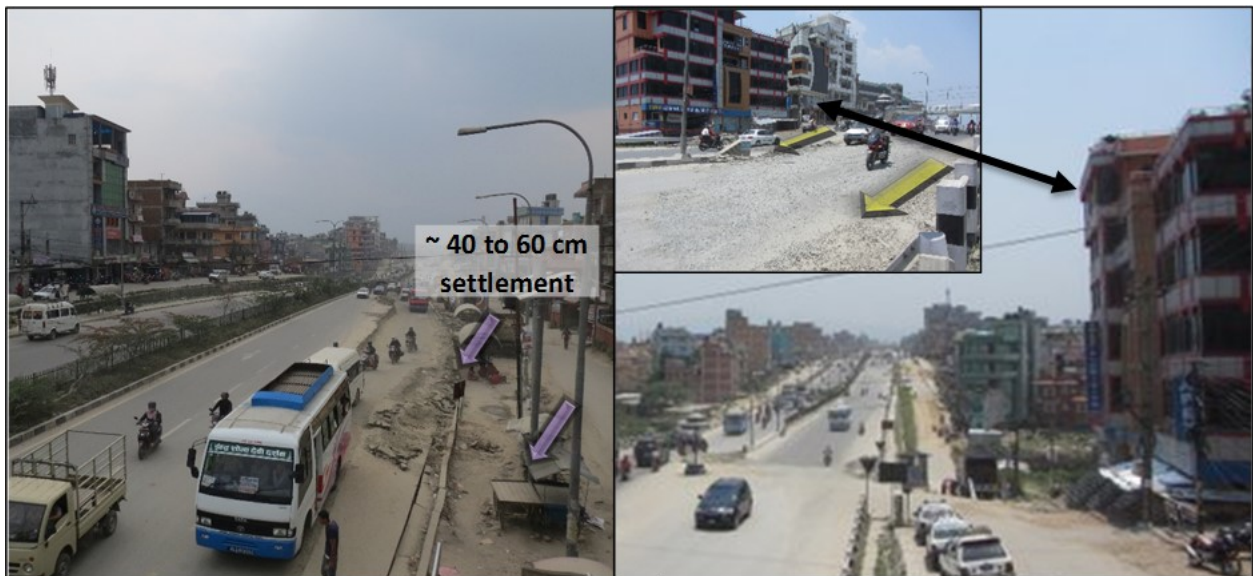
presents pictures of observed lateral cracks and associated vertical offset along the Arniko Highway. Figure 8-4a shows the lateral cracks and associated vertical offset towards the sloping ground, while Figure 8-4b shows the significant vertical offset along the highway.

Figure 8-4 Road damage due to liquefaction induced ground failure in Arniko Highway in Lokanthali, 27°40'29.06"N 85°21'36.77"E.

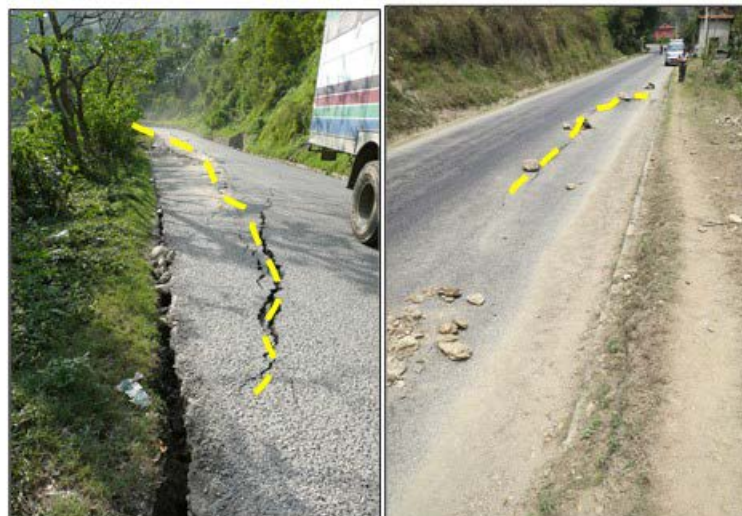
Figure 8-5 Lateral cracks observed on Blacktop roads.

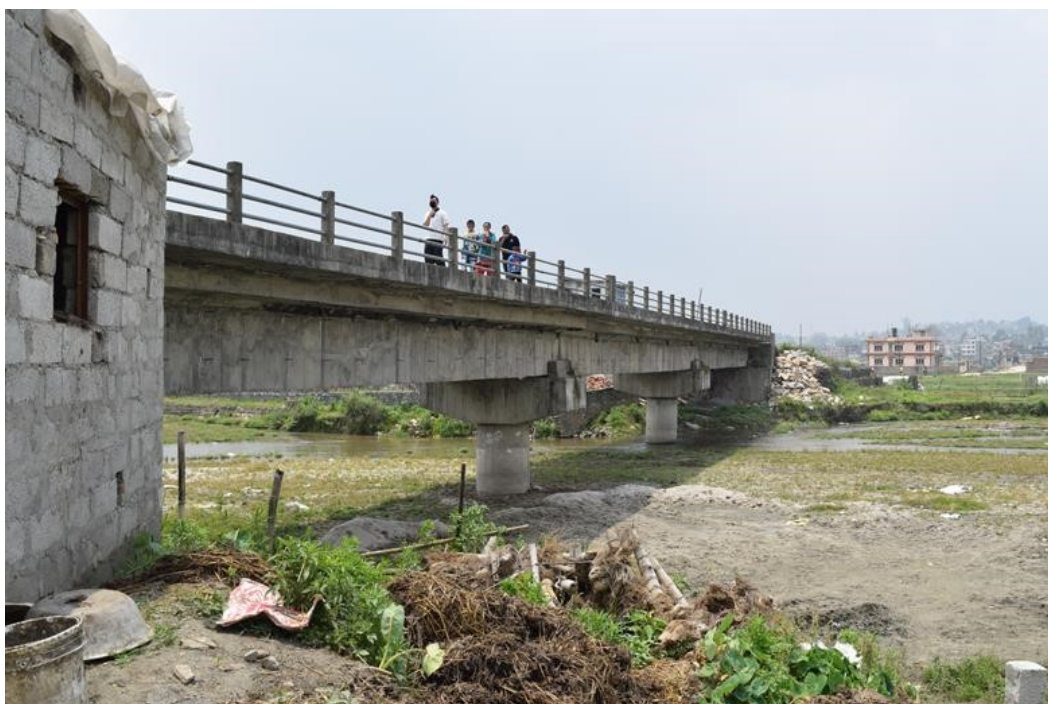
Figure 8-8 Manahara Bridge at Duwakot. This bridge performed well despite of several liquefaction induced sand boils evidenced near the bridge (27°40'23.1"N, 85°20'30.6"E & 27°42'49.584"N 85°24'42.26"E).

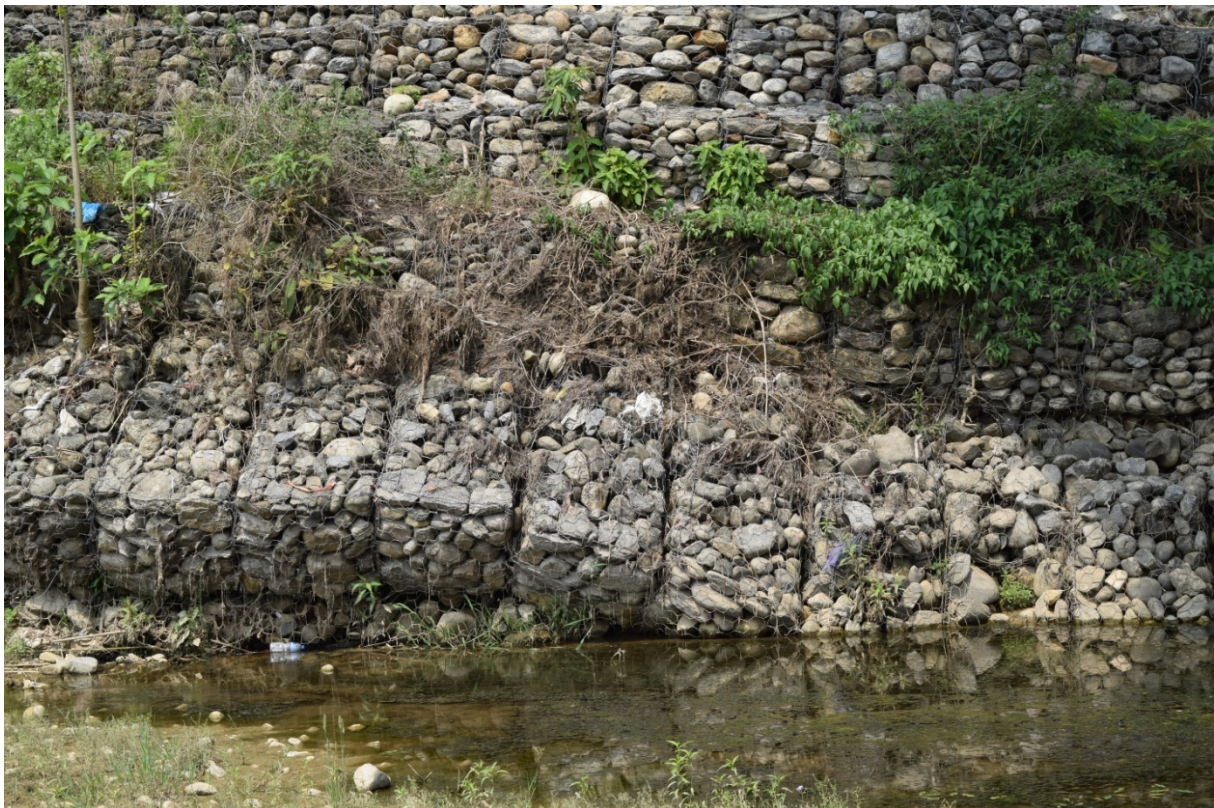
Figure 8-10 Collapse of gabion bank protection retaining wall along Madi Khola due to river bank erosion

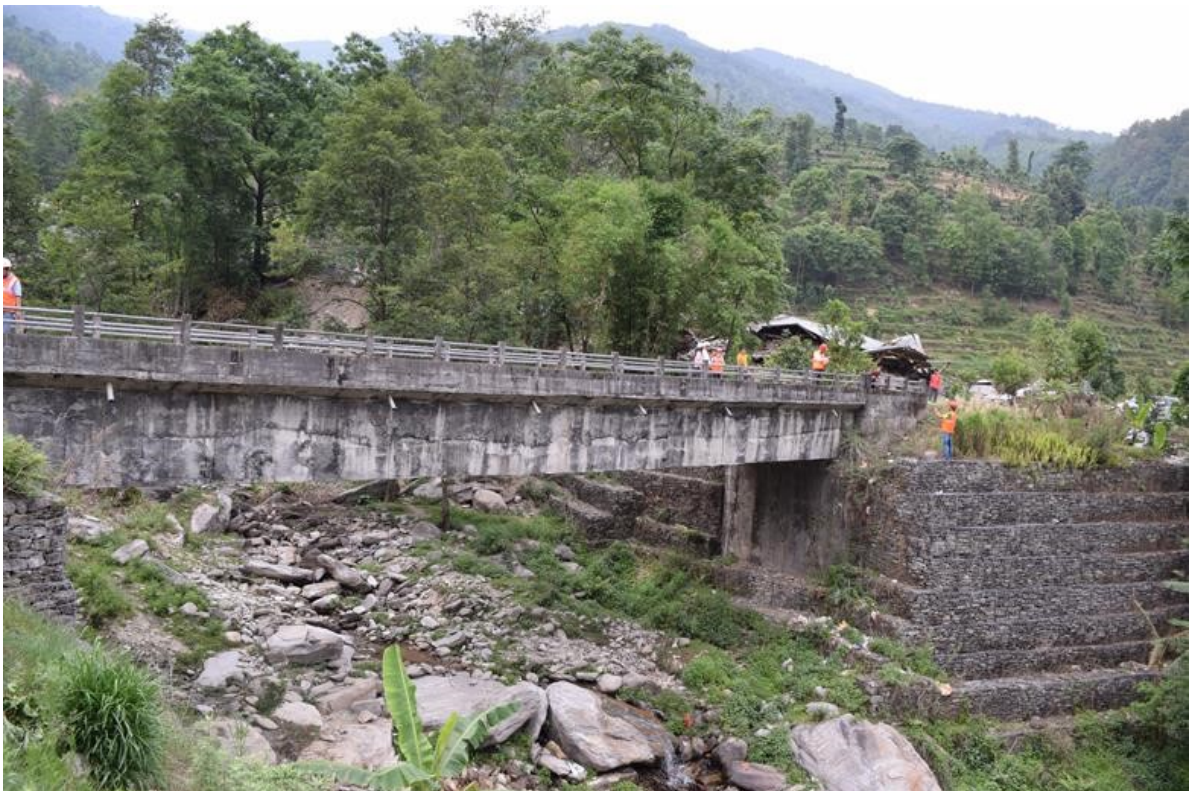
Figure 8-12 Bridge along the access road of Melamchi Water Supply Project being threatened by potential landslides along river banks and seismic settlement of road fill materials (27°55'38.43"N 85°33'14.510"E).

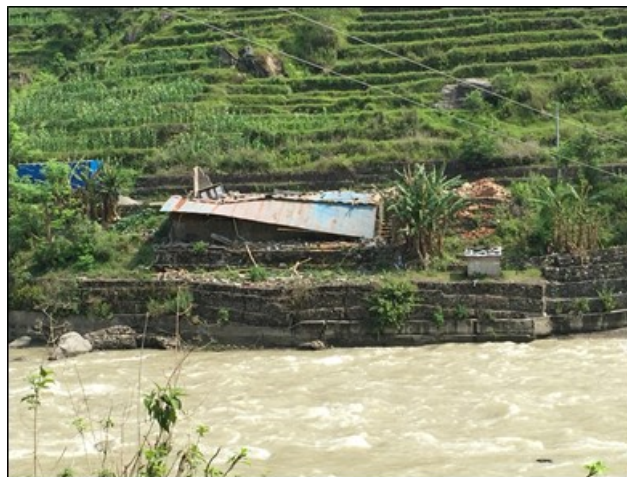
Figure 8-15 Damage in retaining walls due to the slope failures (a) 27 45' 22.2"N 85 51' 8.18"E

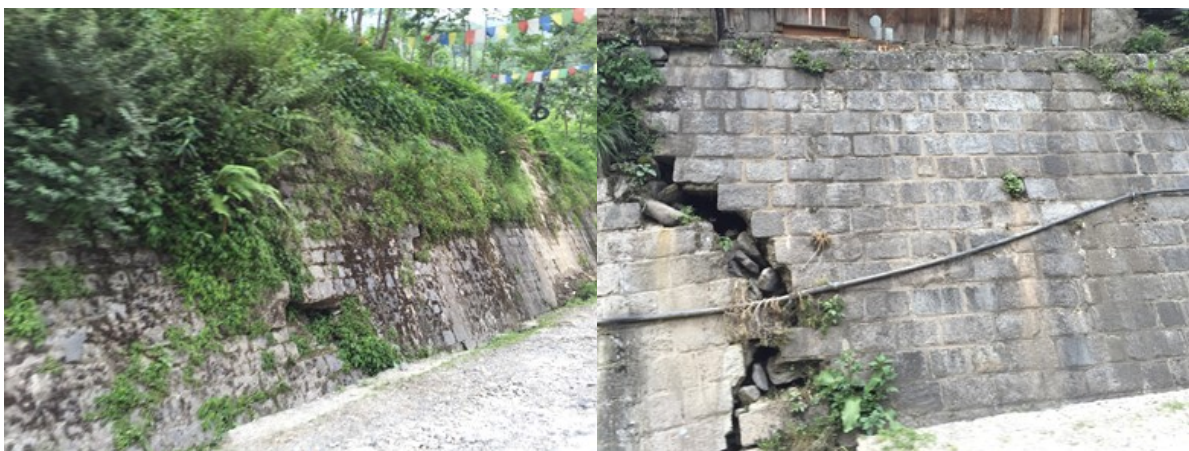
Figure 8-16 Damaged Retaining Wall (a) 27 57' 36.4"N 85 57' 24.2"E, (b) 27 56' 57.2"N 85 57' 8.28"E.

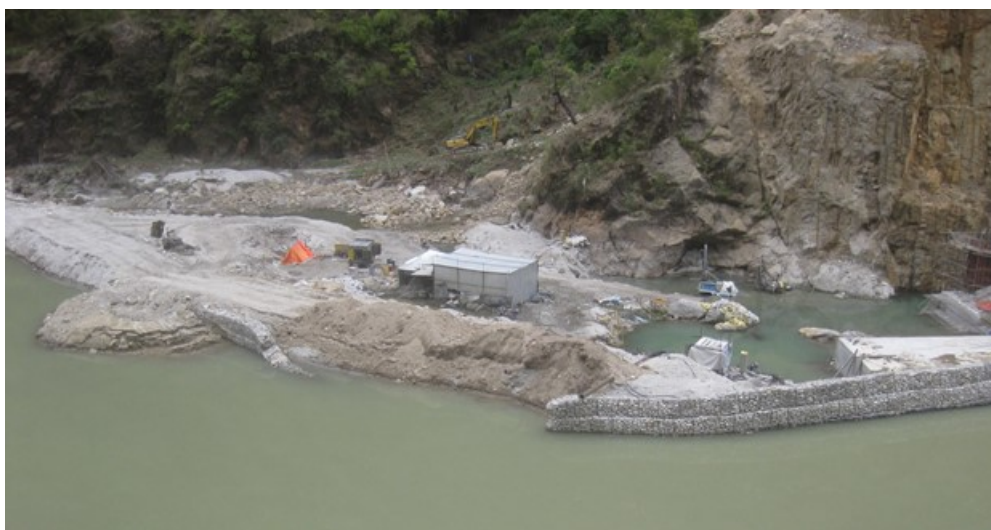
Figure 8-18 Lost diversion wall at Upper Tamakoshi Hydropower Plant (27 55'29.1"N, 86 12'47.26"E)

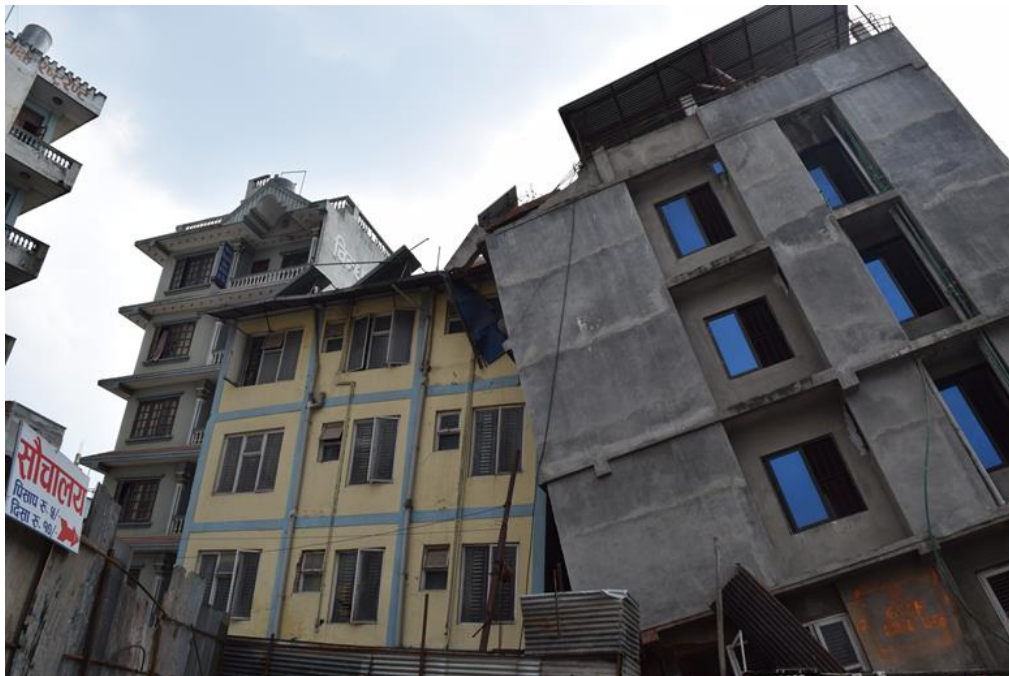
Several buildings in Balaju area (and Gogabu area, which is close to Balaju) collapsed during the earthquake. The majority of these buildings (such as Figure 9-6 through Figure 9-9) have an open ground floor level, and failure might have occurred due to the lack of shear walls. However, a detailed study is required to understand the actual cause of the damage. The cause for the collapse of a six story school building (Figure 9-6) is still unknown.

Figure 9-5 Soft-story collapse of a five story building at Gogabu area ($27^{\circ}44'2''$ N, $85^{\circ}18'42''$ E).

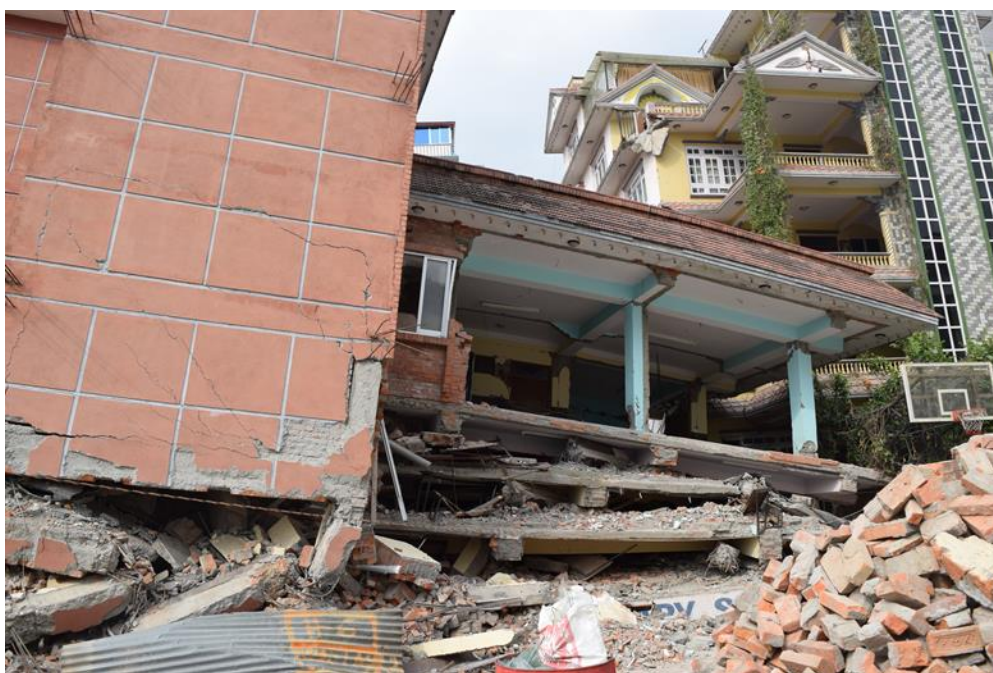
Figure 9-6 Soft story collapse of a six-story school building during the earthquake shaking ($27^{\circ}44'15.5''$ N, $85^{\circ}18'33.8''$ E).

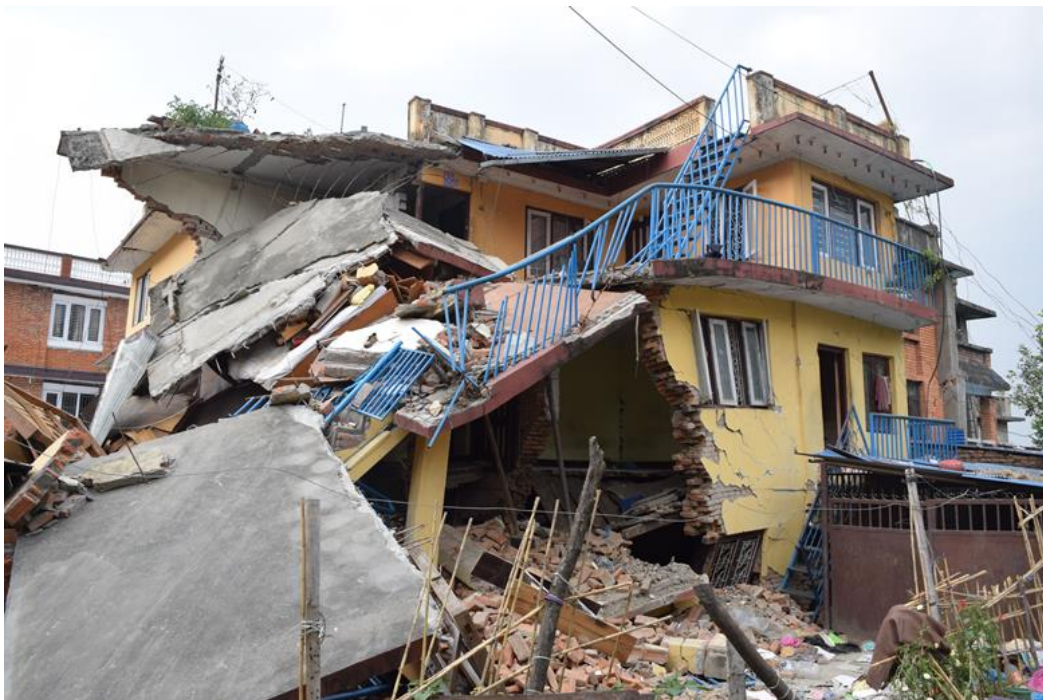
At the ridge of Balaju (known as the Bashara area), several buildings collapsed in a row (Figure 9-10). This could possibly be due to basin edge amplification effects, although detailed investigation is required to confirm this. One RCC frame structure under construction at that area sustained only minor damage (Figure 9-11).

Figure 9-10 Building damage pattern at the ridge of Balaju Baisdharma area. This area is considered a rock site ($27^{\circ}44'6.71''$ N, $85^{\circ}18'11.51''$ E).

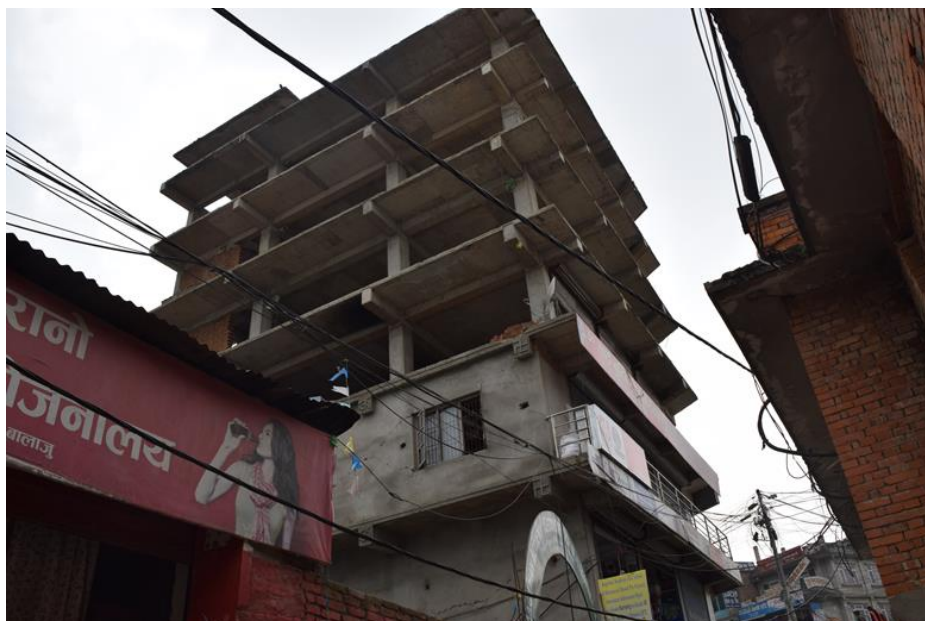
Figure 9-11 Building under construction at Balaju Baisdharma area ($27^{\circ}44'8.28''$ N, $85^{\circ}18'6.91''$ E).

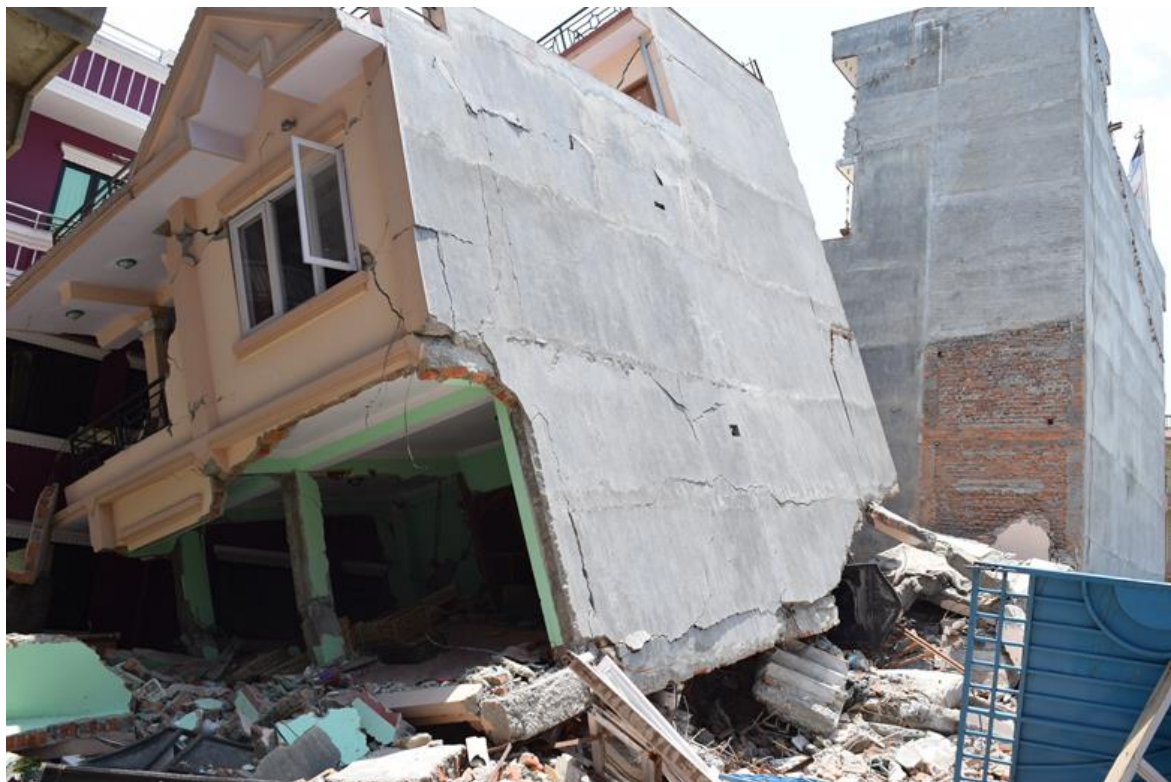
Figure 9-16 More than 5 buildings were collapsed near this building at Sitapaila area (next to the building shown in Figure 9-15).

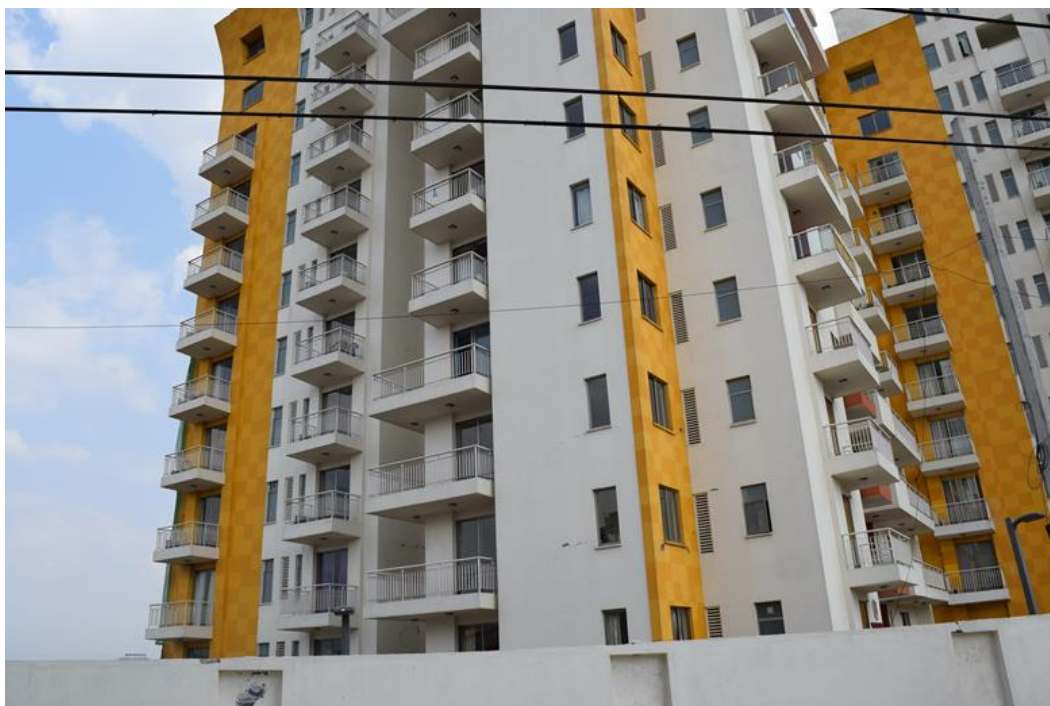
Figure 9-27 Minor damage sustained by an apartment complex at Bishal Nagar ($27^{\circ}43'40''\text{N}$, $85^{\circ}20'05''\text{E}$).

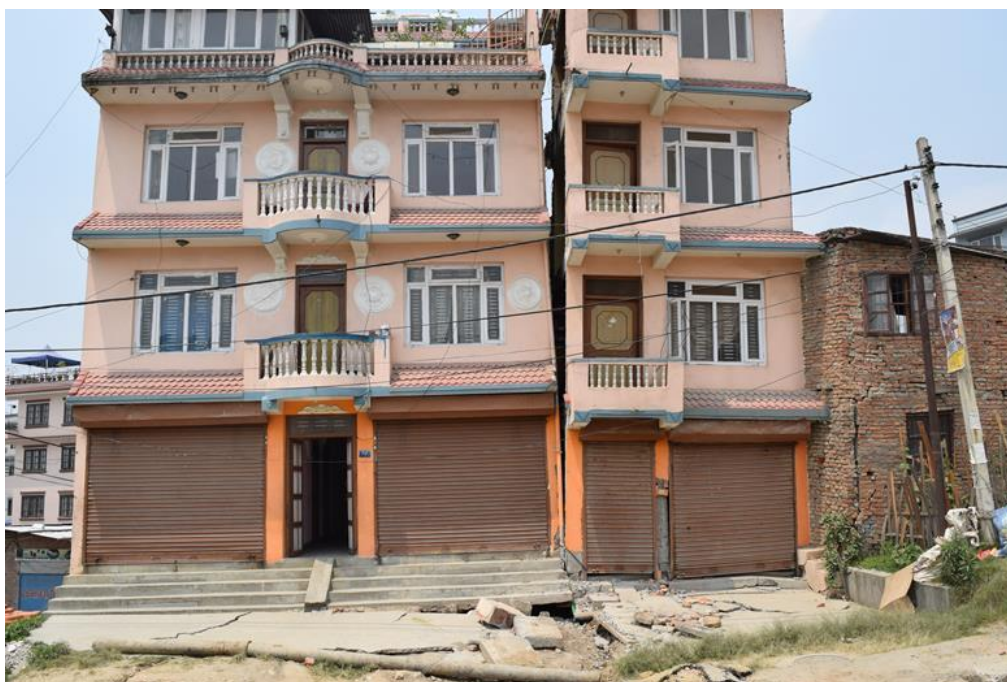
There were some locations where buildings were damaged due to geotechnical effects such as ground failure or foundation failure. One example of such failure are the buildings damaged at Lokanthali due to the liquefaction induced lateral spreading (Figure 9-28 and Figure 9-29).

Figure 9-28 House tilted at Lokanthali area due to the lateral spread ($27^{\circ}40'29.28''\text{N}$, $85^{\circ}21'49''\text{E}$).

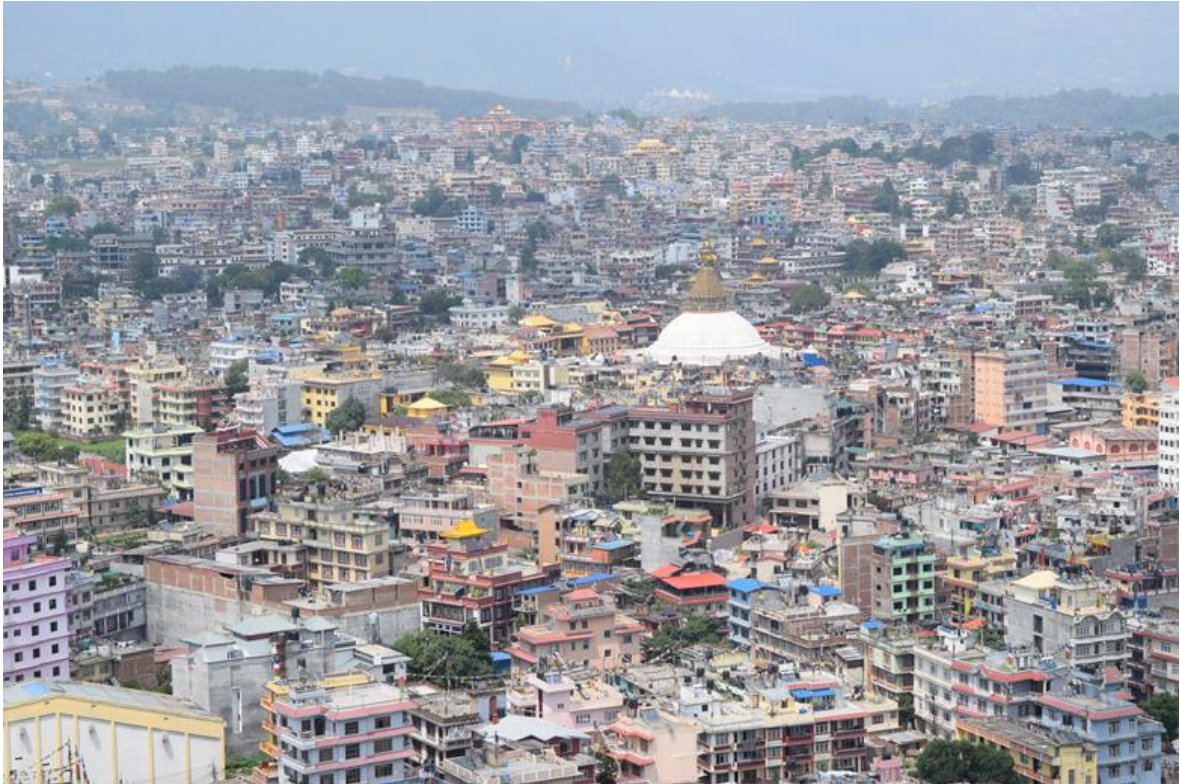
In the north-eastern part of the basin, extensive structural damage was not noted (Figure 9-30). Stupas sustained less damage compared to temples. Many old buildings with unreinforced brick masonry in mud mortar and temples in Bhaktapur sustained serious damage due to the strong ground motion (Figure 9-31 and Figure 9-32). The majority of modern buildings showed only a small extent of damage. There were several isolated cases in Kathmandu where multi-story buildings collapsed (Figure 9-33). The team visited Indrayani village, which is located along a broad ridge, and observed similar damage patterns as in Bhaktapur (where old buildings collapsed and the RCC buildings sustained less damage) (Figure 9-34).

Figure 9-30 Aerial view of north-eastern part of Kathmandu near Bouddhanath temple.

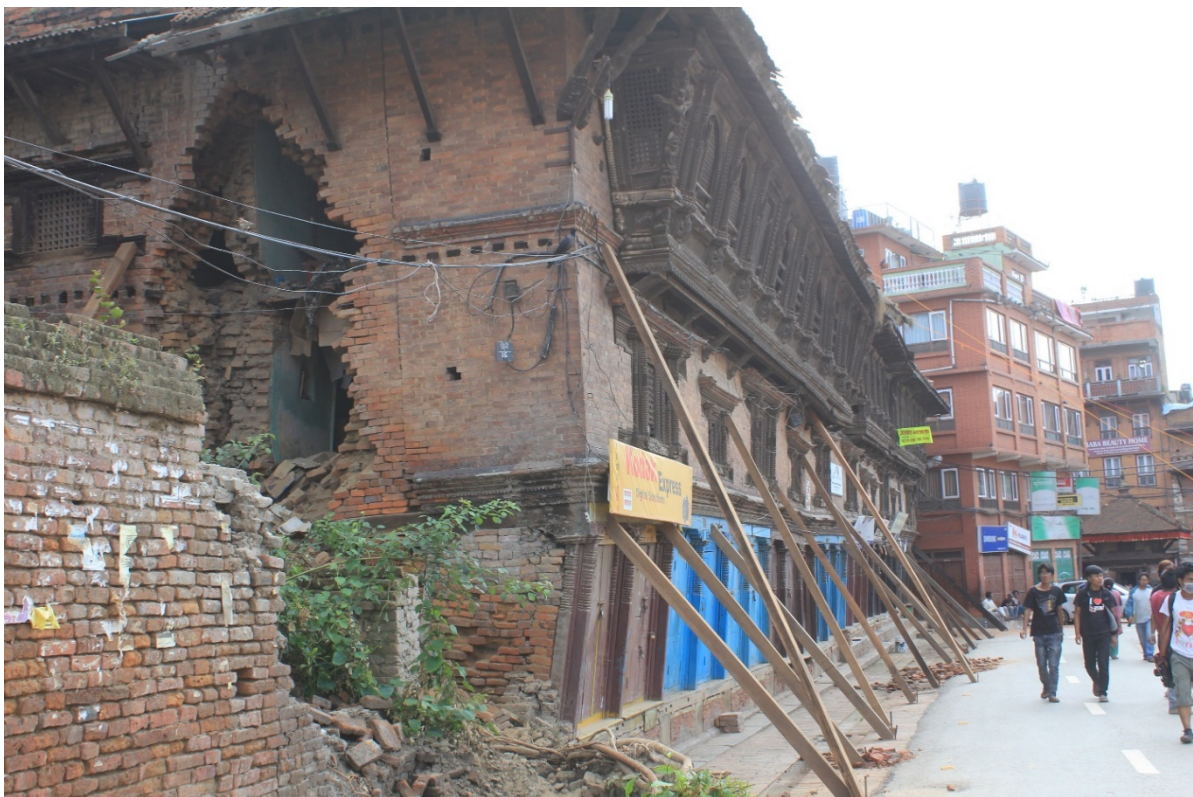
Figure 9-36 Distressed unreinforced masonry building and façade following the May 12, 2015, M_w 7.3 aftershock (27° 40' 19.45" N; 85° 25' 40.80" E).

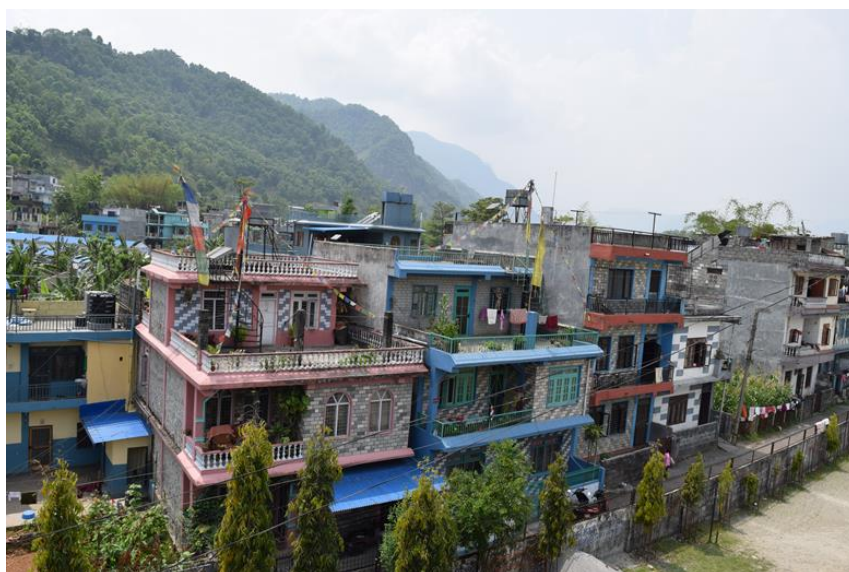
Buildings in Pokhara sustained less damage compared to those in Kathmandu due to the comparatively lower levels of ground shaking in Pokhara (Figure 9-38). However, several buildings exhibited structural cracks (Figure 9-39 and Figure 9-40).

Figure 9-38 Typical building pattern in Pokhara. Majority of these buildings performed well.

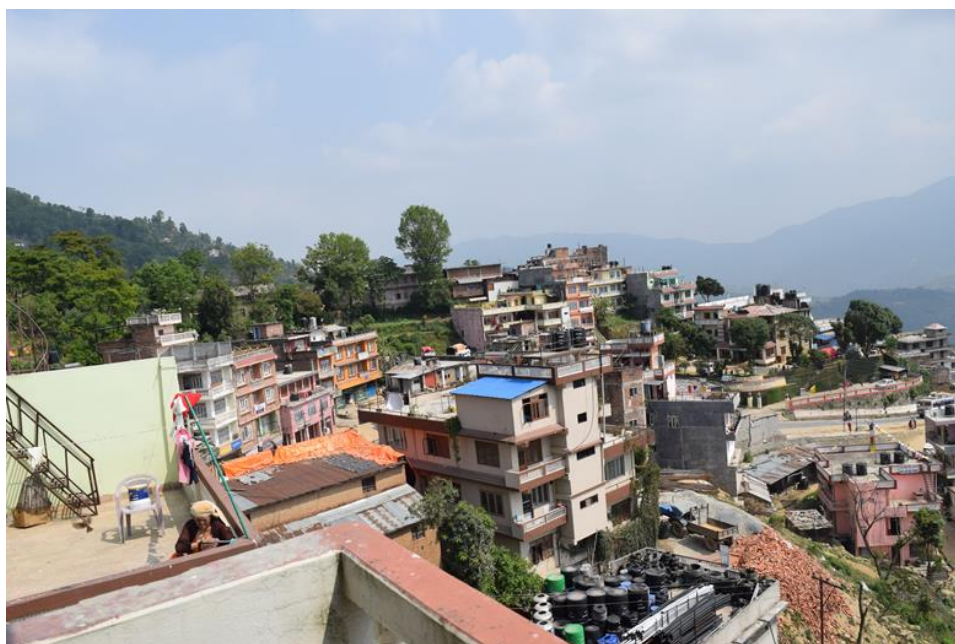
Figure 9-41 Modern buildings in Gorkha Bazar did not sustain massive damage due to the ground shaking.
