Executive Summary

The April 25, 2015 Gorkha (Nepal) Earthquake and its related aftershocks had a devastating impact on Nepal. The earthquake sequence resulted in nearly 9,000 deaths, tens of thousands of injuries, and has left hundreds of thousands of inhabitants homeless. With economic losses estimated at several billion US dollars, the financial impact to Nepal is severe and the rebuilding phase will likely span many years.

The Geotechnical Extreme Events Reconnaissance (GEER) Association assembled a reconnaissance team under the leadership of D. Scott Kieffer, Binod Tiwari and Youssef M.A. Hashash to evaluate geotechnical impacts of the April 25, 2015 Gorkha Earthquake and its related aftershocks. The focus of the reconnaissance was on time-sensitive (perishable) data, and the GEER team included a large group of experts in the areas of Geology, Engineering Geology, Seismology, Tectonics, Geotechnical Engineering, Geotechnical Earthquake Engineering, and Civil and Environmental Engineering. The GEER team worked in close collaboration with local and international organizations to document earthquake damage and identify targets for detailed follow up investigations.

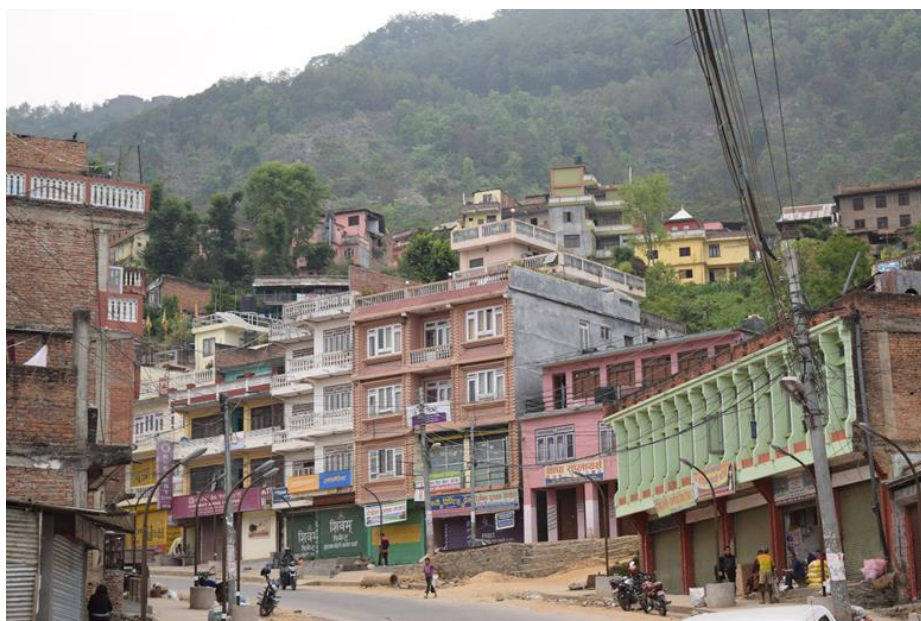
Figure 9-42 Modern buildings in Gorkha Bazar that did not sustain much damage due to earthquake shaking.

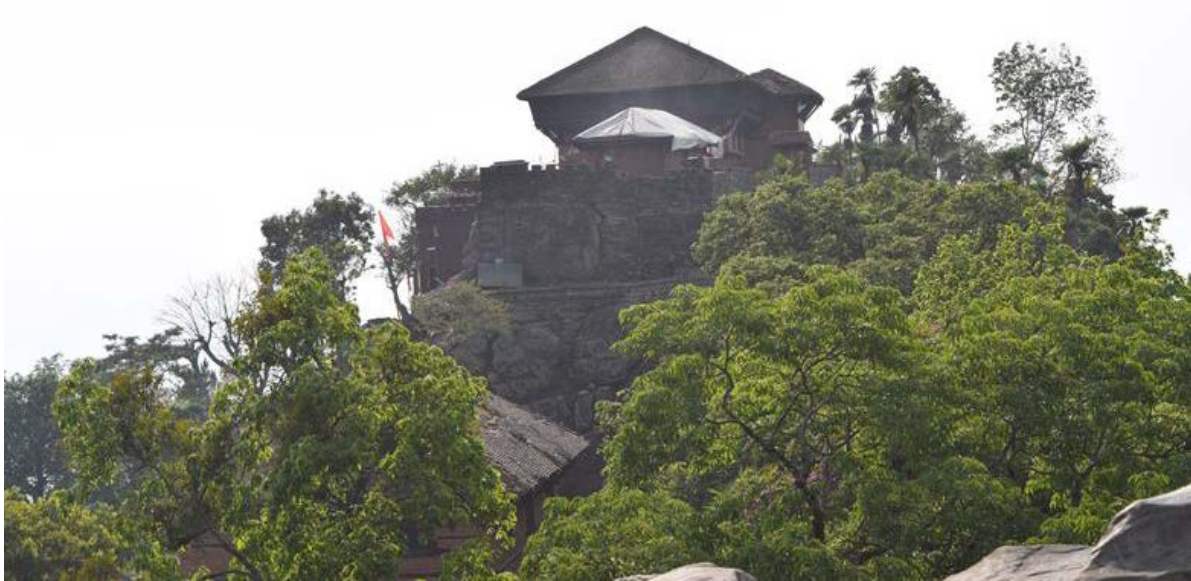
Figure 9-43 Retaining walls of Gorkhna Temple/Gorkha Palace showing shear cracks.

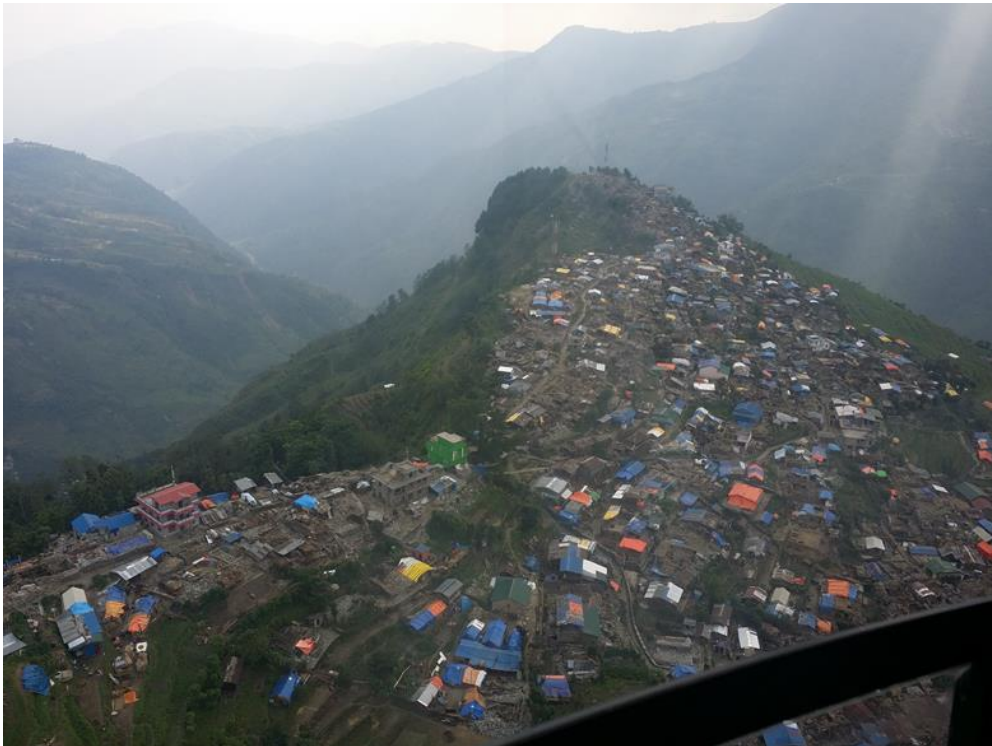
Barpak village is located at the epicenter of the Mw 7.8 earthquake. The majority of buildings are constructed of stone rubble, and the remainder are constructed of RCC, unreinforced stone masonry, or wood framing with metal siding. Nearly all of the stone rubble structures suffered complete collapse (Figure 9-45 through Figure 9-48). In stark contrast, with few exceptions both RCC and wood framed structures with metal siding suffered no damage (Figure 9-49 and

Figure 9-45 An aerial view of seismic damage at Barpak Village.

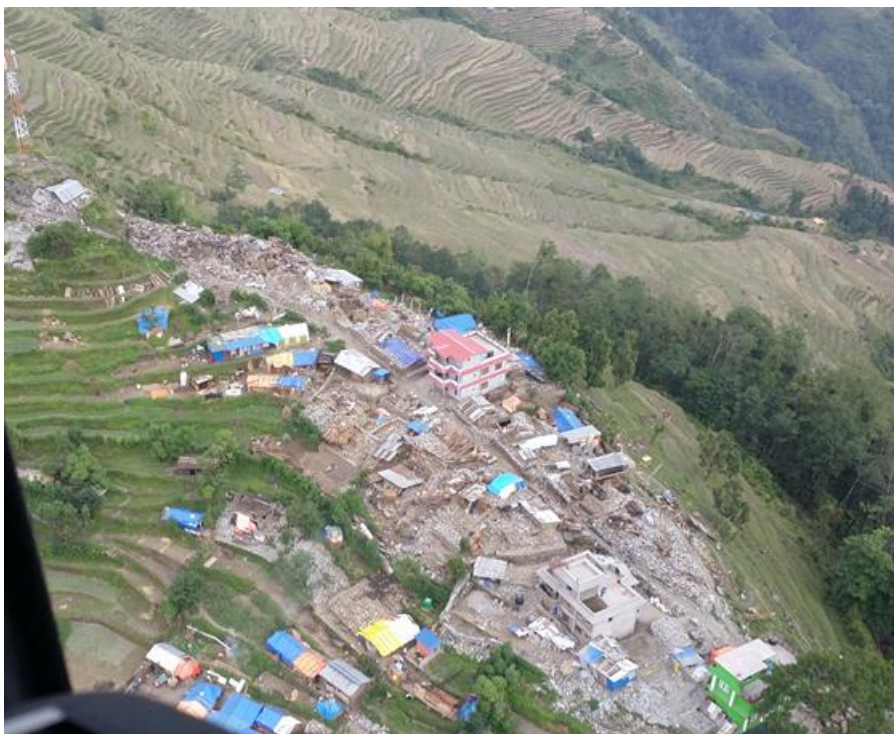
Figure 9-46 A closer look at the damage pattern in Barpak Village.

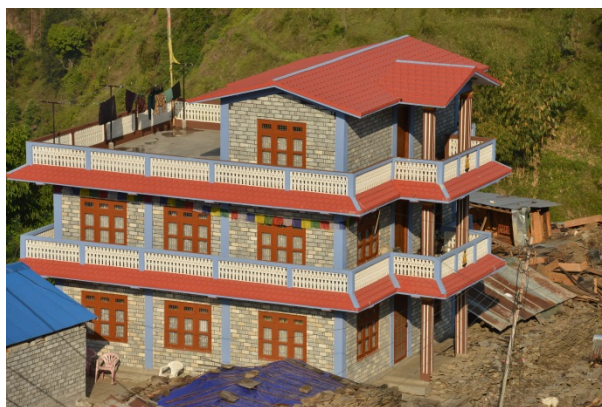
Figure 9-49 Typical condition of RCC structures in Barpak.

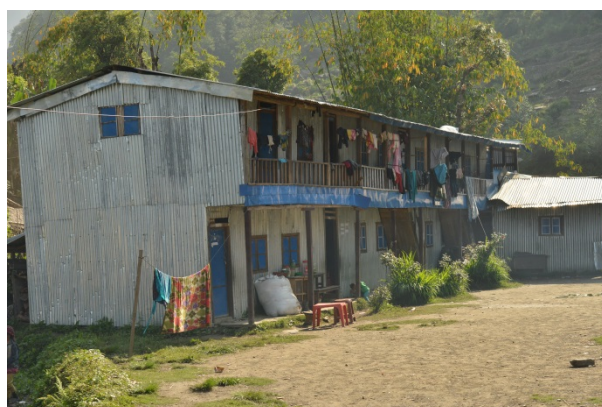
Figure 9-50 The school building of Barpak (wood framing with metal sheet siding).

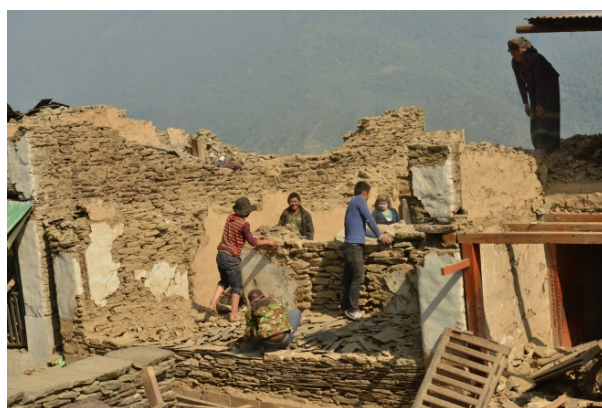
Figure 9-50). Unfortunately, with the limited available local resources and urgency to provide shelter through the monsoon and winter, Barpak is being actively rebuilt with highly vulnerable stone rubble structures (Figure 9-51)

Figure 9-51 Rebuilding Barpak with stone rubble.

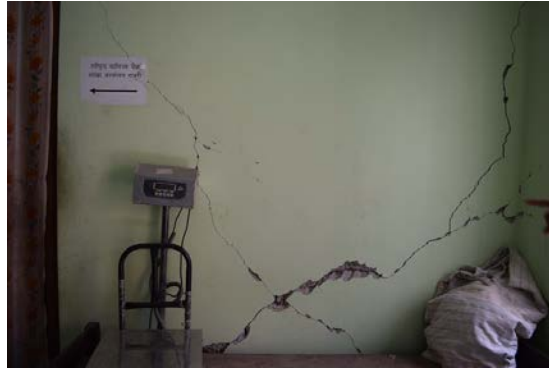
Figure 9-52 Structural damage pattern at a building in Gajuri, Dhading.

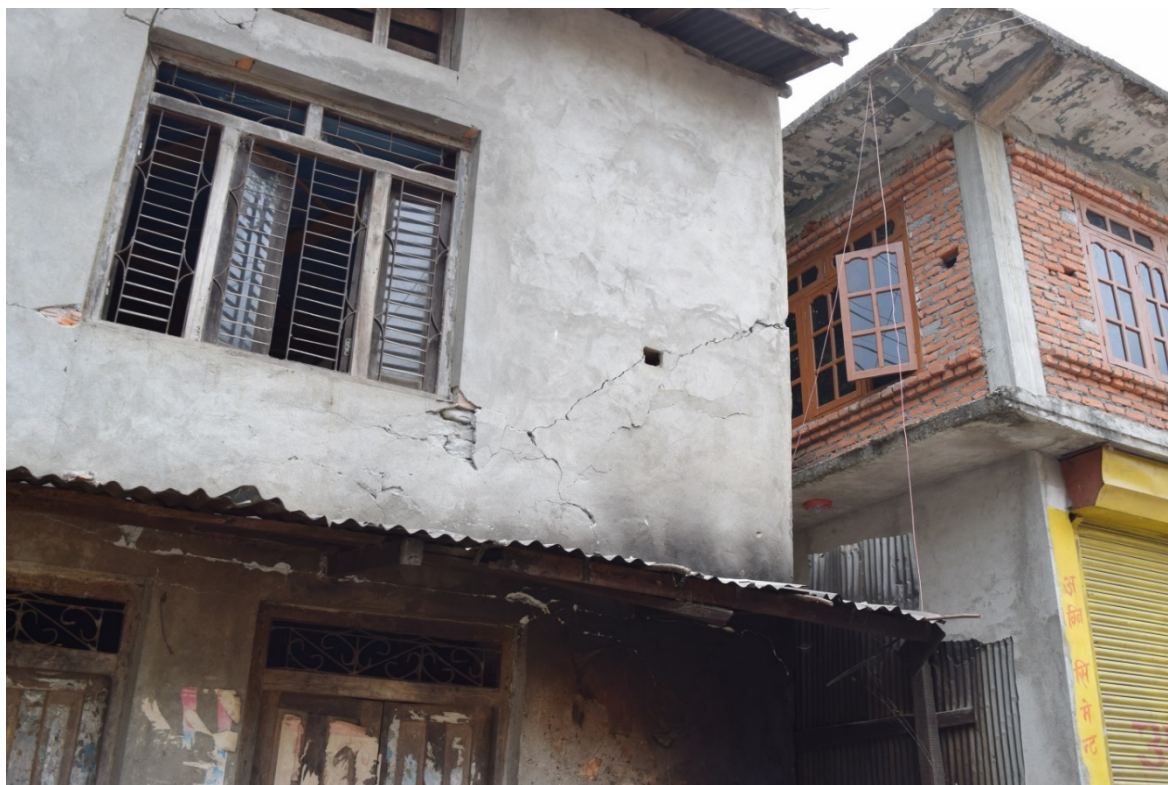
Figure 9-56 Another example of comparative performance of unreinforced and reinforced buildings in Melamchi, Sindhupalchowk.

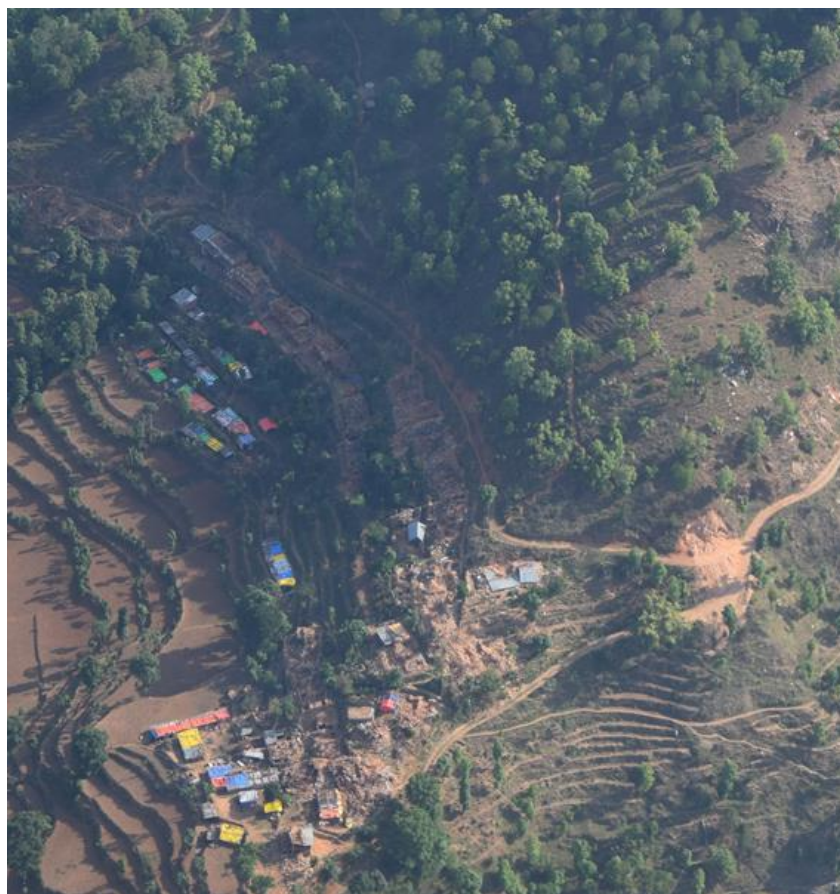
Figure 9-58 An entire village flattened in Sindhupalchowk due to strong ground shaking.

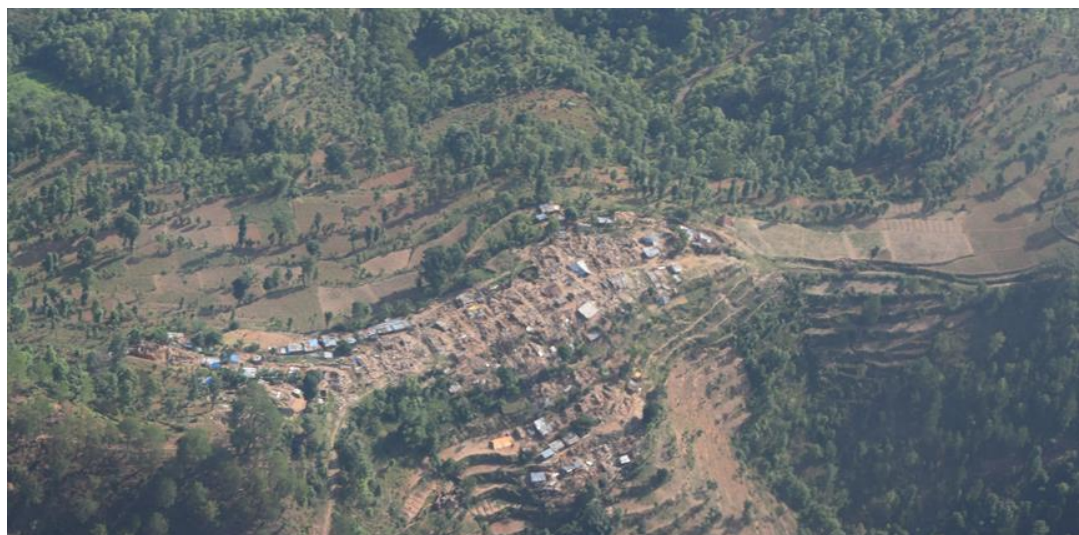
Figure 9-59 Another example of entire village flattened due to earthquake shaking in Sindhupalchowk.

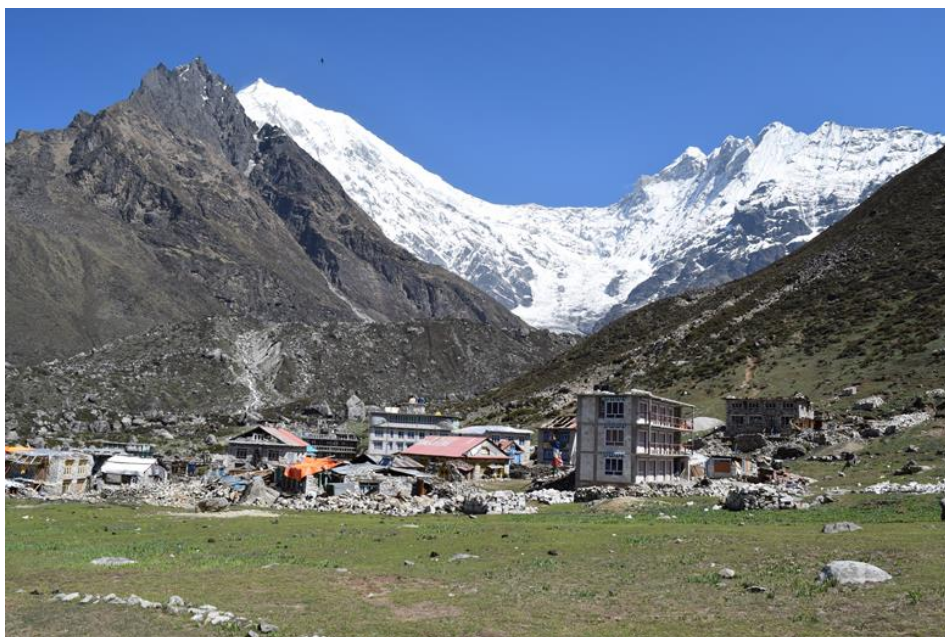
Along the Langtang Trekking Route, almost all small trekking villages and lodges had collapsed. Modern RCC structures performed well whereas the unreinforced stone rubble masonry structures collapsed (Figure 9-60). Within the Rasuwa district along the catchment of Trishuli River near Rasuwagadi, several villages with buildings constructed of unreinforced masonry sustained severe damage or collapsed (Figure 9-61 and Figure 9-62). However, modern RCC buildings in Dhunche performed well (Figure 9-63). As can be observed in

Figure 9-60 RCC structures at Kangjun Gumba, Langtang Trekking Route performed well whereas the unreinforced stone masonry walls flattened due to seismic shaking ($28^{\circ}12.7'0''$ N, $85^{\circ}34.1'0''$ E).

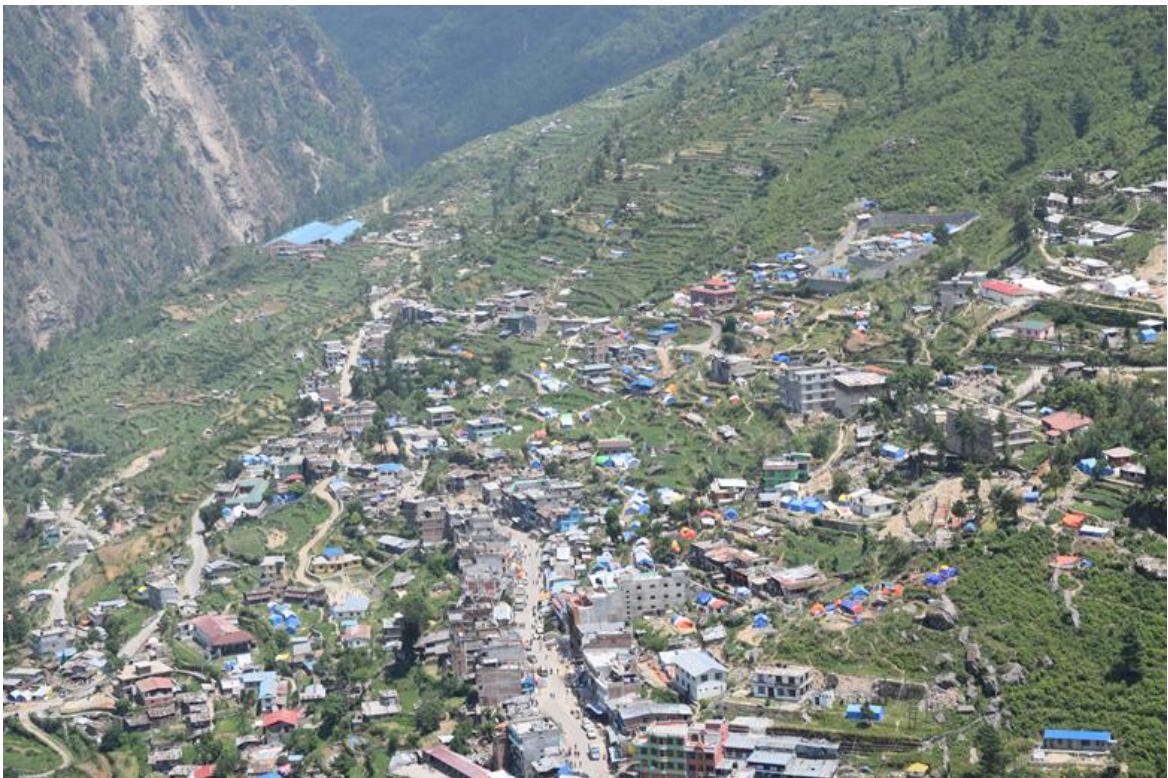
Figure 9-63 Several modern RCC structures at Dhunche of Rasuwa District performed well during the earthquake.

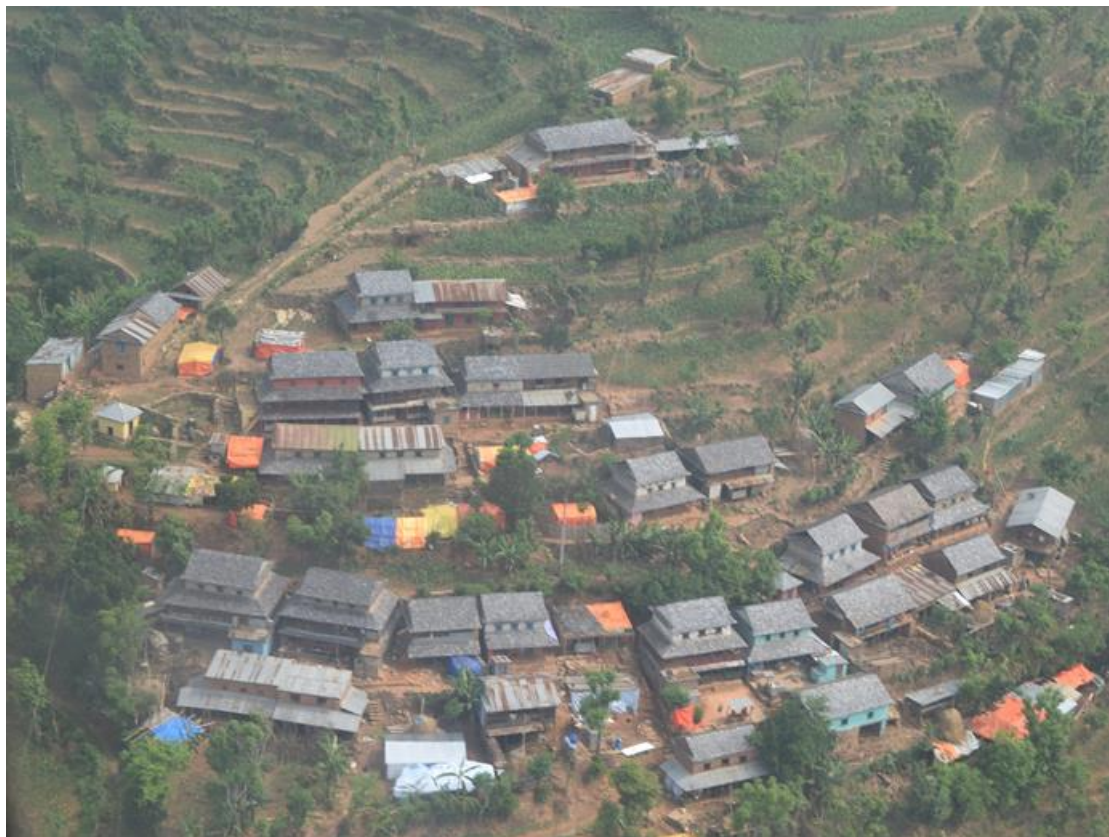
Figure 9-65 Villages near Sundarbazar did not show similar extent of damage as was observed in Rasuwa and Sindhupalchowk.

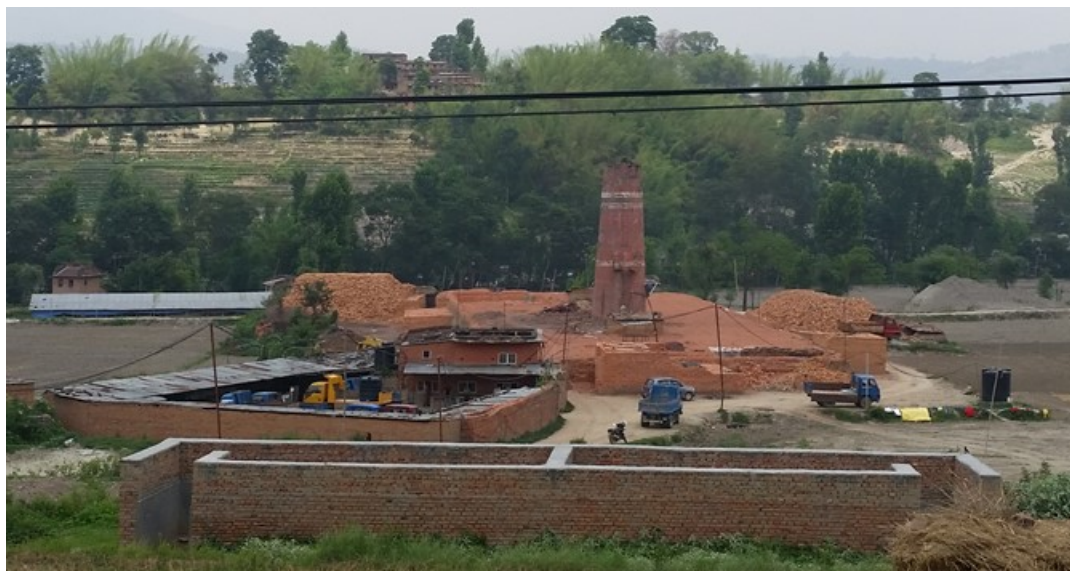
Brick is a primary construction material in Nepal and is produced in kilns located across the country. These kilns have also been a dominant source of air pollution in the Kathmandu Valley. Many kilns stopped operation after the earthquake due to damage to their smokestacks (Figure 9-70). This resulted in likely temporary improvement in air quality however resulting in shortage in building material necessary for reconstruction.

Figure 9-70 Damaged smokestack at a brick kiln in the Kathmandu Valley southeast of Bhaktapur (27° 29' 52.9" N, 85° 26' 52.9" E).
